ABN 12 115 961 487  
PO Box 88  
Bacchus Marsh Vic 3340  
Phone: (03) 5366 6900  
Email:  
Report By:

<b>Dwelling type:</b>	House and Garage.
<b>Dwelling configuration:</b>	Single Storey.
<b>Nature of works:</b>	New Building.
<b>Stage of inspection:</b>	Final 2nd Re-inspection.
<b>Construction Type:</b>	Brick Veneer.
<b>Garage:</b>	Attached.
<b>Foundations:</b>	Slab.
<b>Builder:</b>

### **Defects, observations and other related comments from the Final Inspection on the 2021:**

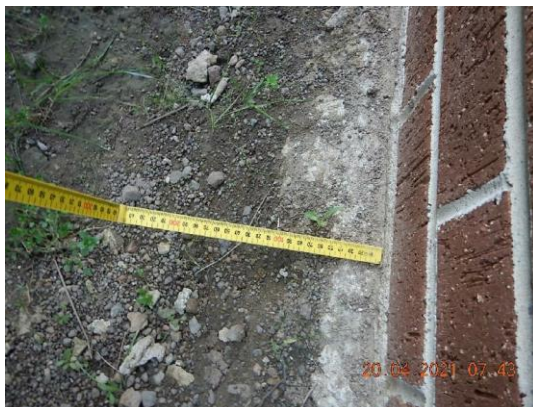
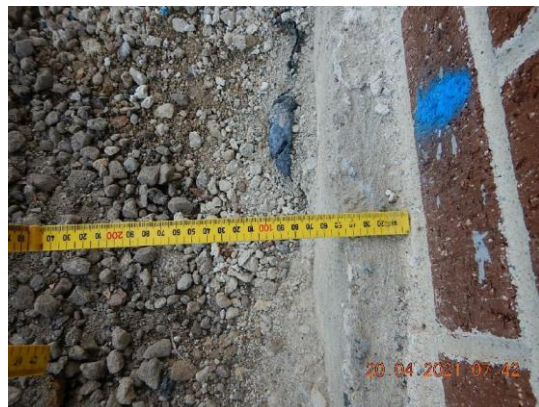
Rear.

LHS.

The over pour will need to be removed. This will require:

- Seek engineering process and design for rectification of this defect.
- Document same.
- Send the engineering to the site surveyor for approval.
- Have the site surveyor witness the repair of the slab to ensure that the builder has carried out the works in accordance with the processes and rectification statements in the engineering documentation.
- Supply a copy of all to my client as per section 26 of the Domestic building contracts Act 1995.
- Satisfy the defect has not been hidden by placing soil over the edge beam of the over poured slab.

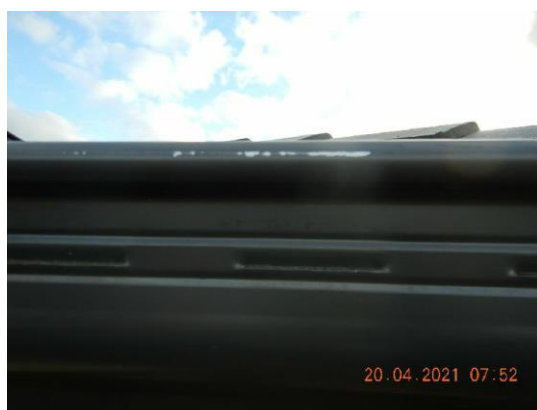
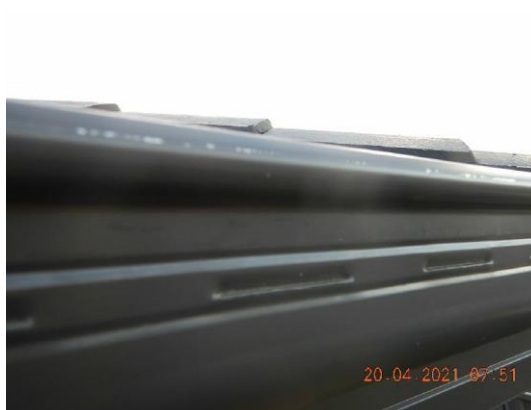
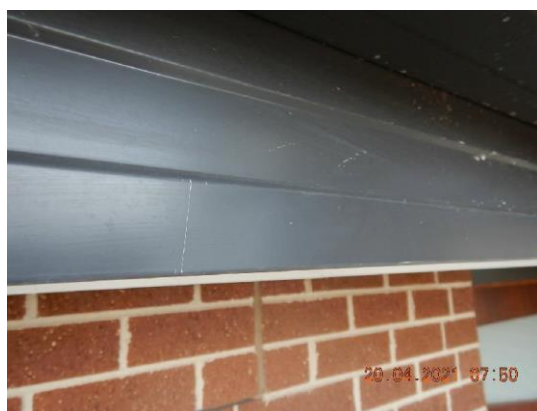
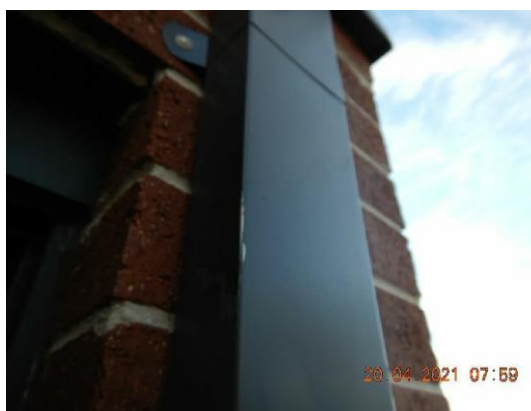
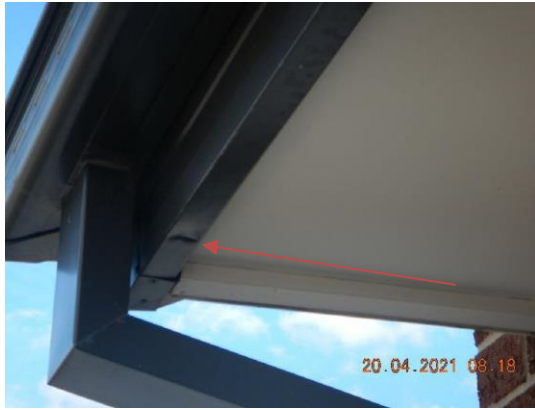
**5.**

The BlueScope Colorbond roofing products to the dwelling have been damaged during construction.

Dint, front elevation LHS.

Damaged areas greater than 2mm in width will need to be replaced.

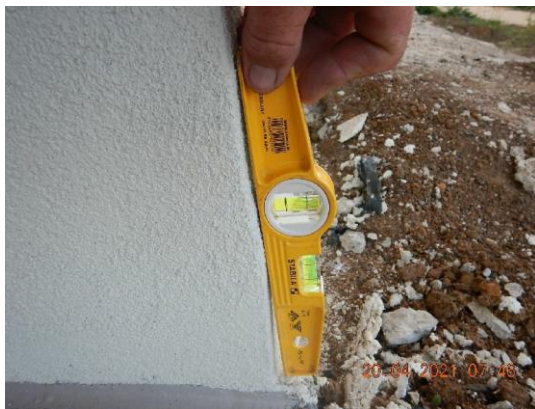
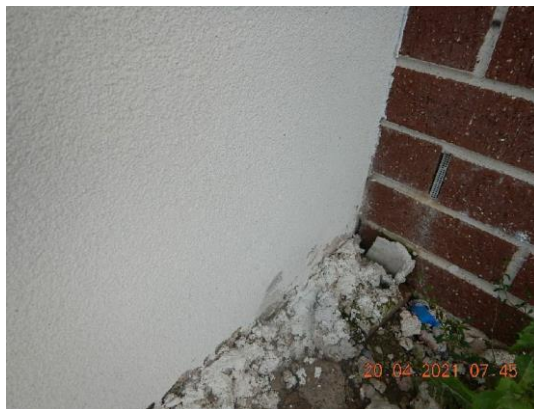
6.

**VBA Guide to Standards and Tolerances:** - Rendered surfaces that show spot rust marks and other blemishes are defective if visible from a normal viewing position.

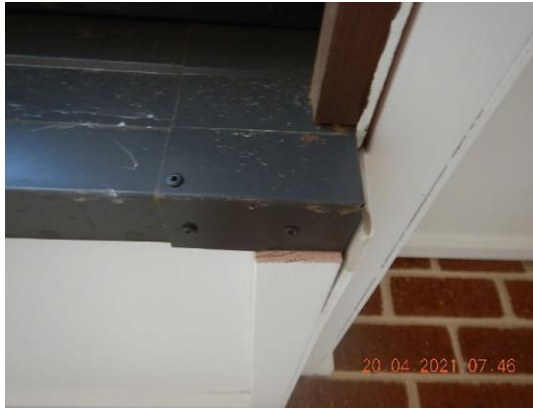
**AS 2311, clause 2.2.3:** - Design should make provision for the protection of all end grain of external timber. To retard the ingress of moisture, exposed timber cladding should be coated all round before being attached to the building framework.

Front porch.

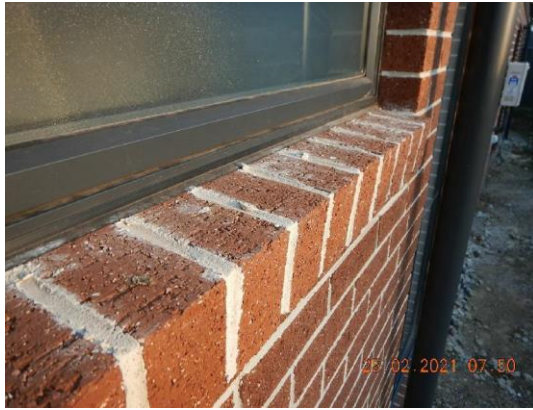
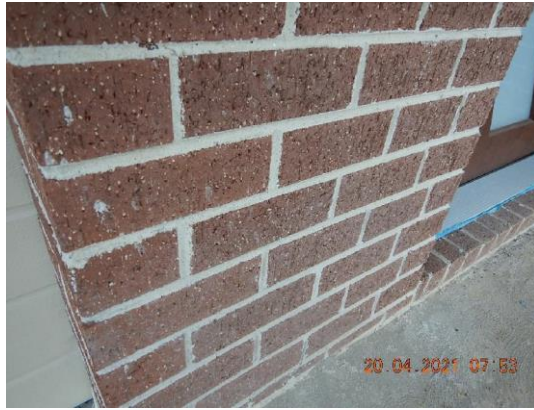
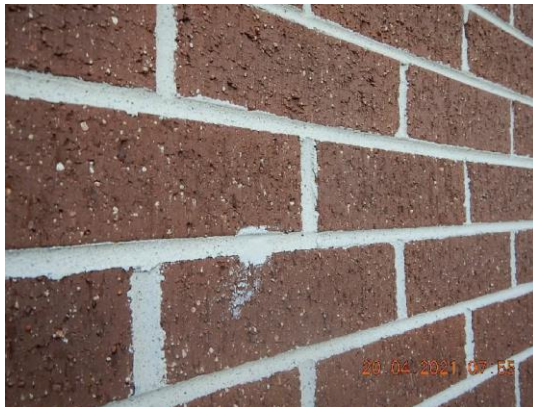
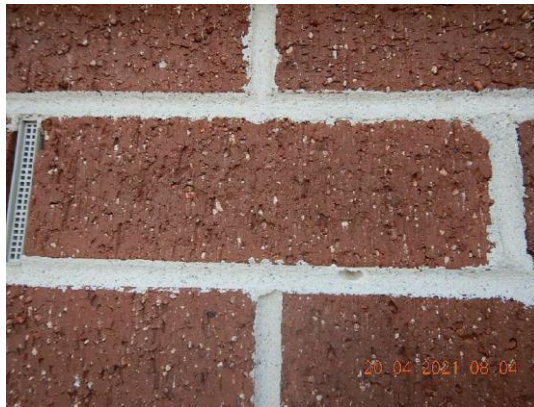
## 9.

**The VBA Guide to Standards and Tolerances:** - Voids, holes, mortar smears, and stains in masonry walls are defective if visible from a normal viewing position.

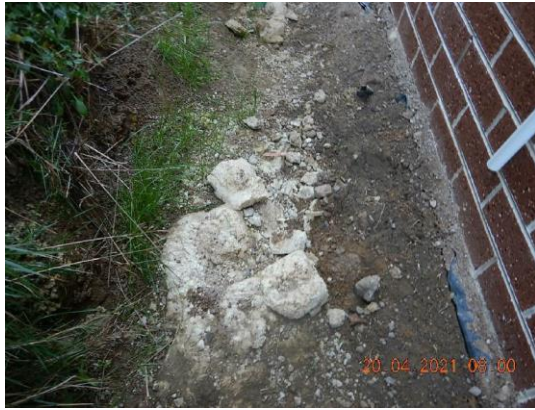
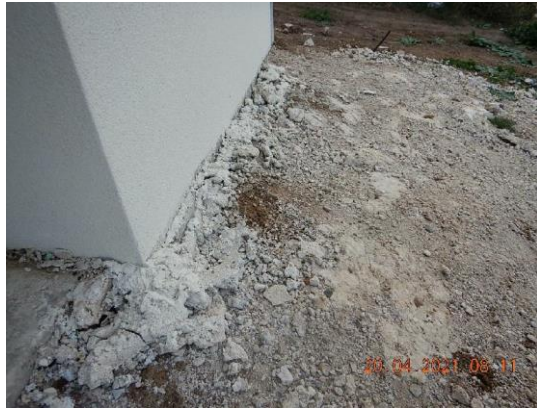
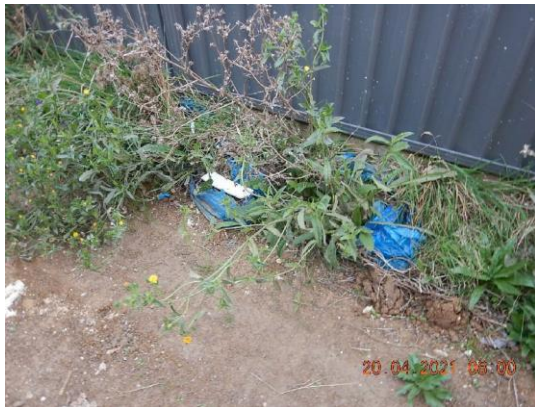
## 10.

**VBA guide to standards and tolerances 2015:** - Building sites are defective if they are not clear of building debris.

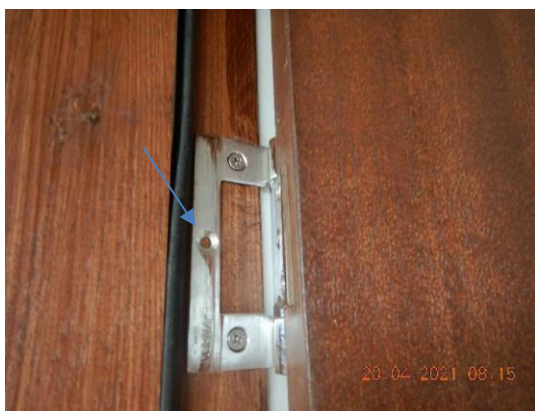
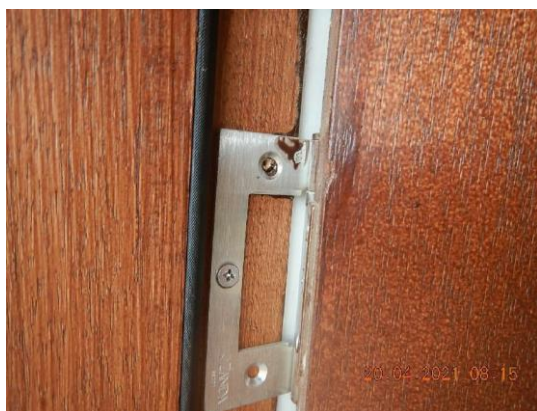
The builder will need to check all hinges and ensure they are fitted in a workman like manor.

Screws & over paint.

- External hinges cleaned or replaced to present as new
- All screws installed
- Hinge pins knocked down
- Hinge pins installed the right way up

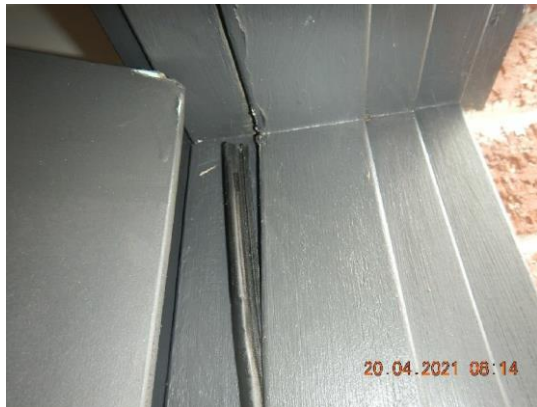
Damaged door seal.

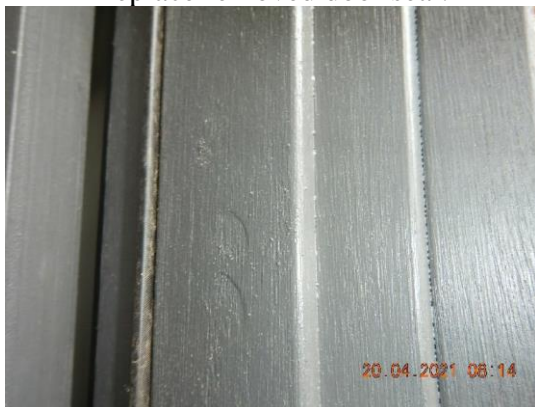
Hammer damage garage rear door.

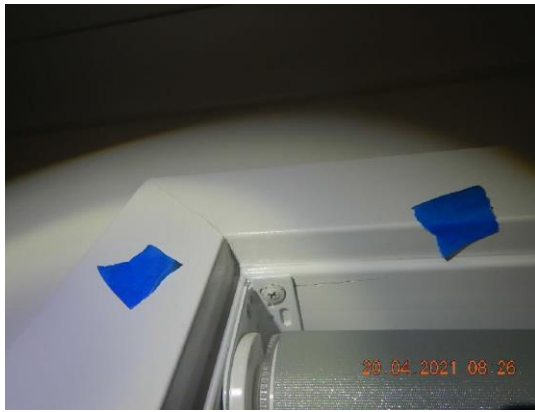
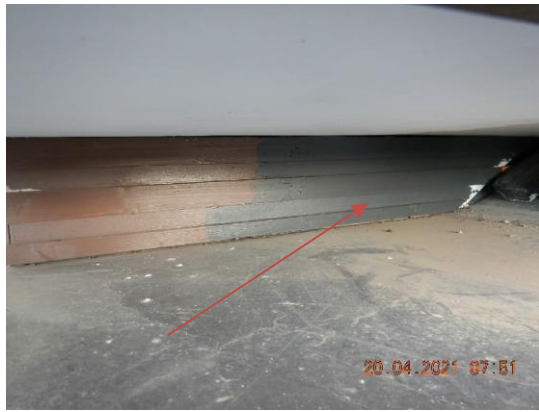
Painted wrong colour.

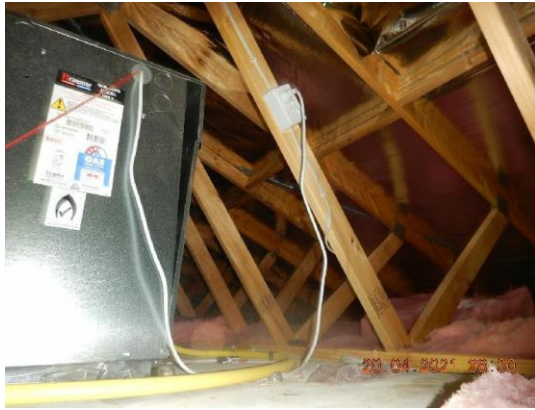
The light switch to this dwelling fails this requirement.

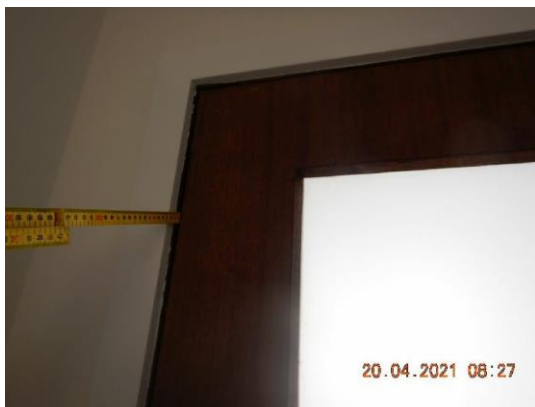
A few door margins will need to be reworked to comply with the inserted.

Check all.

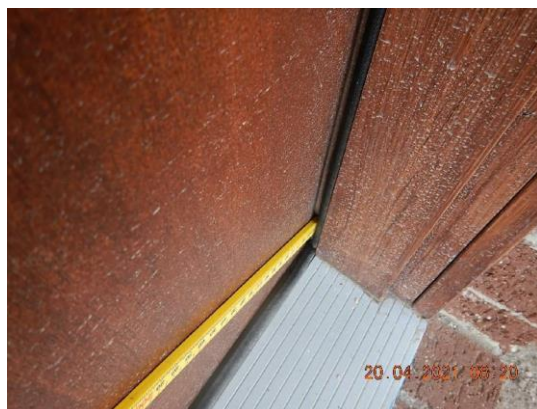
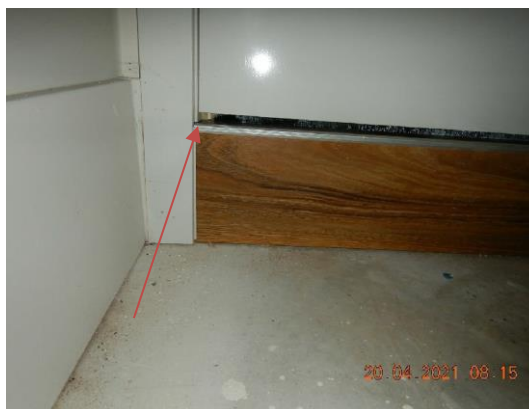
## 19.

The required weather seal as documented is non-functional. The NCC and the energy report on the dwelling calls for all doors and windows to be sealed, all areas must comply.

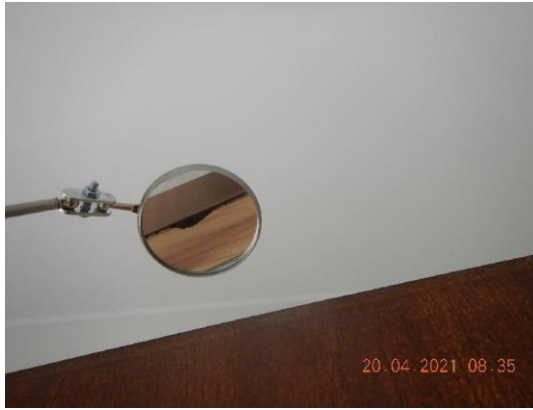
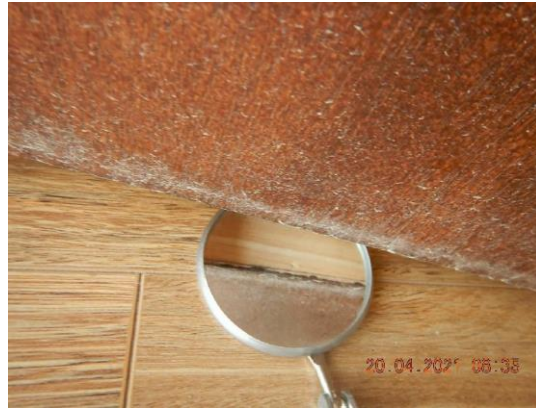
20.

**VBA Guide to Standards and Tolerances:** - Tops and bottoms of door must be sealed in accordance with the manufacturer's specifications.

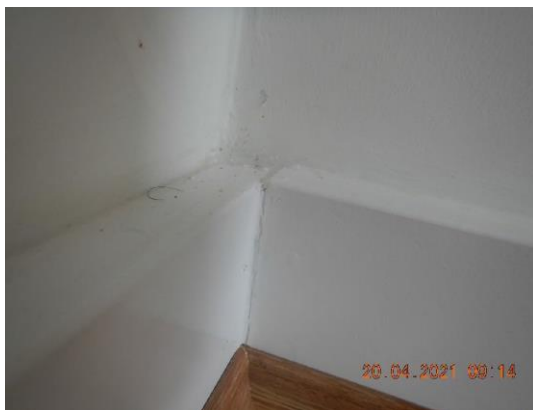
The fixing to this dwelling is presenting as having a few visible defects. All areas must present in accordance with the following.

Misaligned.

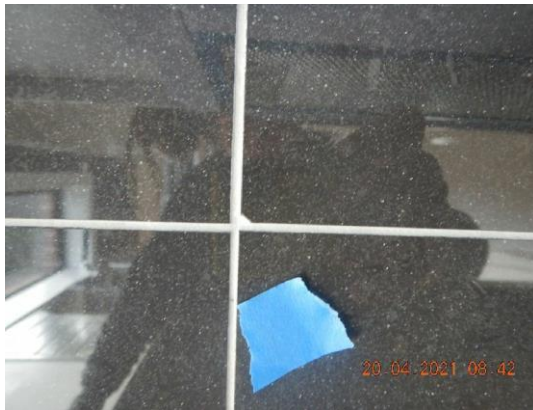
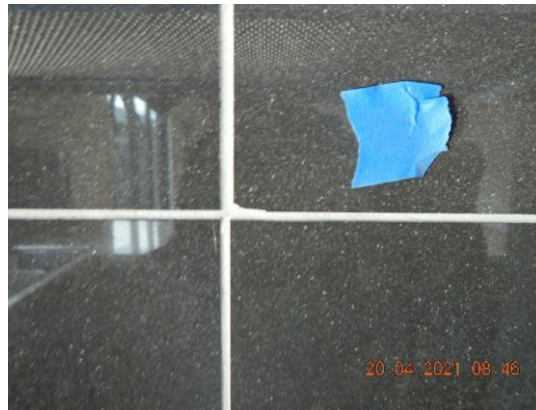
**VBA Guide to Standards and Tolerances:** - Tiles are defective if cracked, pitted, scratched or loose.

Chipped.

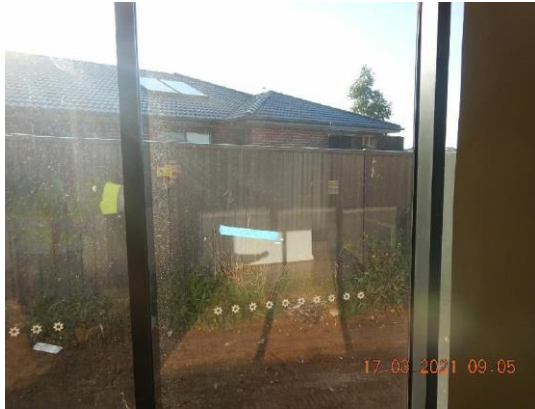
**The Victorian Building Authority:** - Calls for all glass to be protected during the build. Allowance is made for minor damage. This dwelling glass in parts exceeds the allowance stated in the VBA advice below.

Scratched.

Given this item can be difficult to see, it can be assumed not all areas have been marked. The owner and builder will need to check for additional scratches in different lighting conditions.

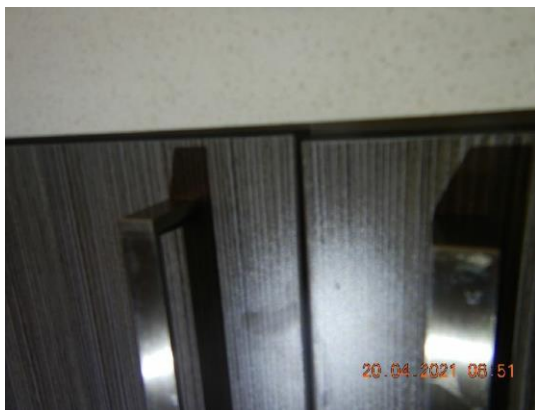
Unless otherwise specified, cabinet door and drawer fronts are defective if they are not aligned, or do not have consistent gaps between them at handover, and can be seen from a normal viewing position.

All to comply.

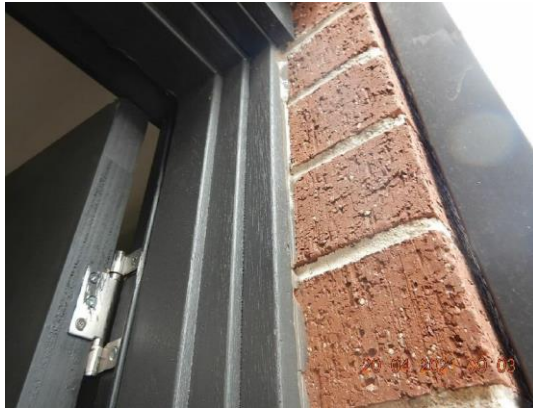
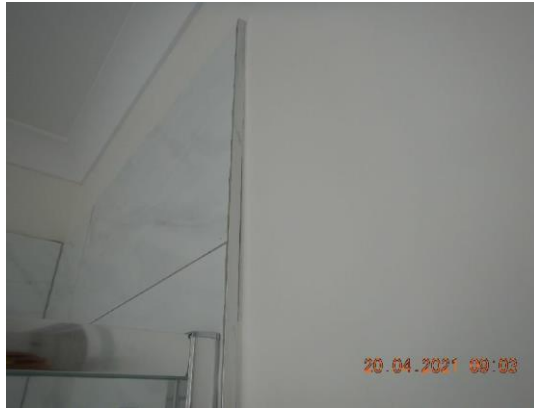
### 31.

We noted poorly installed or missed caulking/gapping/grouting throughout the dwelling. The Builder will need to rework all areas prior to handover.

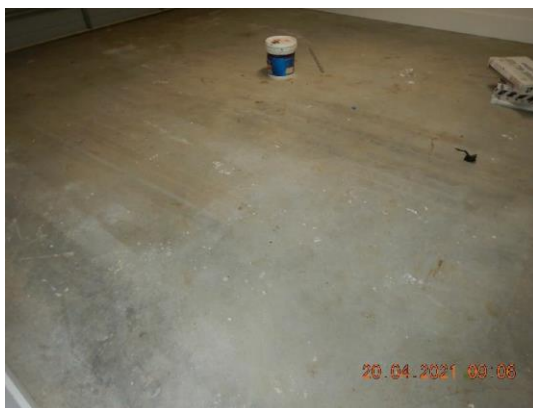
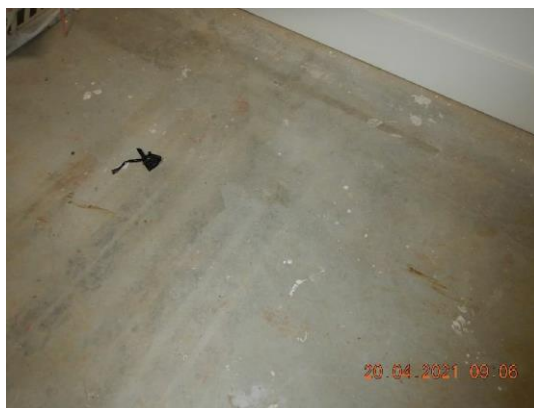
32.

**VBA Guide to Standards and Tolerances:** - The building site and works shall be clean and tidy on completion. Building sites are defective if they are not clear of building debris.

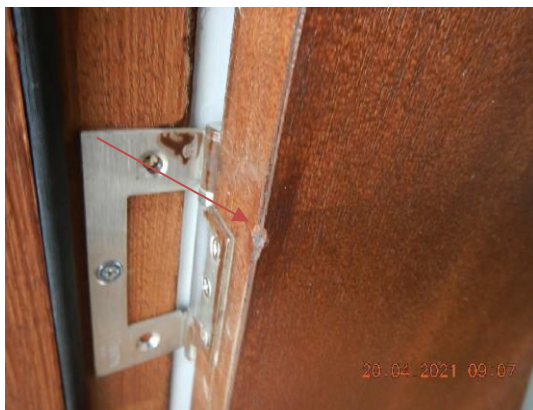
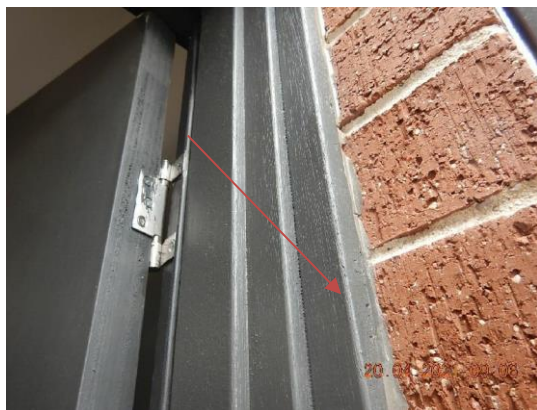
Door damage.

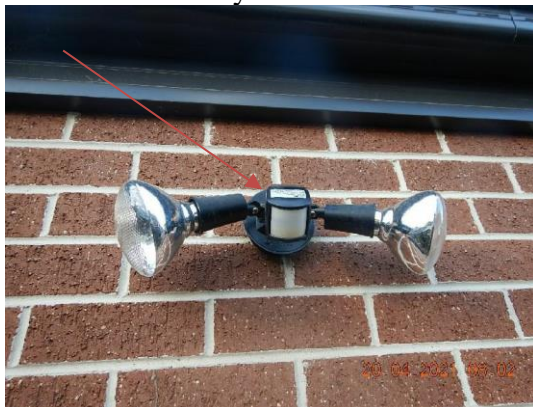
Loose.

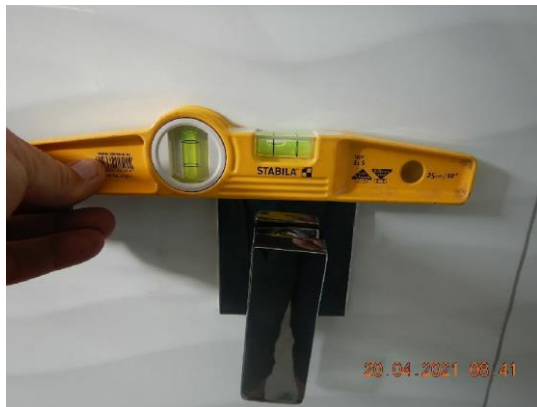
OOL.

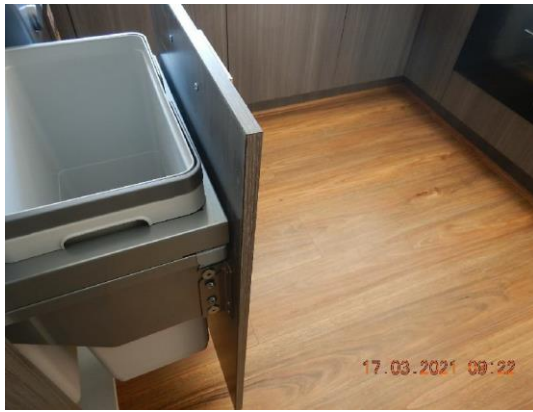
Loose cupboard door.

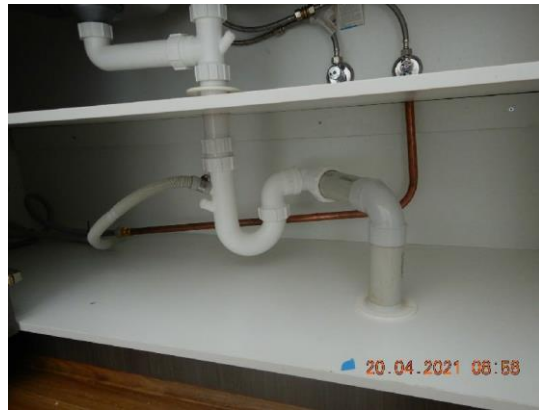
Exposed copper pipe not fixed.
