Dwelling type:	House and Garage.
Dwelling configuration:	Single Storey.
Nature of works:	New Building.
Stage of inspection:	Final.
Construction Type:	Brick Veneer.
Garage:	Attached.
Foundations:	Slab.
Builder:

Schedule of Defects:

Defects, observations and other related comments from the Final Inspection on the 26/04/2021:

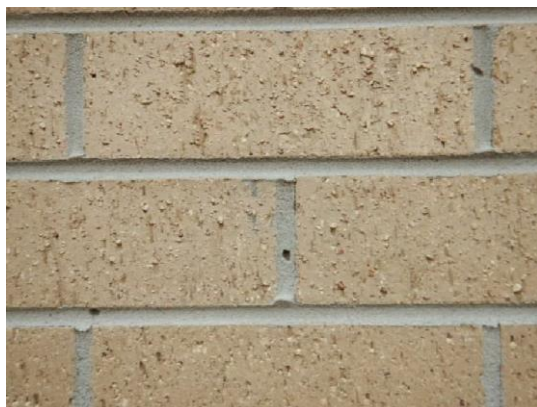
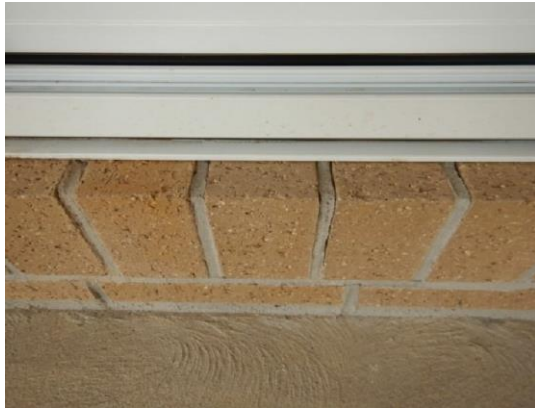
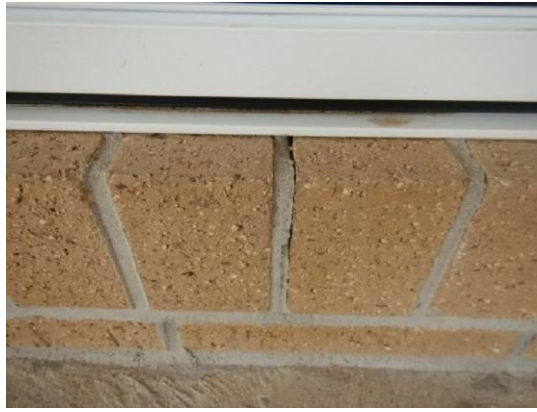
2. **This defect was previously noted and had not been fully rectified at the time of the final inspection on the 26/04/21.**

Masonry faces are defective if they are not cleaned and free of excess mortar. Homeowners are entitled to expect that the works are clean and tidy on completion. This would include paint and plaster excesses, etc. to be removed from the brickwork.

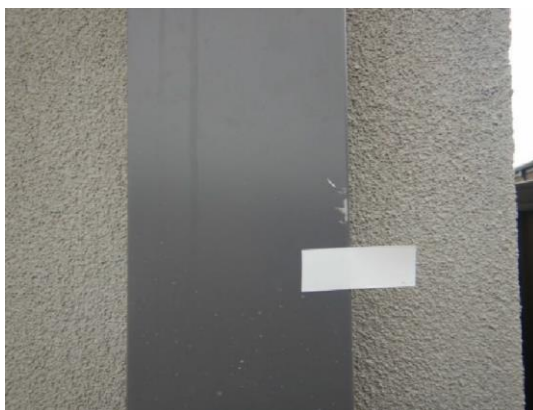
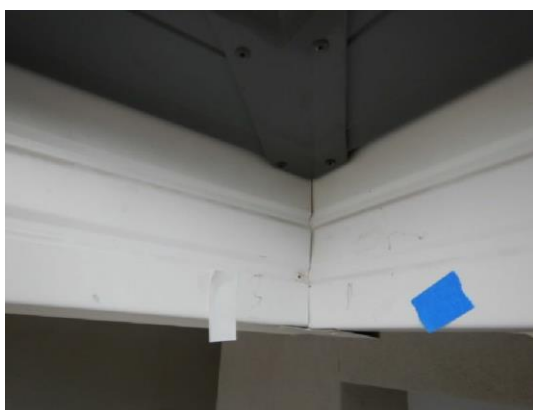
5. This defect was previously noted and had not been fully rectified at the time of the final inspection on the 26/04/21.

The BlueScope Colorbond roofing products to the dwelling have been damaged during construction.

Damaged areas greater than 2mm in width will need to be replaced.

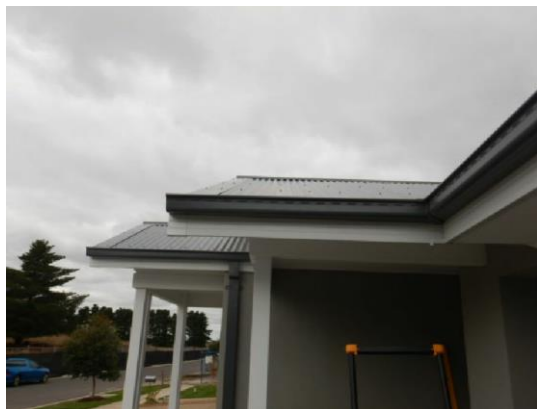
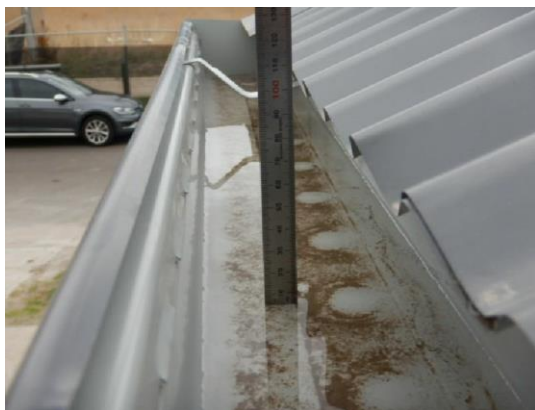
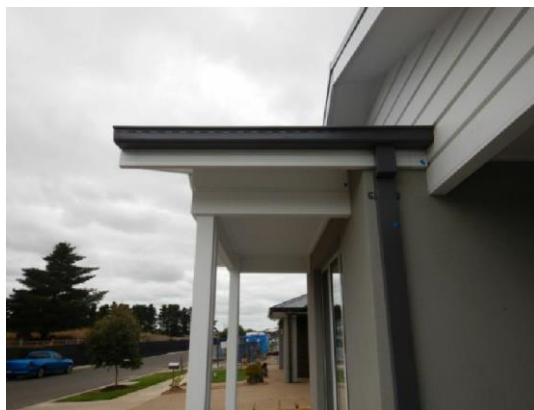
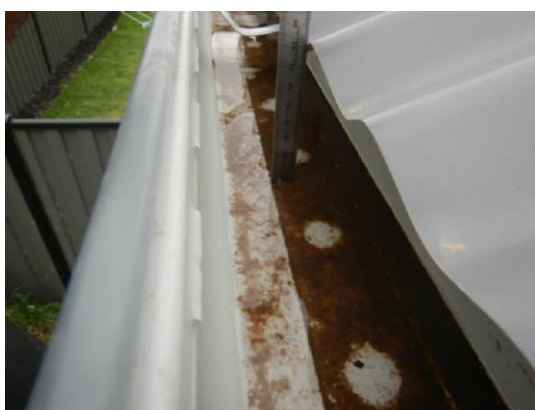
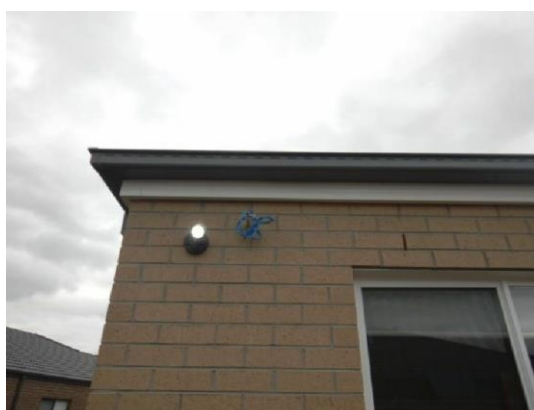
6. This defect was previously noted and had not been rectified at the time of the final inspection on the 26/04/21.

AS 3500.3: - The minimum allowable gradient is 1:500 to achieve an effective gradient with no permanent ponding.

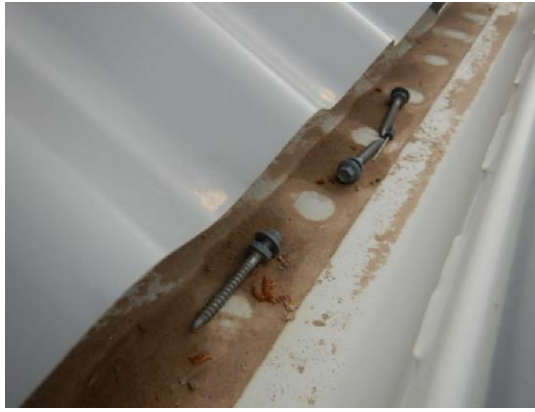
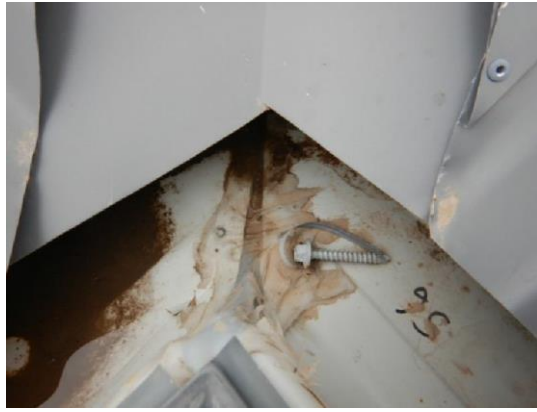
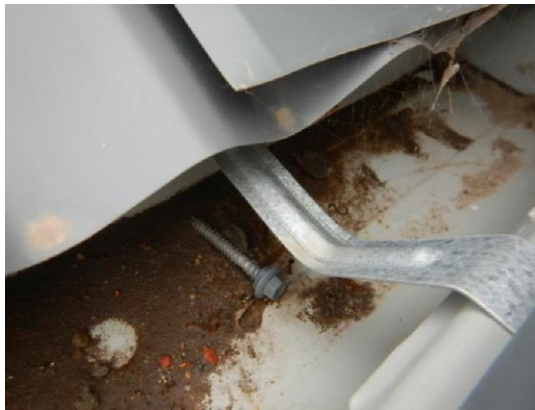
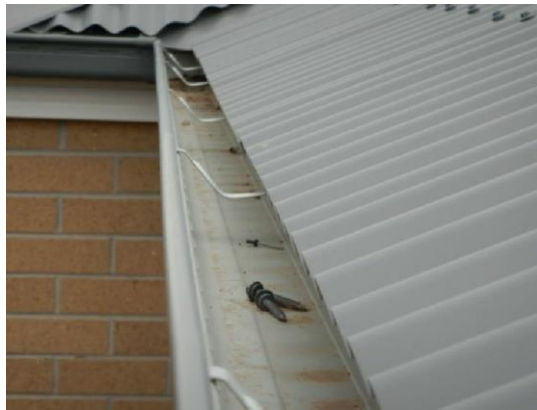
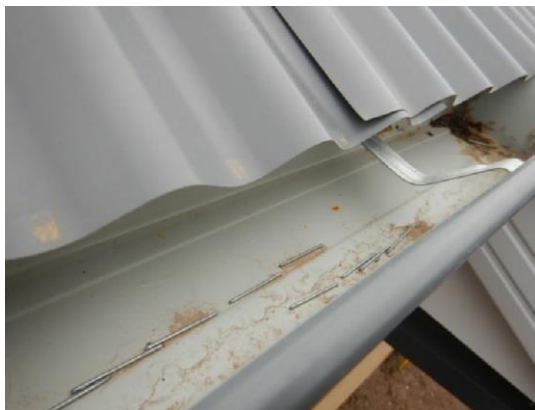
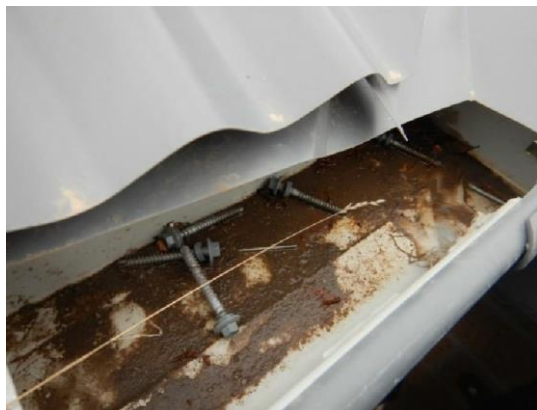
7. This defect was previously noted and had not been rectified at the time of the final inspection on the 26/04/21.

Standards Australia HB 39: - The gutters and roof sheeting must be fully cleaned of metal particles, roof screws, pop rivets, mortar, paint, and the like.

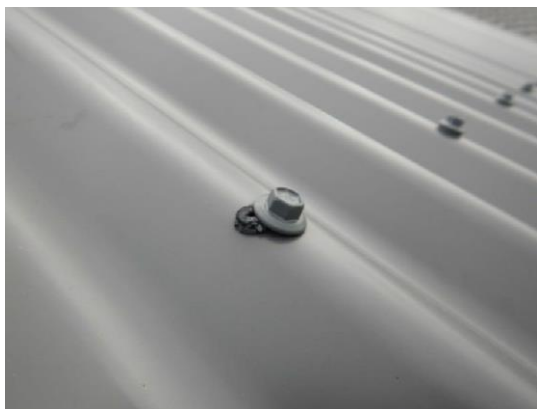
8. This defect was previously noted and had not been rectified at the time of the final inspection on the 26/04/21.

A number of roof screws have been over tightened deforming the washers. This must be avoided as it can lead to a loss of the water seal and lead to future water leaks.

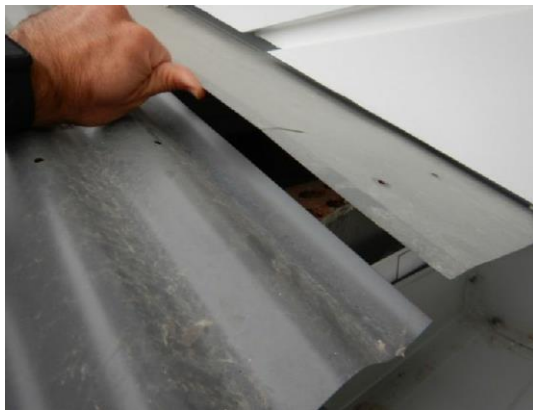
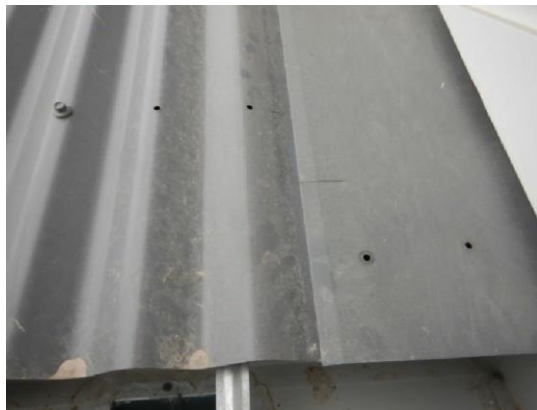
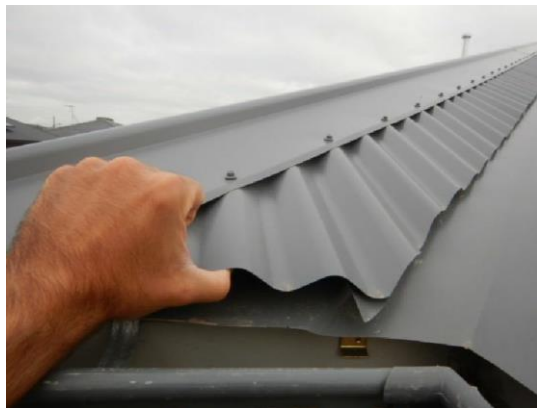
9. **This defect was previously noted and had not been fully rectified at the time of the final inspection on the 26/04/21. Critical item potentially allowing water ingress to roof frame.**

NCC 2019; 3.5.1.5: - Roof sheets must be fixed off as per Table 3.5.1.4.

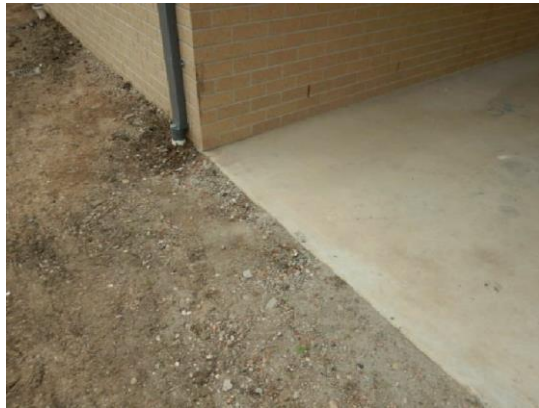
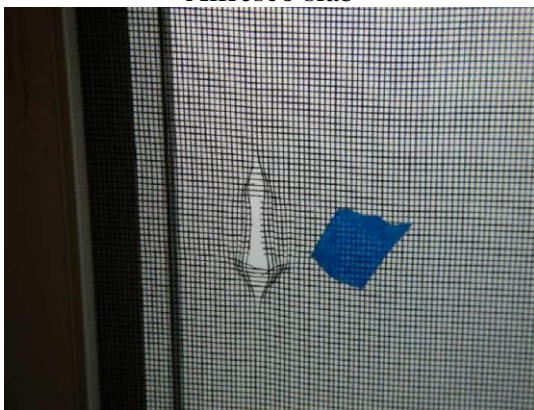
Alfresco slab

10. This defect was previously noted and had not been fully rectified at the time of the final inspection on the 26/04/21.

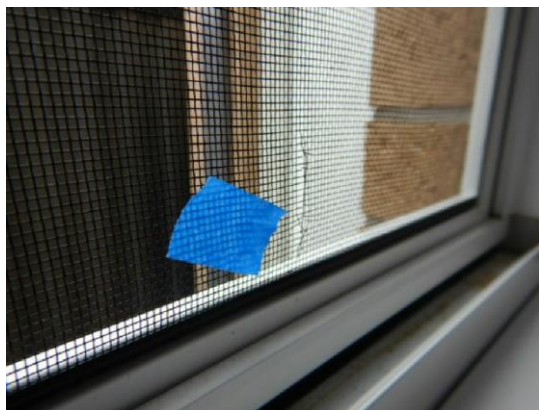
Damaged fly screen's multiple locations

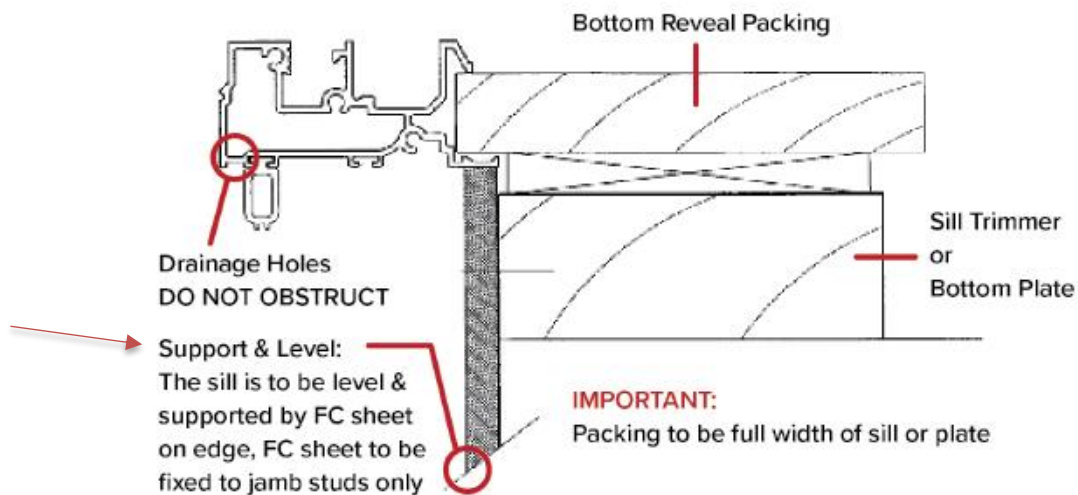
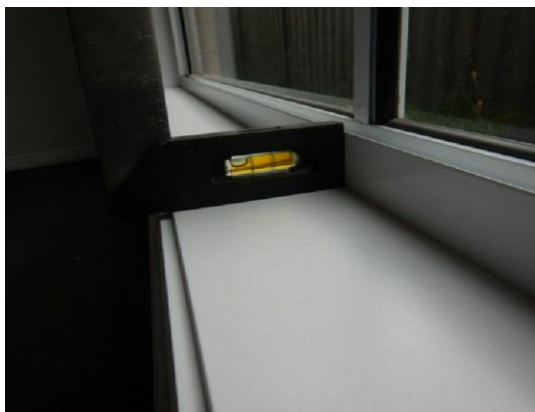
11. This defect was previously noted and had not been fully rectified at the time of the final inspection on the 26/04/21.

Some of the bottom reveals too wide windows are presenting with significant fall back towards the window.

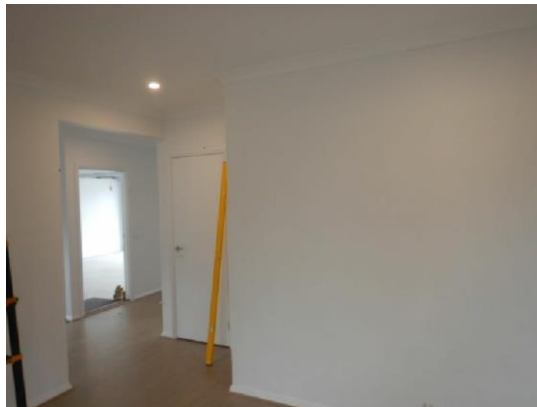
OOP Lounge

12. This defect was previously noted and had not been fully rectified at the time of the final inspection on the 26/04/21.

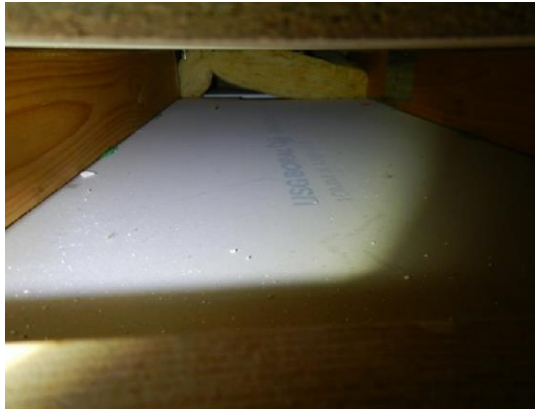
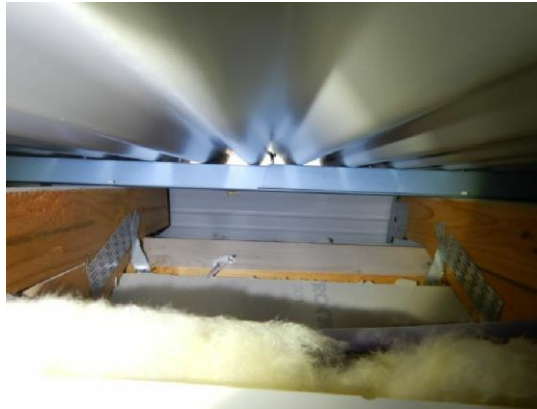
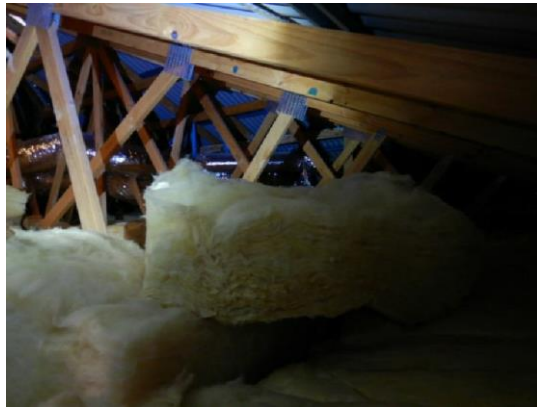
13. This defect was previously noted and had not been fully rectified at the time of the final inspection on the 26/04/21.

The insulation in the ceiling has the following defects.

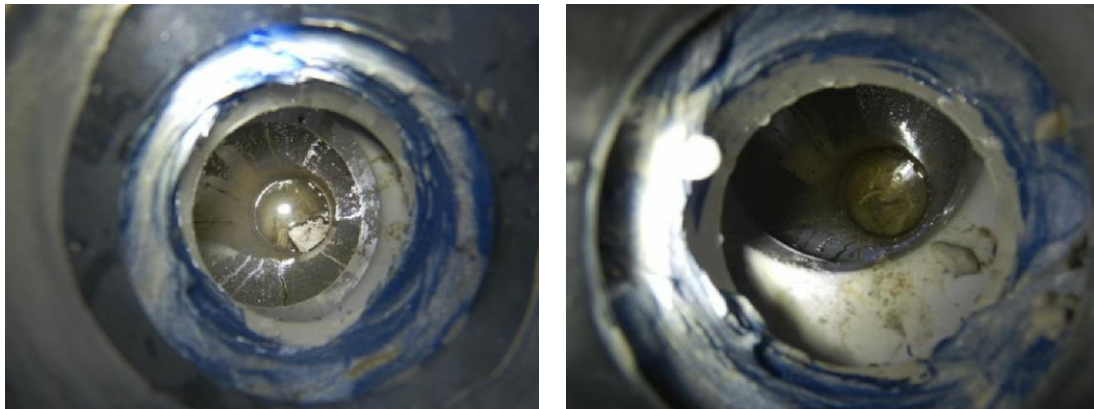
14. This defect was previously noted and had not been fully rectified at the time of the final inspection on the 26/04/21.

3500.2 - 2018, part 4.3.1 (g): - the interior of each pipe must be cleared of any foreign matter prior to commissioning.

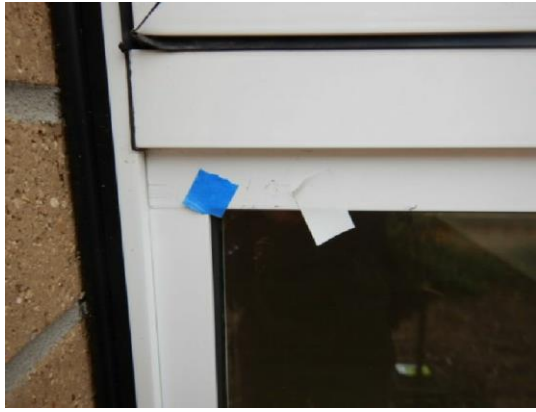
The powder coat finish on aluminium frames has been damaged through the finished coating. The damage could have been avoided with appropriate protection and care. Individuals are often tempted to spray over the scratches with an aerosol lacquer, which is an inferior product. Acrylic lacquer is soft and offers only moderate durability to ultraviolet, pollution and general dirt and grime. Also, the layer of chromate has not been replaced, which greatly reduces the durability of the coating. Dark colours will fade after moderate UV exposure. If this occurs, we recommend our clients use this paper trail to seek replacement, at that time.

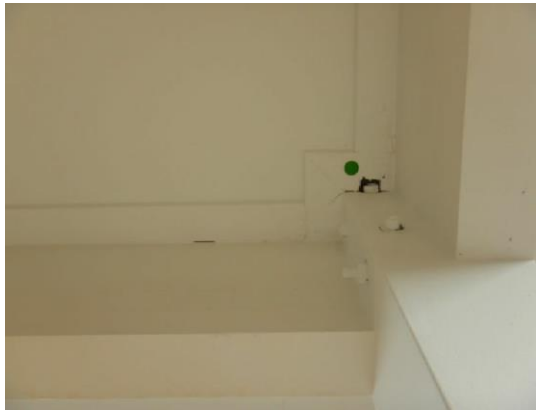
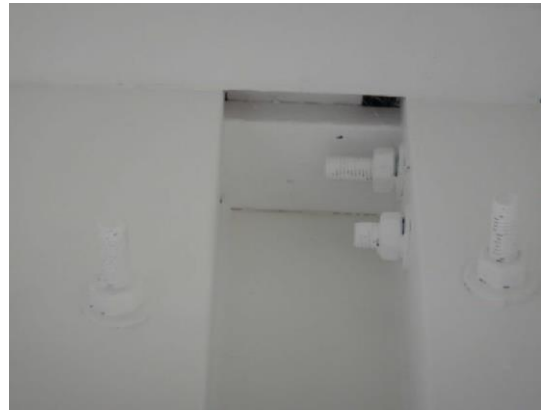
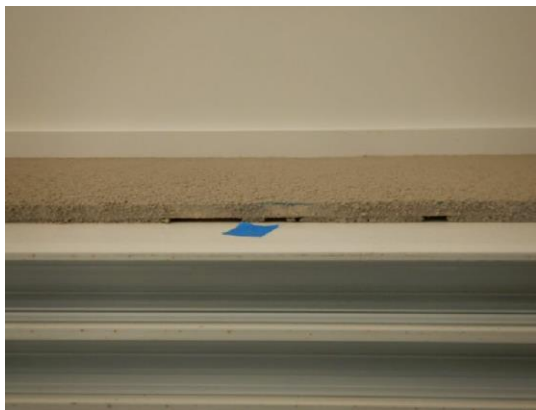
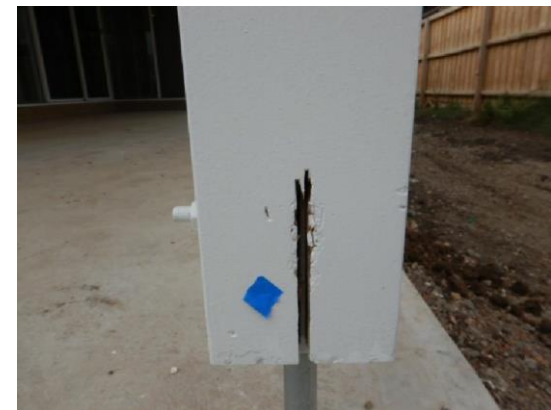
It is noted in multiple locations the building is presenting with gaps to the building exterior, these are both unsightly and potentially allow the entry of water, excess ventilation or vermin. All areas to be reworked with suitably sealed with quad, silicon, infill panels or flashing as required.

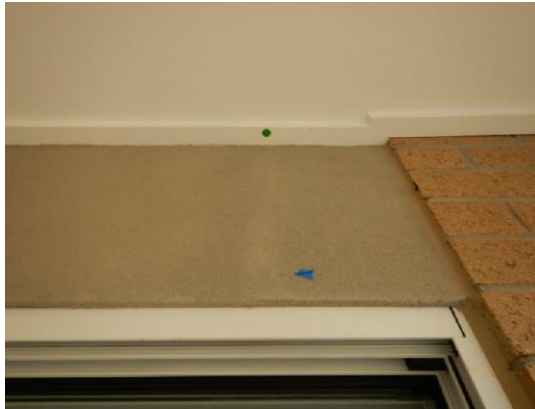
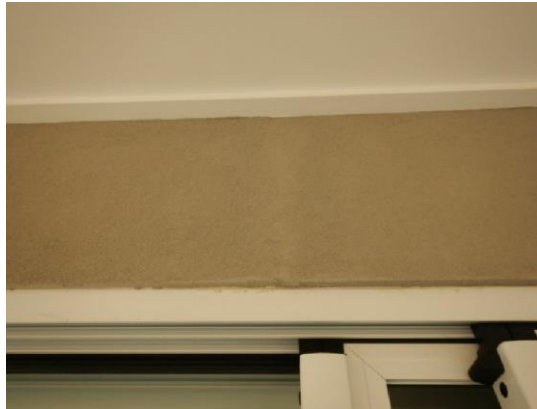
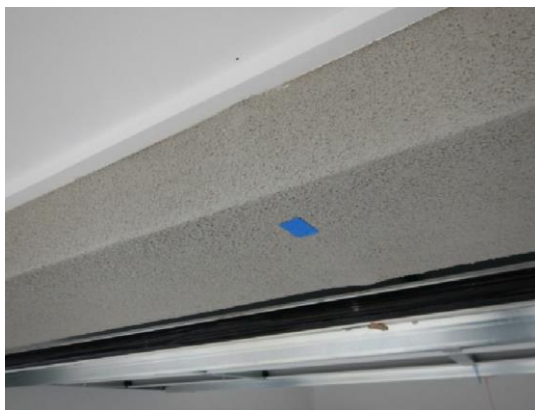
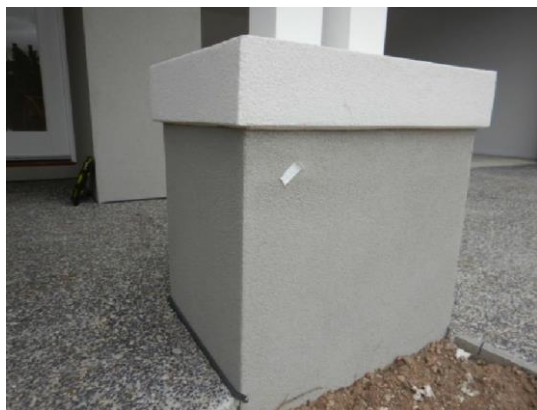
VBA Guide to Standards and Tolerances: - Rendered surfaces that show spot rust marks and other blemishes are defective if visible from a normal viewing position.

Obvious spot rust marks, due to the composition of the material and other blemishes are defective if they are visible from a normal viewing position.

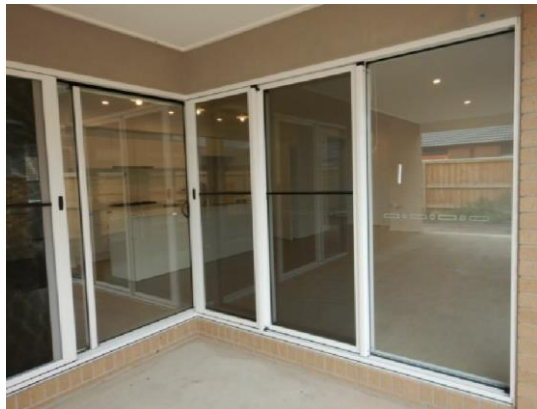
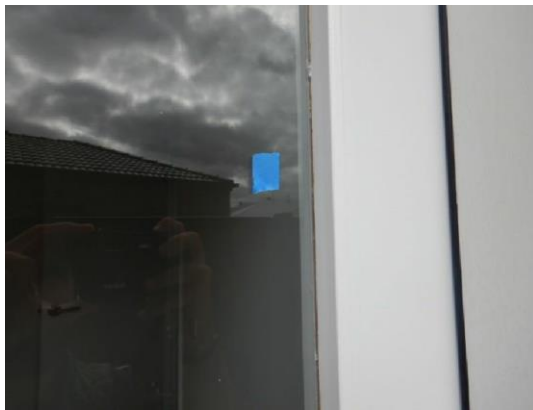
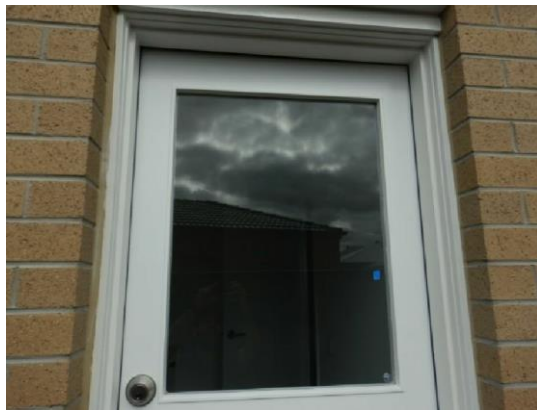
The Victorian Building Authority: - Calls for all glass to be protected during the build. Allowance is made for minor damage. This dwelling glass in parts exceeds the allowance stated in the VBA advice below.

Given this item can be difficult to see, it can be assumed not all areas have been marked. The owner and builder will need to check for additional scratches in different lighting conditions.

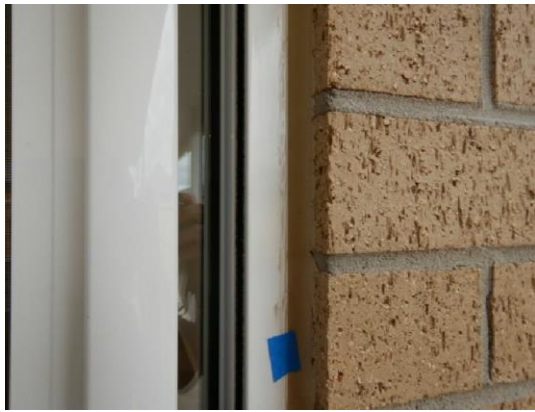
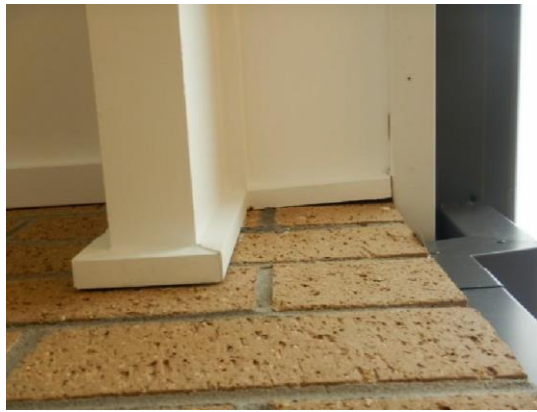
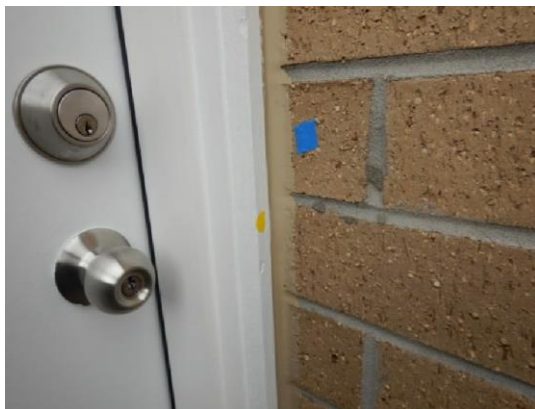
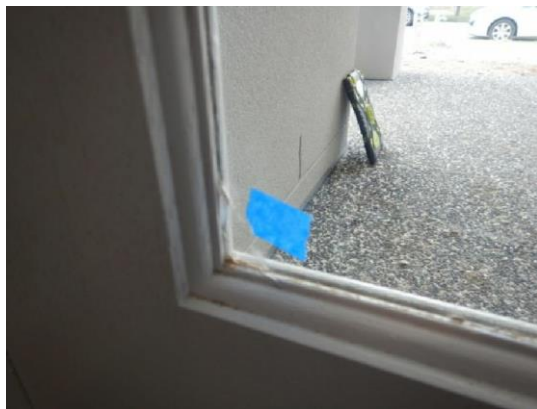
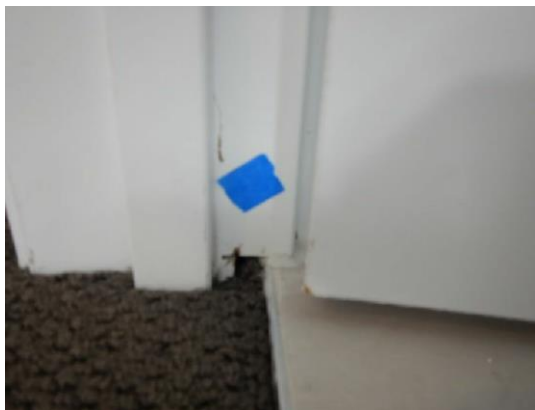
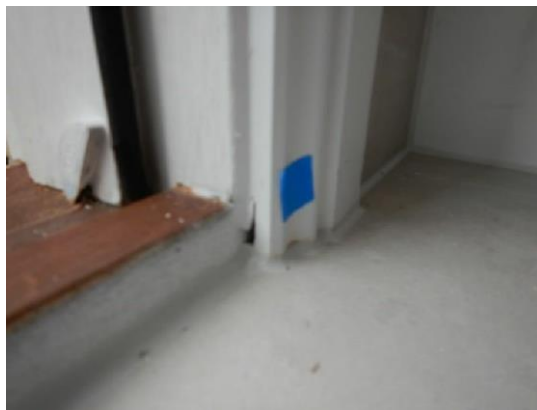
We noted poorly installed or missed caulking/gapping/grouting throughout the dwelling. The Builder will need to rework all areas prior to handover.

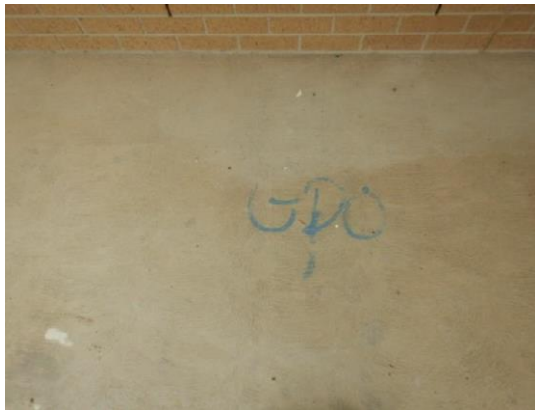
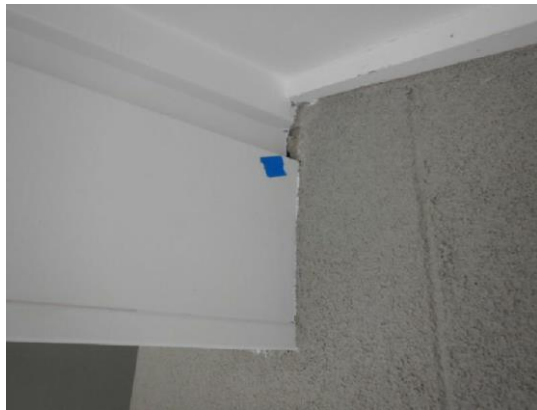
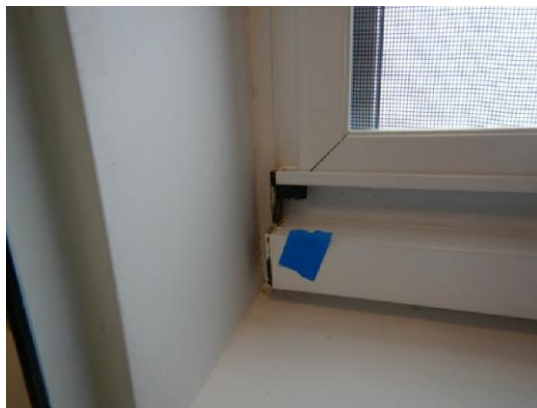
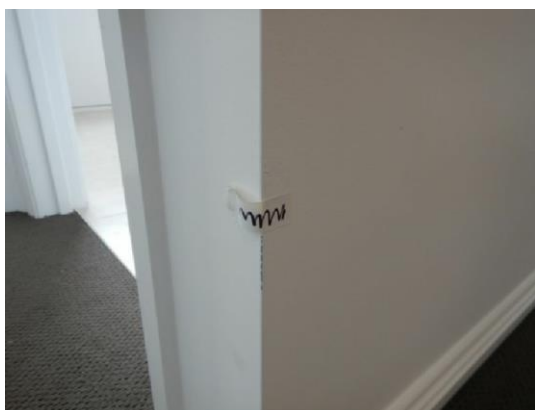
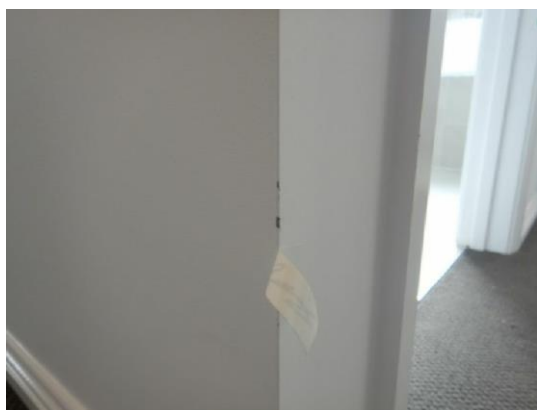
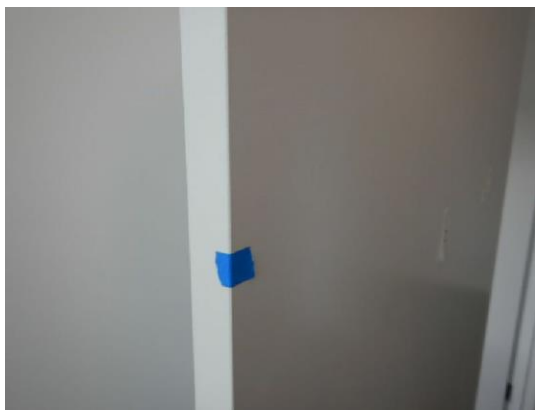
Painted areas have not met these requirements.

Note - not all areas have been marked. The following images are an example of this defect.

Defect noted through out dwelling, refer to tape on site.

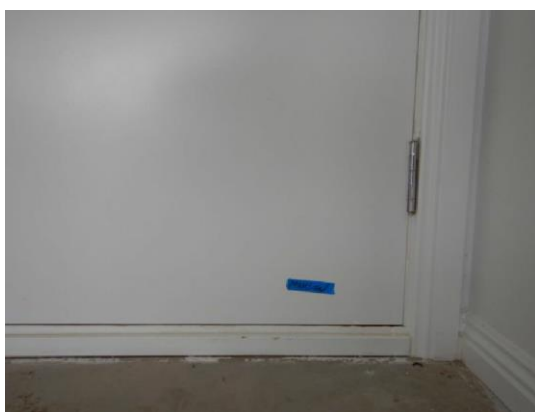
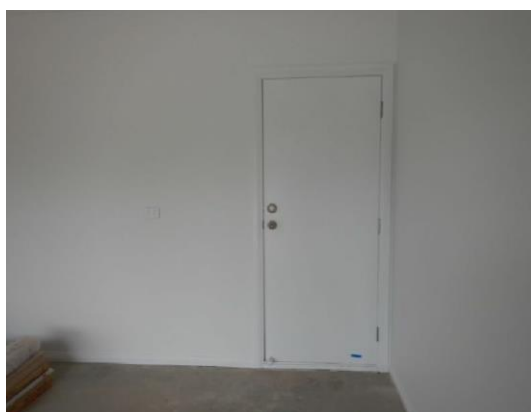
A number of door margins will need to be reworked to comply with the inserted.

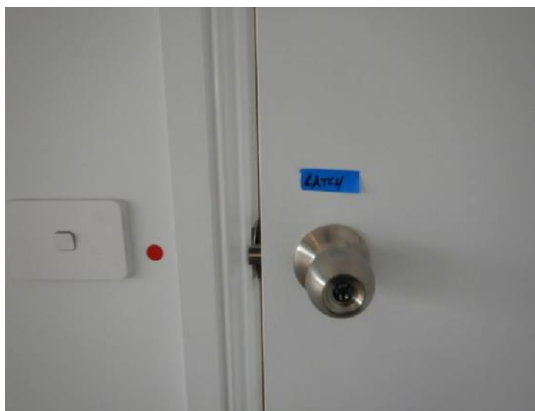
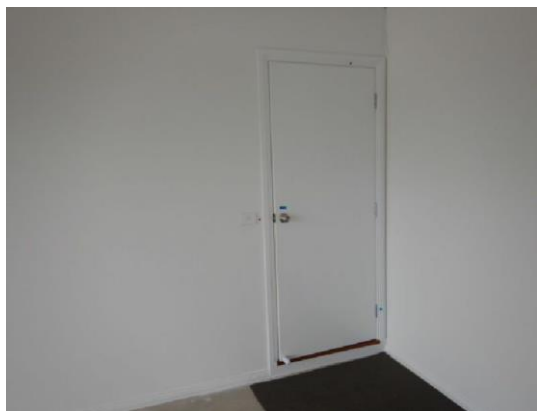
During the documented maintenance period after completion, handles, locks and latches are defective if they do not operate as intended by the manufacturer. If the maintenance period is not documented, three months is the assumed time period after completion. After the end of the maintenance period, failure is not a defect unless it is caused by the builder's workmanship or a faulty product supplied by the builder.

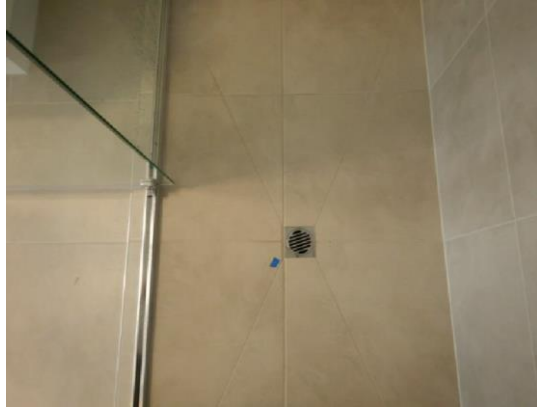
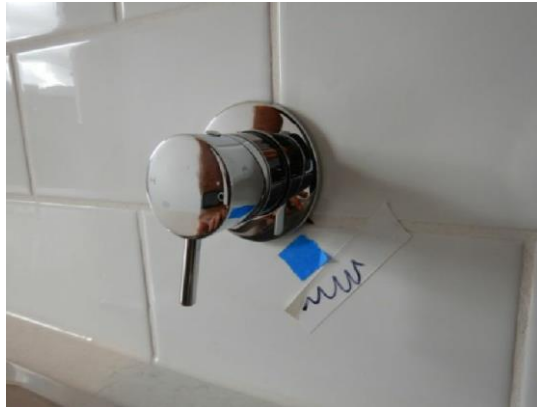
All installed grout needs to be installed as per AS 3958.1, part 5.7.1. Any area presenting with these defects will need to be reworked prior to settlement.

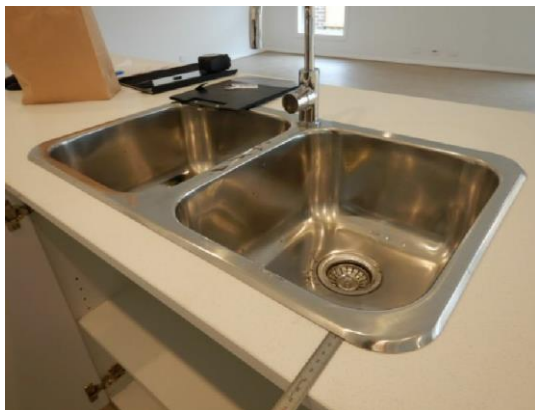
AS 4386, part 11.4: - Mandates all sinks to be sealed to the benchtop. The Victorian Building Authority advise to all builders is to seal all sinks, basins, and benchtops. When cutting out or drilling into the benchtop, the cut-out area must also be sealed. The restriction of water into the benchtop material is mandatory. See inserted from the VBA and the Standard. This dwelling fails these requirements. Extract As 4386, part 11.4.

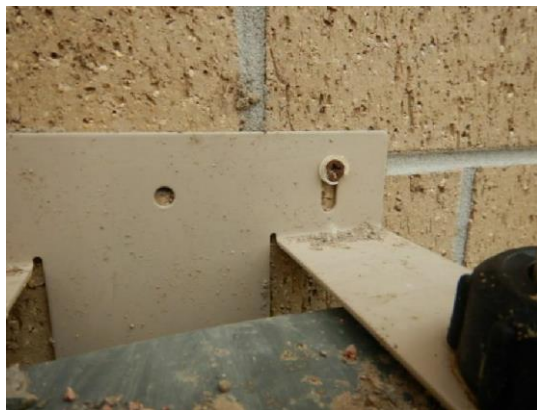
100mm cover to pipe

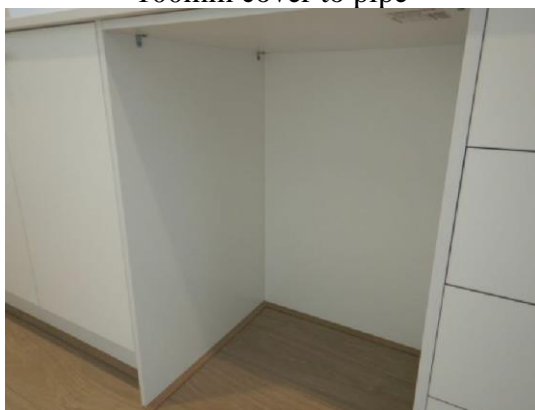
Rusted screws
