Dwelling type:	House and Garage.
Dwelling configuration:	Double Storey
Nature of works:	New Building.
Stage of inspection:	Fixing & Waterproofing.
Construction Type:	Hebel.
Garage:	Attached.
Foundations:	Slab.
Builder:

An inspection was conducted at the above address on 27/04/2021 for the purpose of a general home inspection, requested by the 'client'.

Defects, observations and other related comments from the Fixing & Water Proofing Inspection on the 27/04/2021:

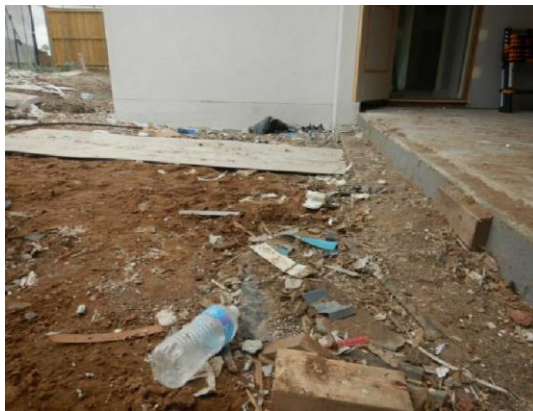
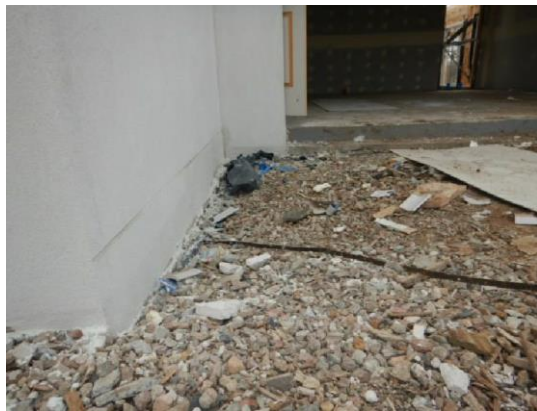
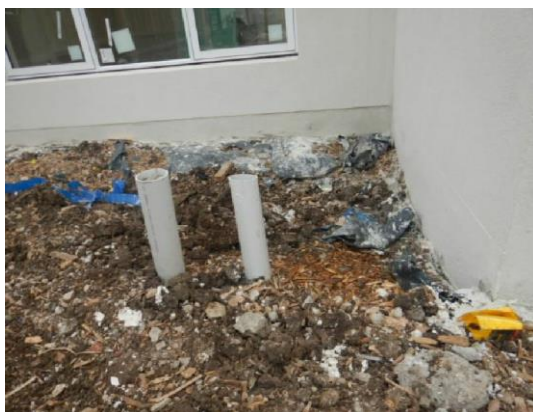
The dwellings slab footings can pool with water due to the way the block has been cut and the lack of back filling.

The NCC is very clear in its requirements to have the soil graded from the start away from the dwelling as a minimum of 50 mm over 1 m. This has not been done. We refer all to the NCC, part 3.1.3.3.

We also refer the builder to the soil report and engineering drawings that clearly call for the site drainage to be managed via sloping water away from the slab and more so, managing same.

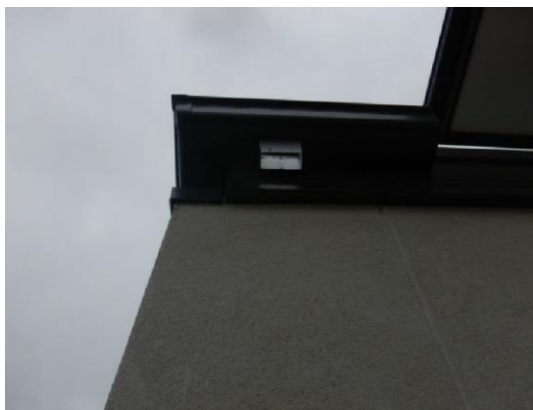
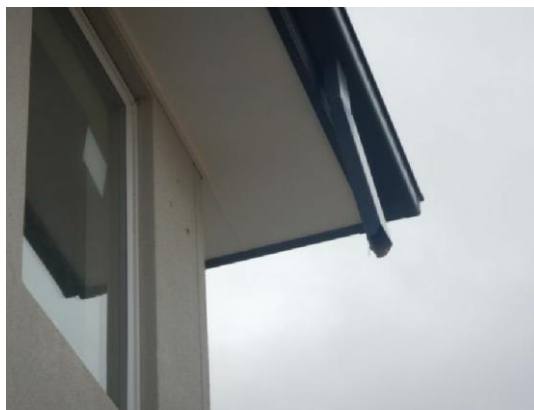
2. Item previously noted, not rectified at the time of Inspection on 27/04/21.
The NCC 2019; Part 2.2 Damp and Weatherproofing: - A building including any associated site work must be constructed in a way that protects people and other property from the adverse effects of redirected surface water.

Temporary downpipes have come away from the gutters and need to be reattached.

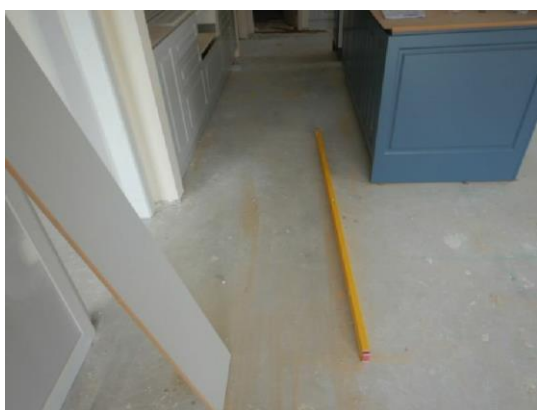
Kitchen

3. Item previously noted, not rectified at the time of Inspection on 27/04/21.
VBA Guide to Standards and Tolerances; 2.08: - New concrete floors must not differ more than 4 mm over any 2 m length or 10 mm in any room or area.

We measured random areas of the concrete slab with a 2 m straight edge and found the slab levels to have not met this requirement.

Note: The builder cannot claim the 10 mm in any room because the 4 mm over 2 m requirement has been breached.

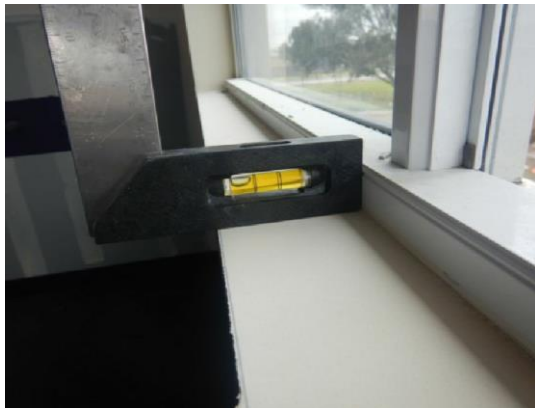
Some of the bottom reveals too wide windows are presenting with significant fall back towards the window.

Many window manufactures require a 7 mm cement sheet or pine board strip placed in the cavity to support the heavy glazed section; this was not present at the time of inspection. This often also results in bows to the top styles long after the windows are installed.

All areas to comply

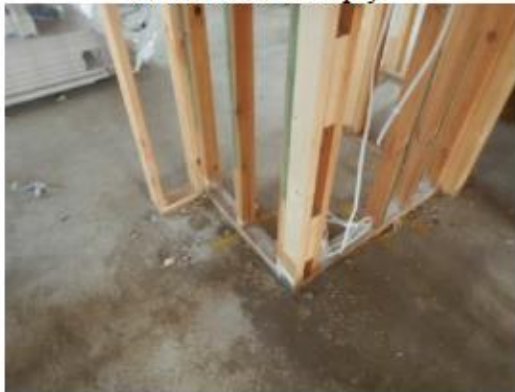
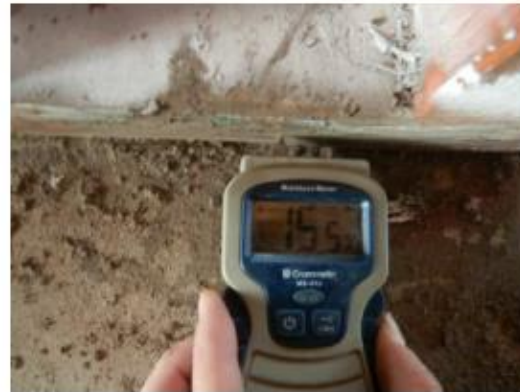
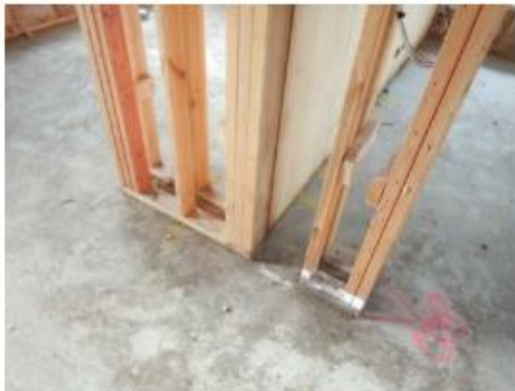
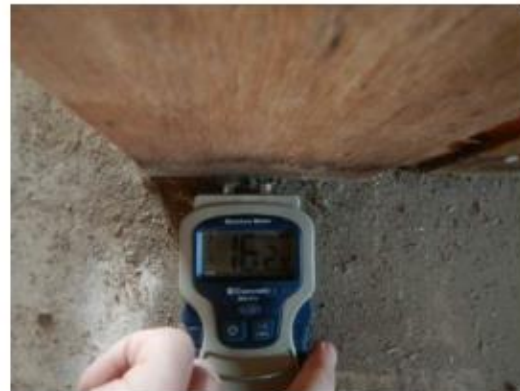
AS 2589; 2.6.2 & AS 1684.2; Appendix E: - The maximum moisture content for seasoned timber at the time of installing gypsum linings shall be less than 15%.

This seasoned pine house frame currently exceeds this maximum.

All Areas to comply.

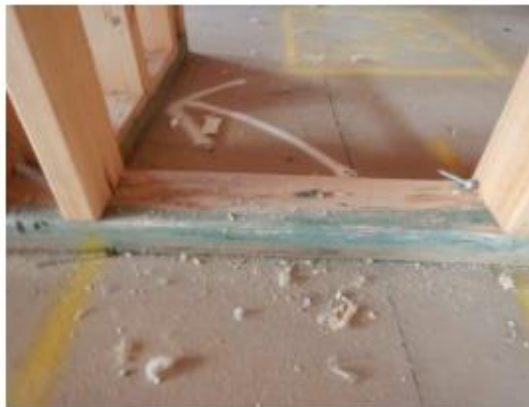
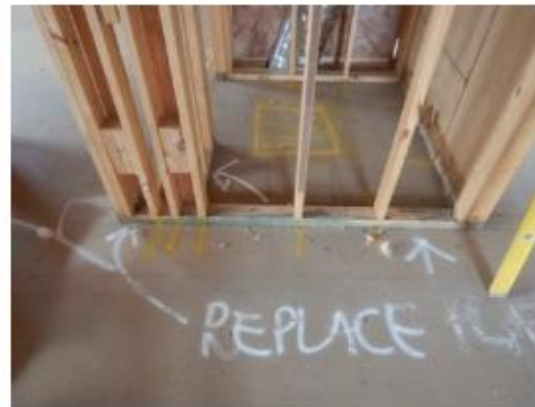
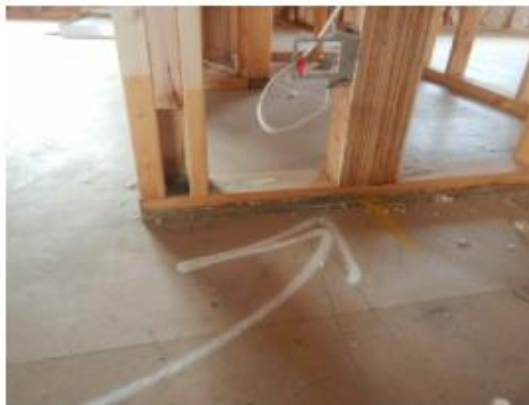
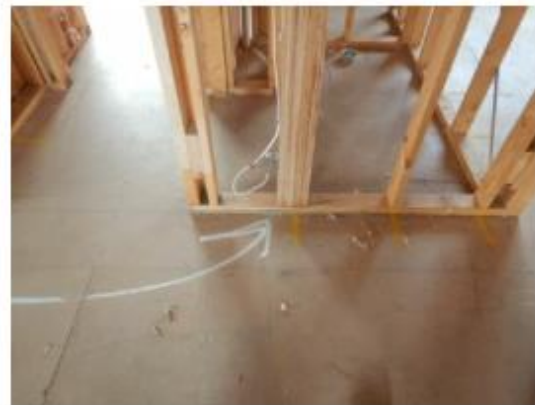
Many areas were noted to present with severe mould or like.

I am not a mould specialist; therefore, I will not comment on the impact the observed mould (or material which appears to resemble mould) could have on the structure. I have included the details of a mould specialist below.

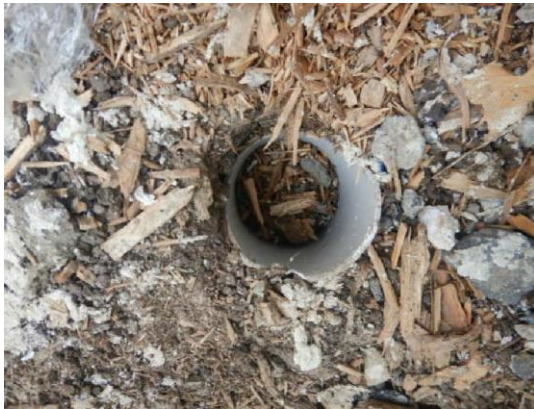
We noted areas where the stormwater riser pipes are showing rocks and dirt within the pipe junctions.

The builder will need to clear these excesses from within the junction as part of the AS 3500.3 plumbing regulations commissioning process obligations.

As a result, the builder will need to rework this plumbing connection to present a functioning stormwater system that is clear from obstruction.

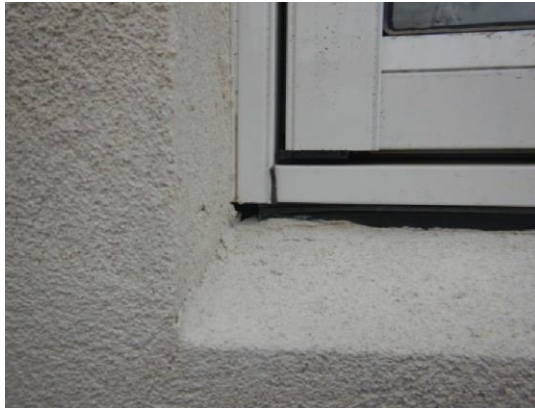
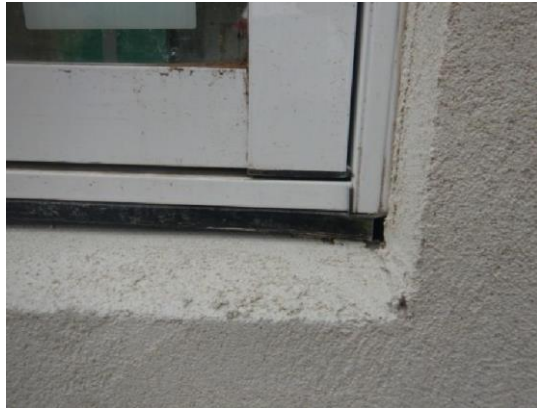
There are a few windows/bricks that have been installed short AS 2047 calls for installation in a manner that restricts water ingress and excessive air infiltration. Some reworking will need to take place. If the builder intends on using a silicon to bridge small gaps, the silicon must be neatly applied and be UV rated.

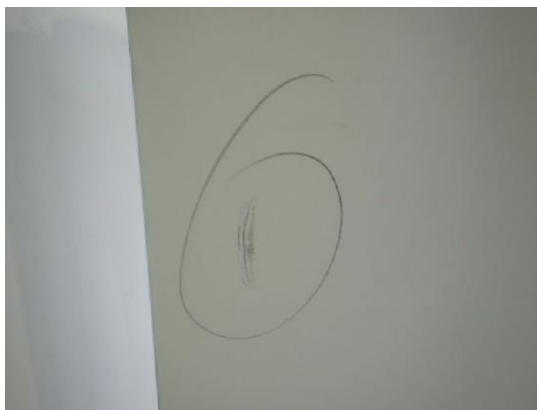
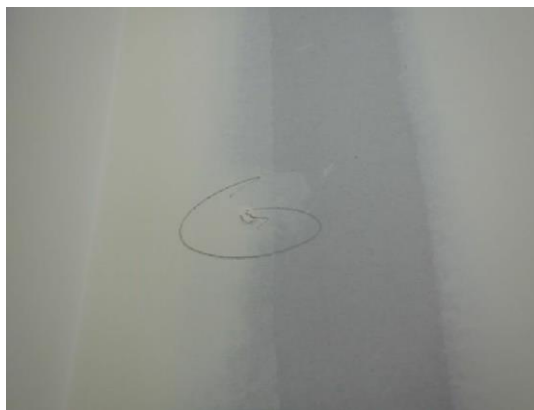
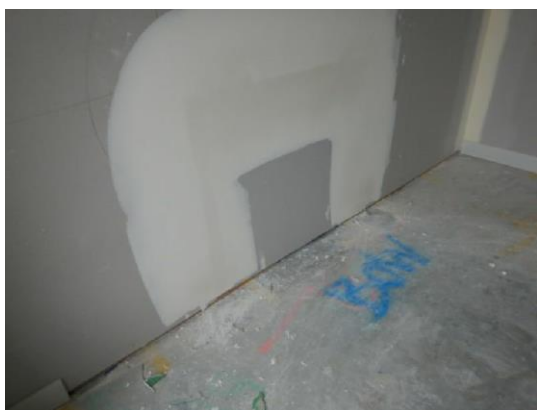
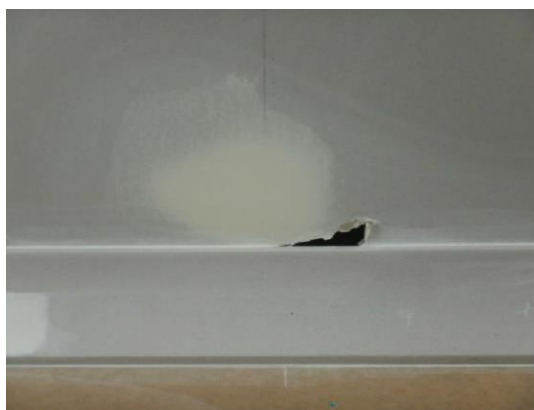
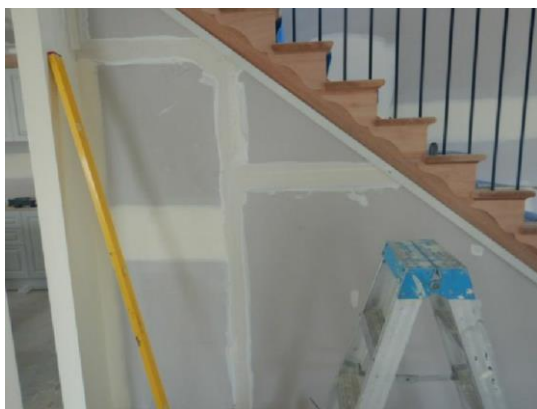
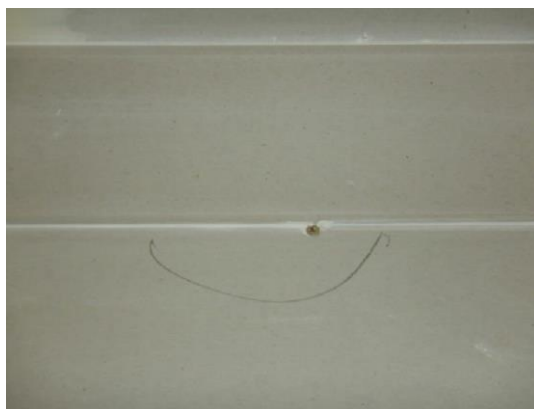
It was noted some elements of work associated with fixing and plastering of the walls, cornices and architraves have not been completed at the time of inspection. All works will require to be set in accordance with the requirements for a level 4 finish prior to application of base coat painting.

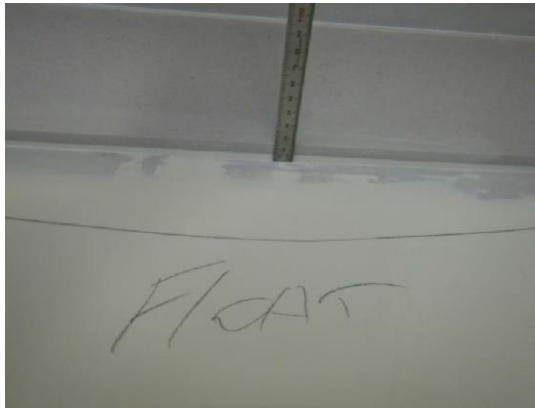
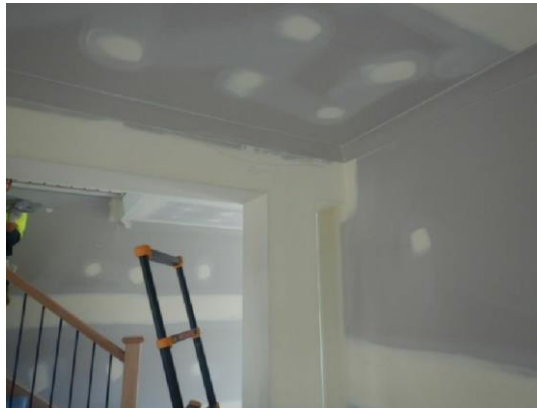
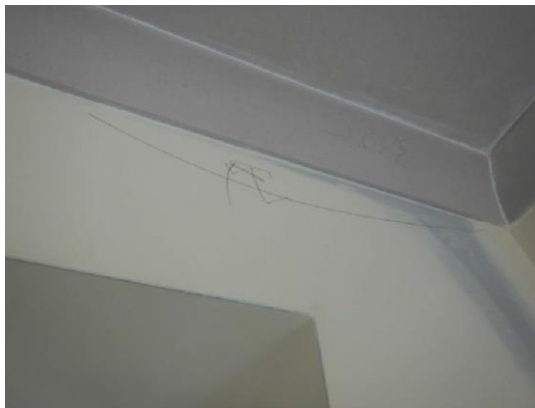
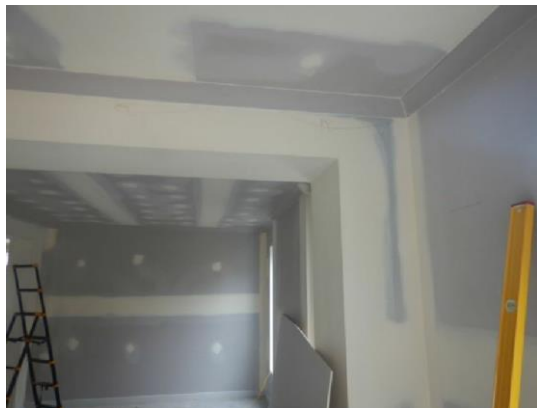
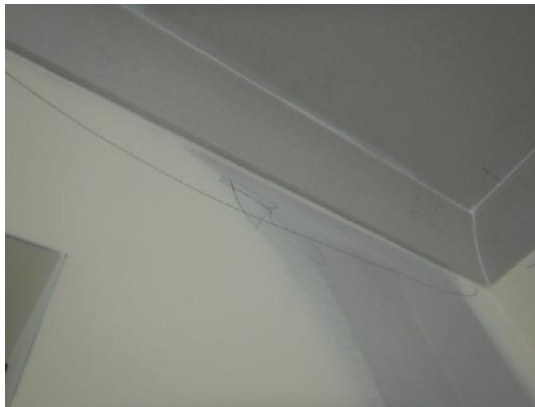
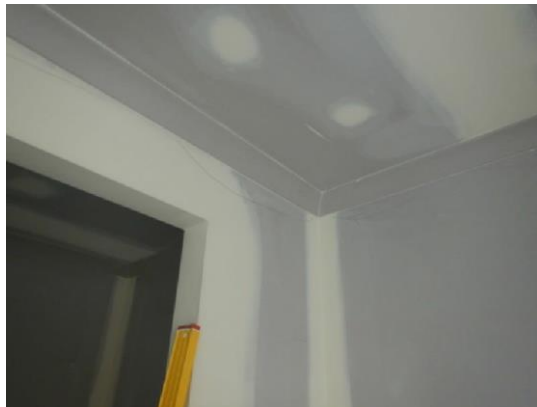
We noted the plaster wall below the cornice in a few areas is showing a noticeable bow. This bow is causing visible thickening of the cornice adhesive at the junction to the cornice bottom edge.

The builder will need to plaster float these areas to present a flat plastered surface that aligns evenly to the cornice underside. Thus, ensuring a proper finish with reasonable care and skill.

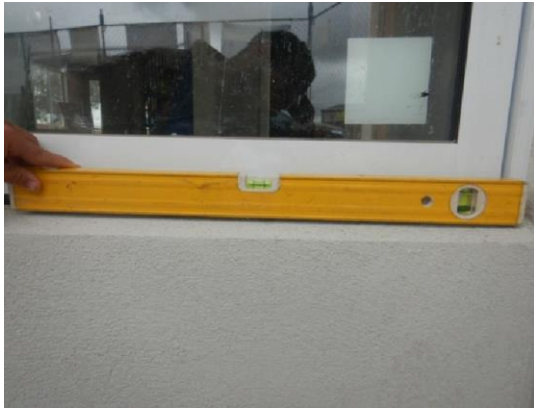
OOL Porch

There are a few areas in the home that exceed the allowance of 4 mm tolerance over 2 m.

As stated, the acceptable allowance is 4 mm over 2 m. These walls will need to be reworked to ensure that the builder complies with this requirement.

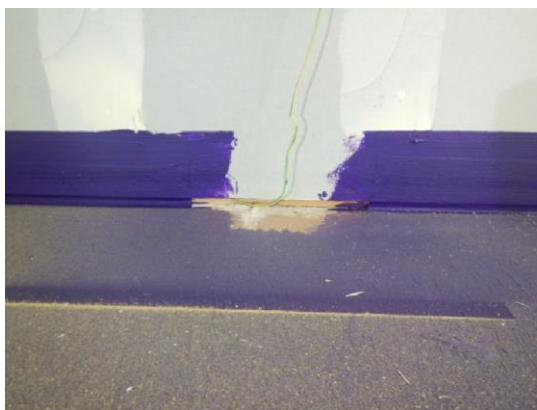
Ensuite

We noted some small holes, cracks, or gaps in various sections to the waterproof membrane in wet areas (marked with blue tape).

All areas must be sealed waterproof in accordance with the NCC Volume 2 and the manufactures specifications.

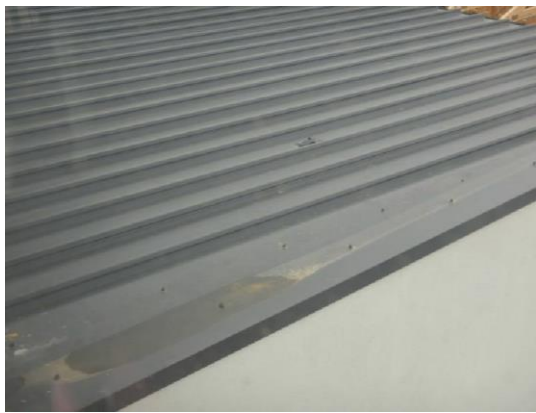
As per the inserted from AS 3500.3, the roof must be reworked to ensure the roof is not subjected to premature corrosion. Note that complete drainage is called for in the Standard.

Rectification Required: YES
