<b>Dwelling type:</b>	House and Garage.
<b>Dwelling configuration:</b>	Double Storey
<b>Nature of works:</b>	New Building.
<b>Stage of inspection:</b>	Fixing & Waterproofing.
<b>Construction Type:</b>	Hebel.
<b>Garage:</b>	Attached.
<b>Foundations:</b>	Slab.
<b>Builder:</b>

### **Defects, observations and other related comments from the Fixing & Water Proofing Inspection on the 10/02/2021:**

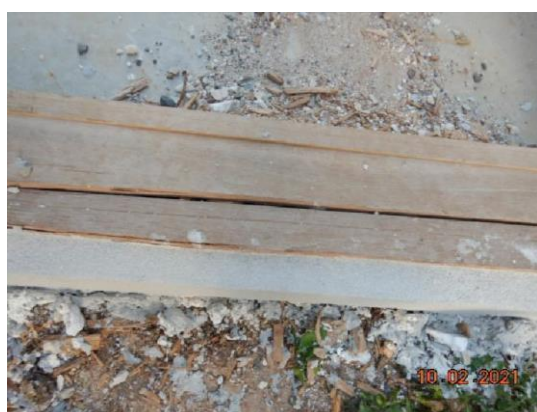
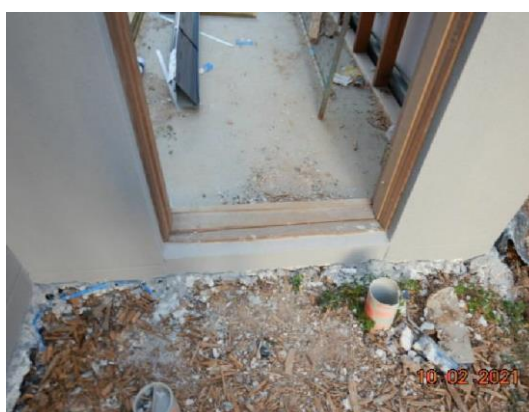
1.

**Victorian Domestic Building Contracts Act; Part 9 s.137:** - The vendor (builder) warrants that materials must be good and suitable for the purpose which they are used. Unless otherwise stated in the contract, materials shall be new.

- (b) the vendor warrants that all materials used in that domestic building work were good and suitable for the purpose for which they were used and that, unless otherwise stated in the contract, those materials were new; and
- (c) the vendor warrants that that domestic building work was carried out in accordance with all laws and legal requirements, including, without limiting the generality of this warranty, this Act and the regulations.

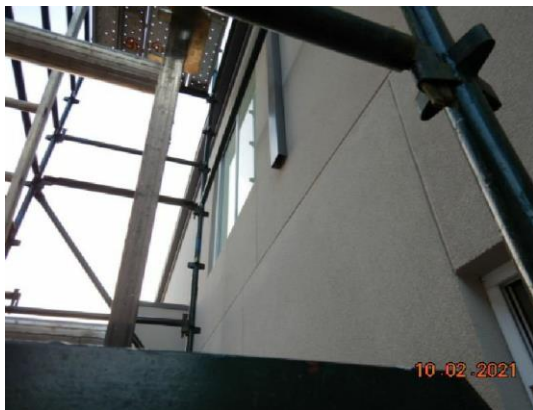
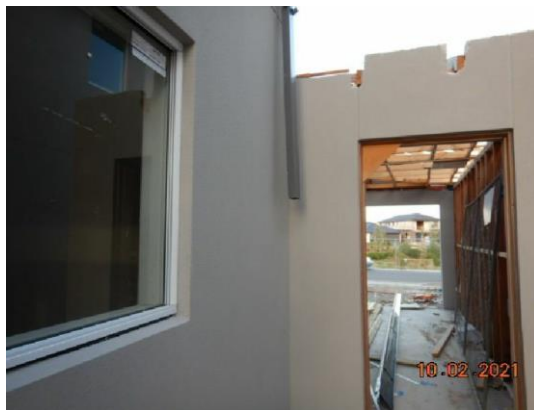
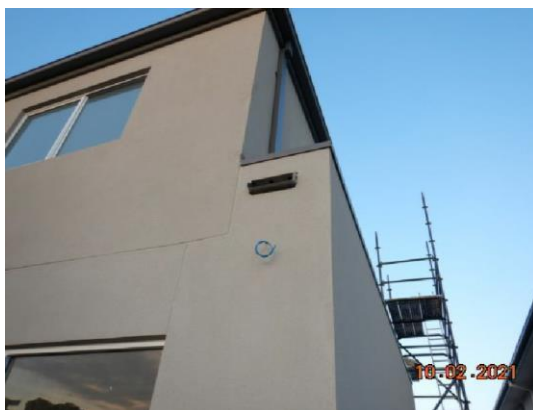
2.

**NCC 2019; Part 2.2 Damp and Weatherproofing:** - A building including any associated site work must be constructed in a way that protects people and other property from the adverse effects of redirected surface water.

Temporary downpipes have not been installed to this dwelling; the excess surface water should be avoided.

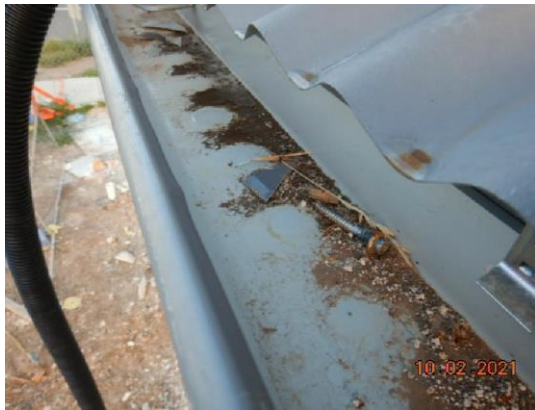
### 3.

**Standards Australia HB 39:** - The gutters and roof sheeting must be fully cleaned of metal particles, roof screws, pop rivets, mortar, paint, and the like.

The roof and gutter installation to this dwelling has not met this requirement.

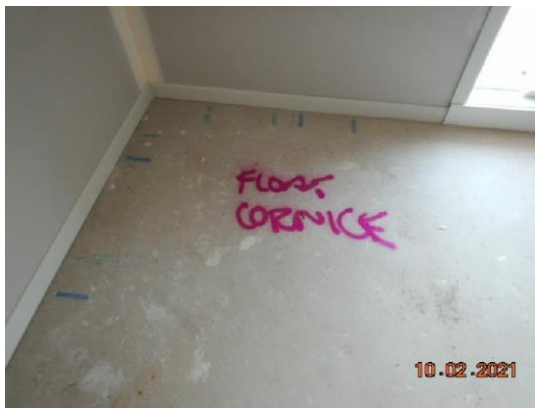
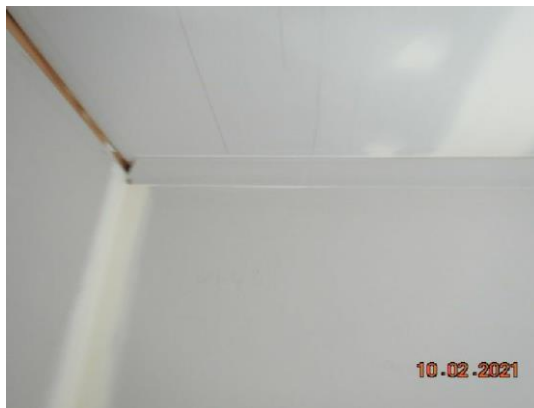
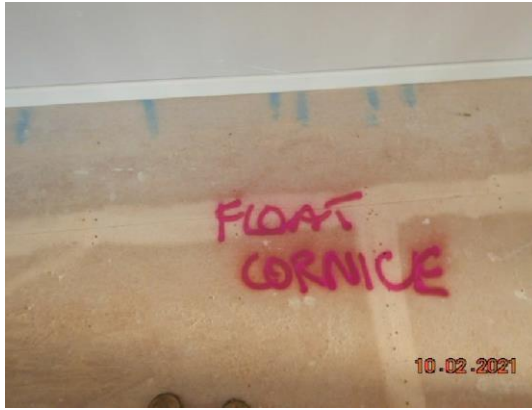
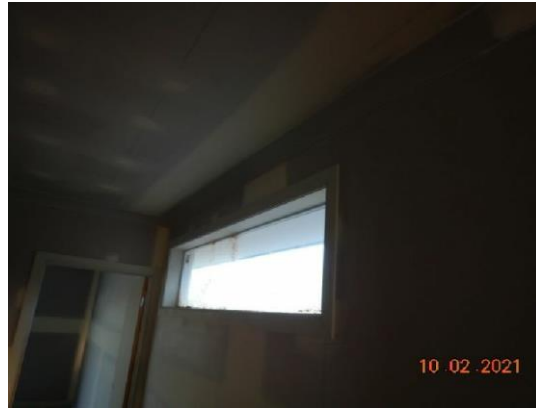
### 4.

We noted the plaster wall below the cornice in a few areas is showing a noticeable bow. This bow is causing visible thickening of the cornice adhesive at the junction to the cornice bottom edge.

The builder will need to plaster float these areas to present a flat plastered surface that aligns evenly to the cornice underside. Thus, ensuring a proper finish with reasonable care and skill.

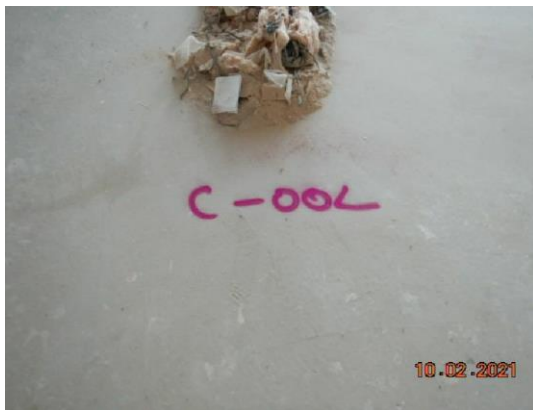
There are a few areas in the home that exceed the allowance of 4 mm tolerance over 2 m, please refer to photographs below.

Ceiling out of level

As stated, the acceptable allowance is 4 mm over 2 m. These walls will need to be reworked to ensure that the builder complies with this requirement.

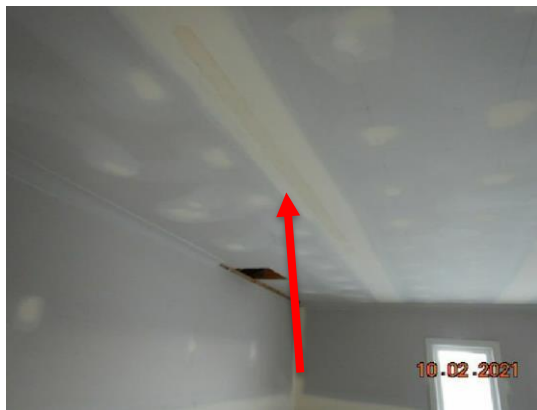
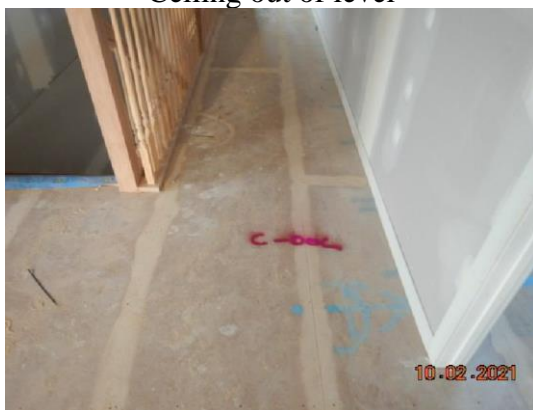
Ceiling out of level

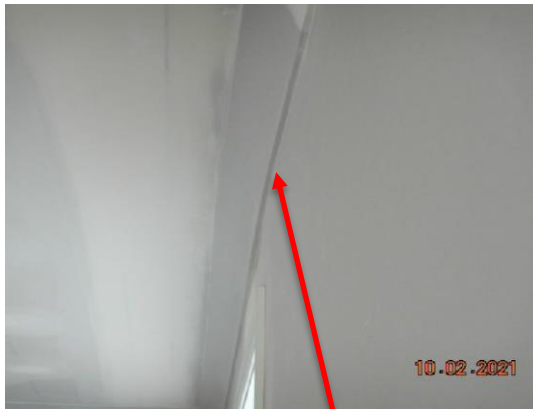
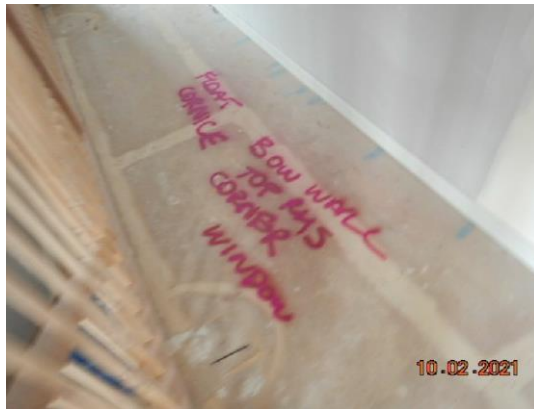
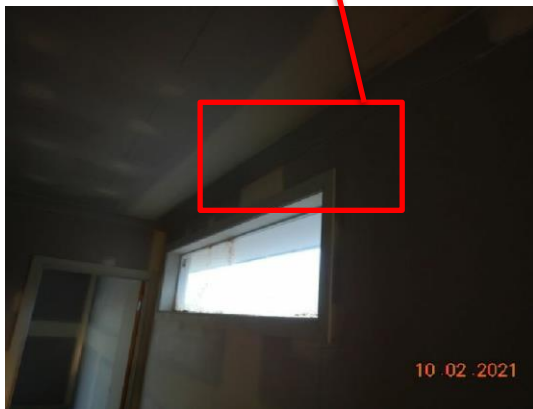
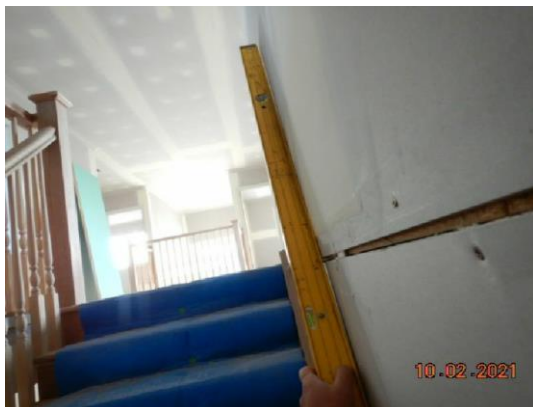
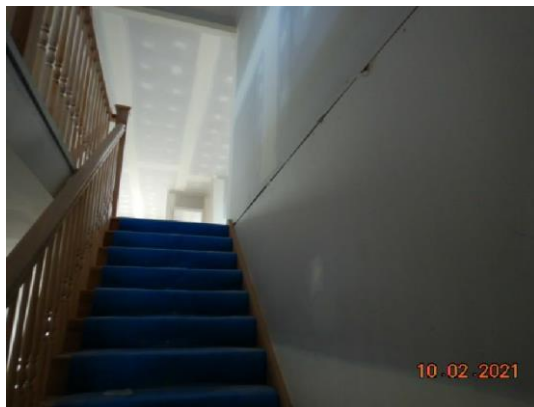
Out of alignment

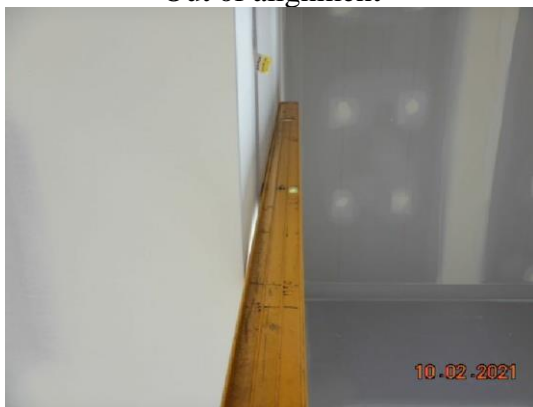
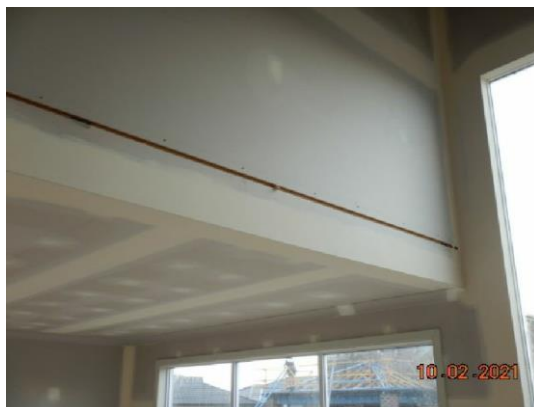
Out of alignment

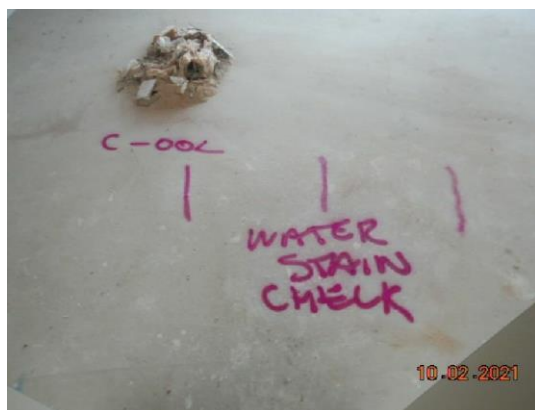
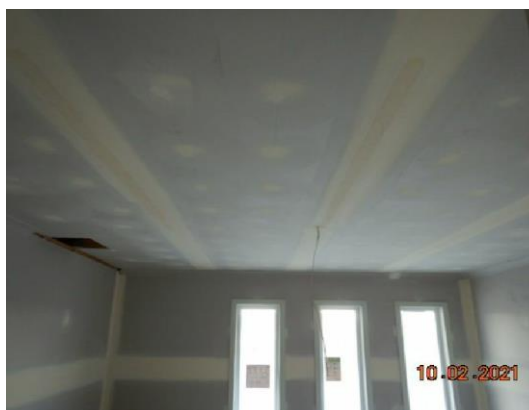
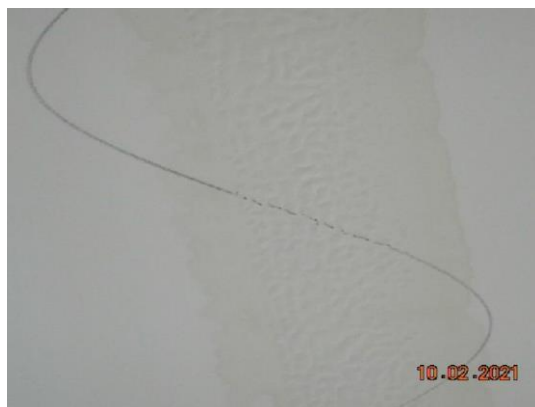
## 6.

It was noted that there is plaster that has been wetted and possibly soaked through. Below is an extract released by the Gypsum Association on the matters of plaster wetting and when the plaster should be replaced.

If the plaster was not dried within 24 to 48 hours and you have concerns about mould, we suggest you seek to have the builder check for and remove any potential mould.

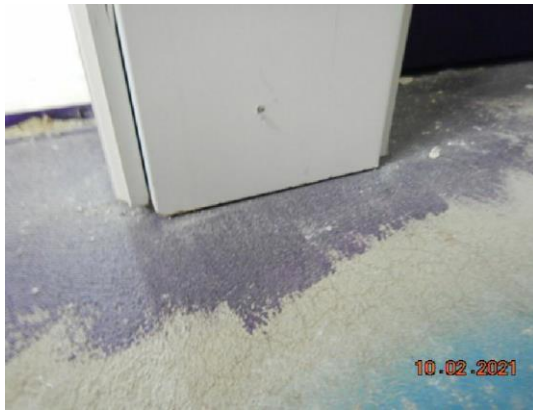
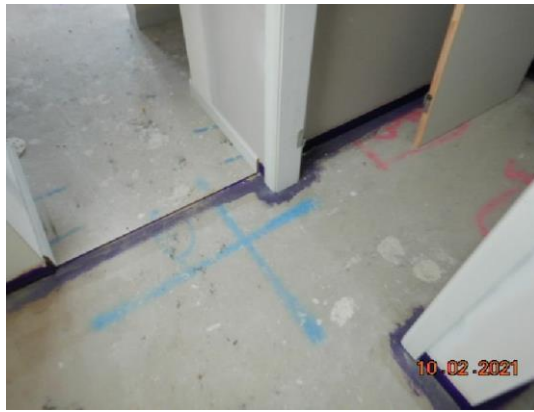
7.

**AS 3740; 3.17:** - Architraves and door jambs shall finish above the floor tiling where possible. Any portion below the floor tiling shall be waterproofed.

Architraves and / or door jambs do not meet this requirement.

**Note: Trimming of the architraves whilst in place must be done with extreme care so as not to damage the waterproofing membrane.**

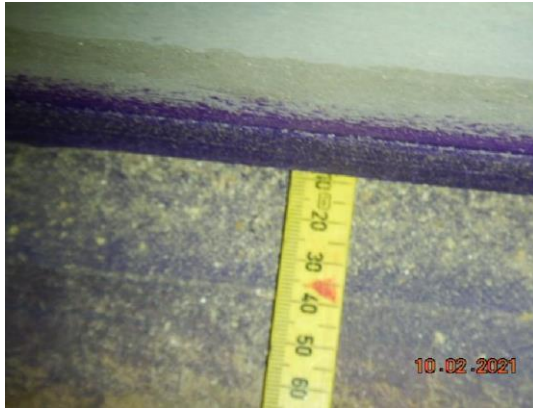
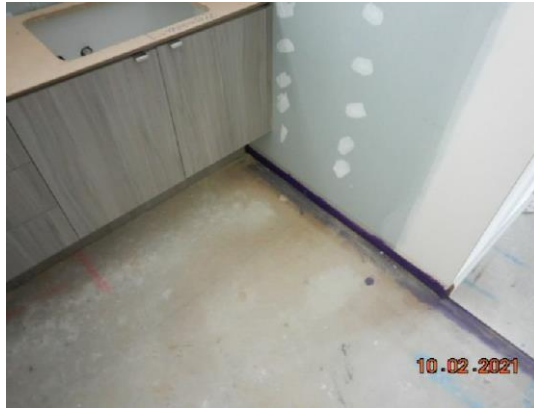
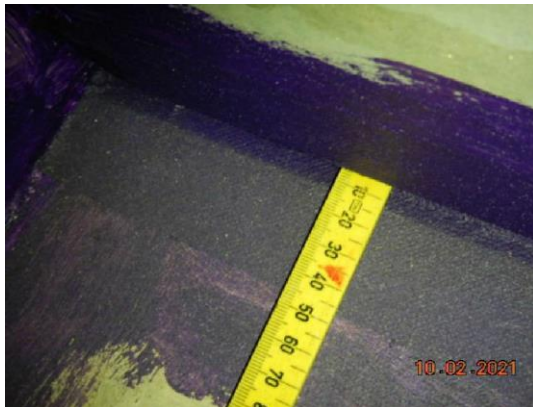
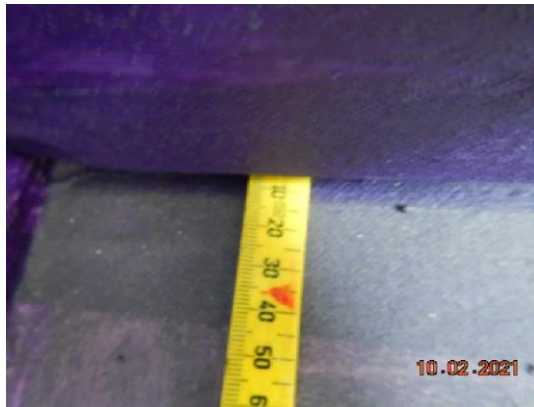
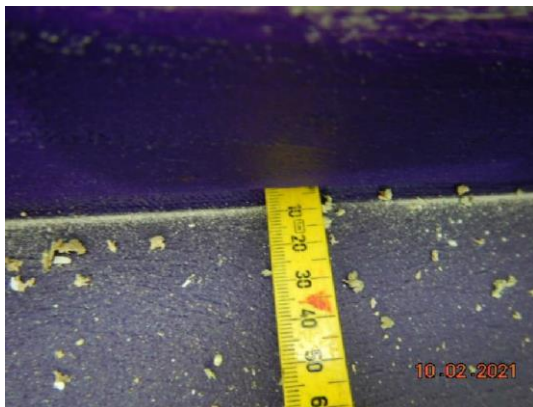
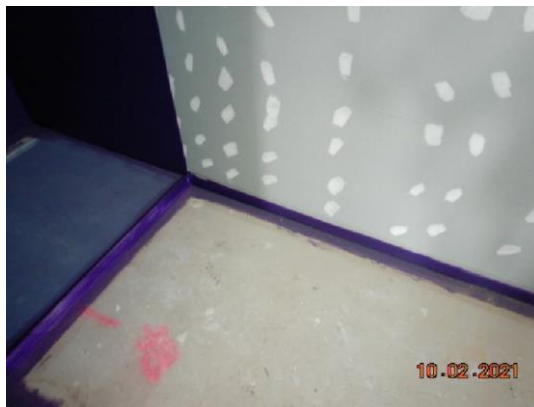
# 8.

The floor junctions to all wet areas have not been waterproofed as per AS 3740. The junction is to be installed with bond breaker and as per the extract below.

All areas to comply

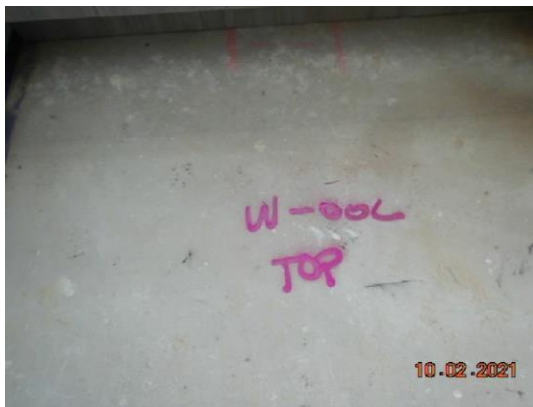
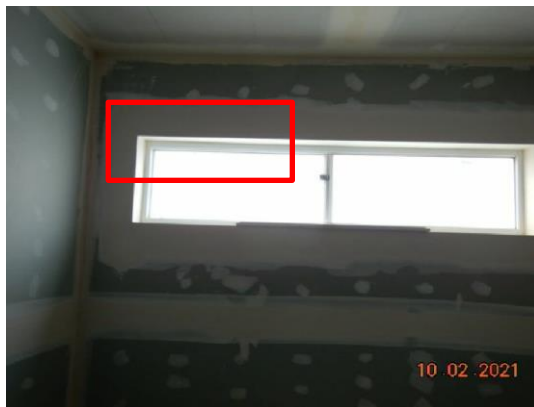
#### 9.

A small number of window and door frames are presenting out of plumb more than the 4 mm over 2 m tolerance.

All windows and doors will need to be plumb and level.

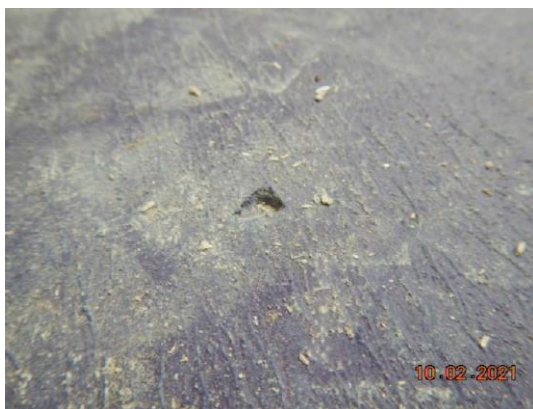
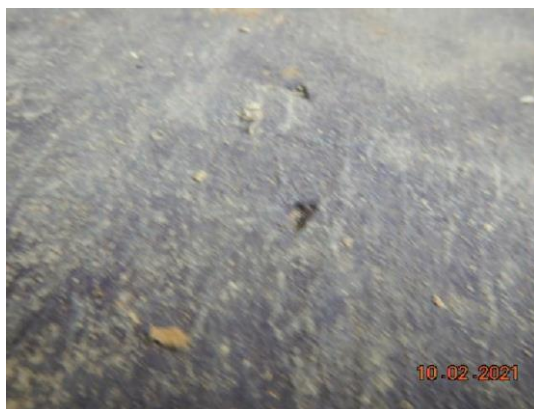
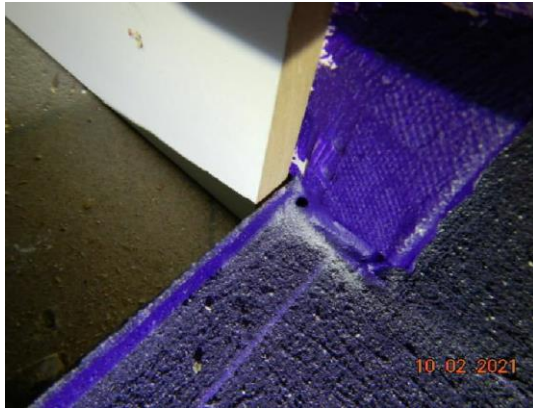
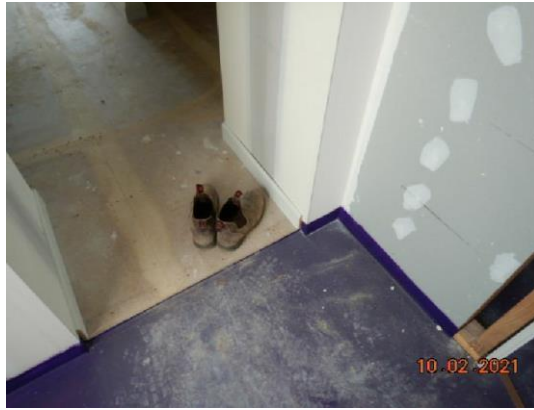
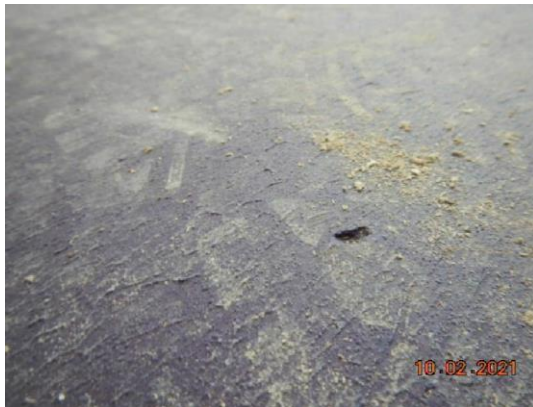
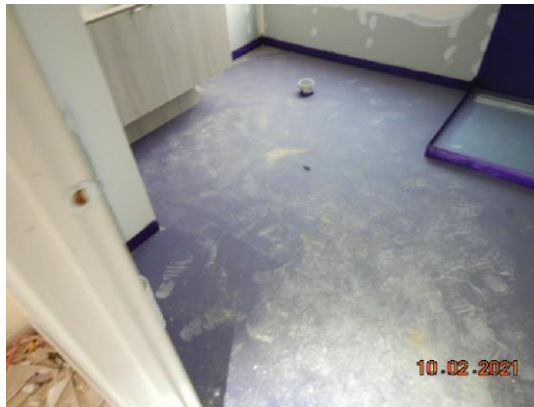
## 10.

We noted some small holes, cracks, or gaps in various sections to the waterproof membrane in wet areas (marked with blue tape).

All areas must be sealed waterproof in accordance with the NCC Volume 2 and the manufactures specifications.

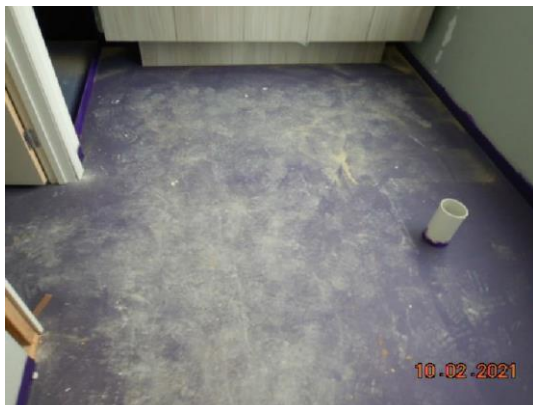
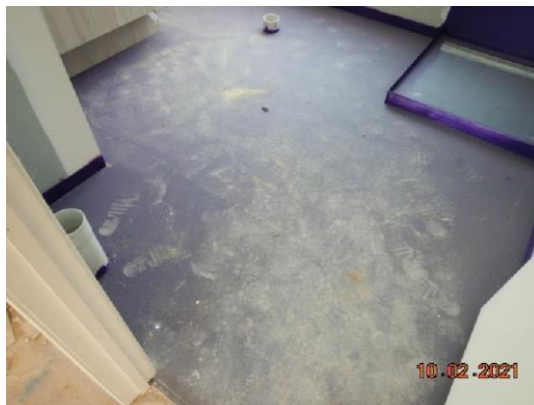
# 11.

We noted dirty boot prints presenting on the waterproof membrane, as documented in the photographs below. The concern is potential damage to the membrane from scratches, possibly from dirt abrasion or scuffs from debris caught in the soles of footwear. All areas should be protected.

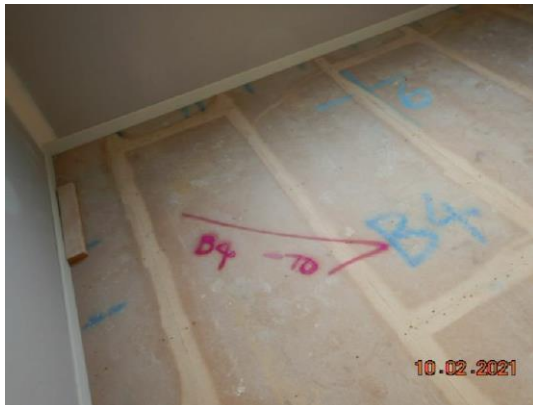
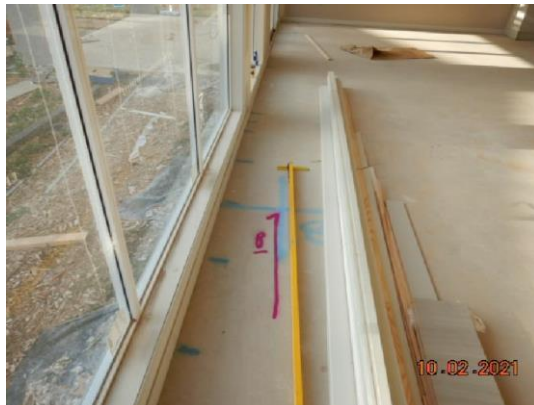
## 12.

The concrete and timber floors to the dwelling have areas showing out of level.

The allowance is 4 mm over 2 m. All floors to the dwelling must be levelled to 4 mm over 2 m. The builder cannot claim the 10 mm allowance in any given room if he has breached the allowance of 4 mm over 2 m. These out of level and bowed floor areas are marked with spray paint.

The builder will need to level the floors to the allowance.

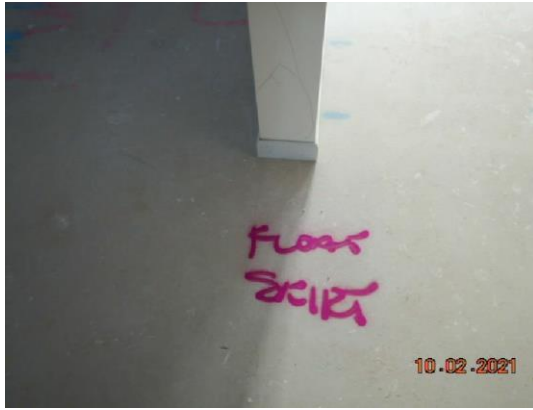
## 13.

We noted the plaster wall above the skirtings in a few areas is showing a noticeable bow. This bowing has come about following the carpenter straightening the skirting because of excessive plaster build-up at the external corners. If filled with no more gaps, this wall bowing will cause visible unsightly thickening of the skirting top edge at the junction to the wall.

The builder will need to plaster float these areas to present a flat plastered surface that aligns evenly to the skirting.

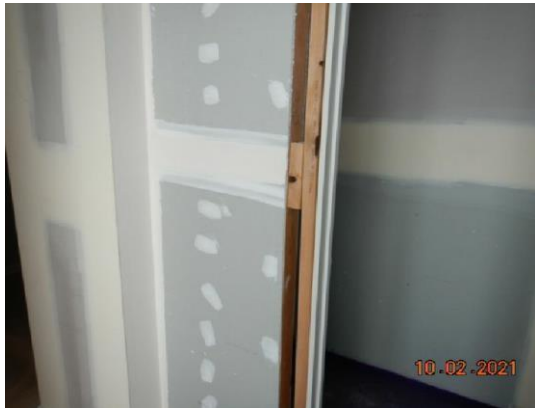
Incomplete

The following items will need to be completed or repaired same.

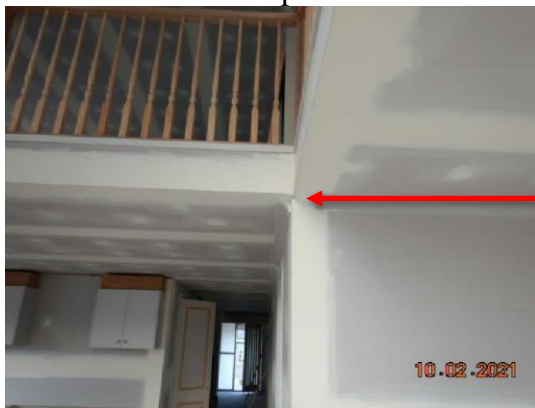
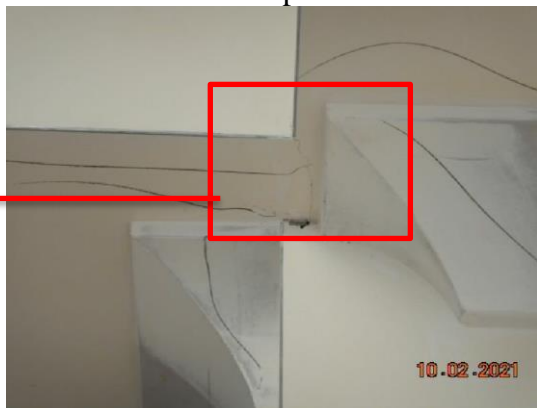
Cornice short
