Dwelling type:	House and Garage.
Dwelling configuration:	Single Storey.
Nature of works:	New Building.
Stage of inspection:	Frame.
Construction Type:	Brick Veneer.
Garage:	Attached.
Foundations:	Slab.
Builder:

Schedule of Defects:

Defects, observations and other related comments from the Frame Inspection on the 20/04/2021:

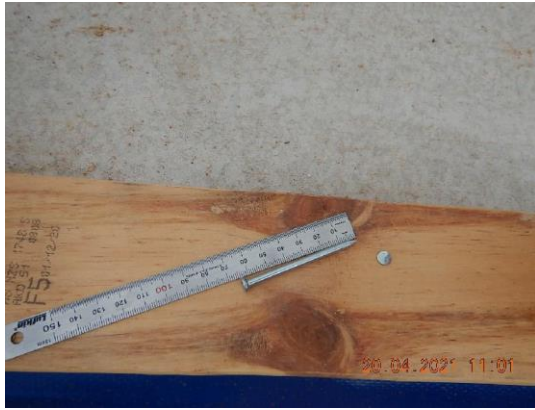
1.

Nails used were found to be less than 75mm and as such, have not met this requirement.

65mm nails used.

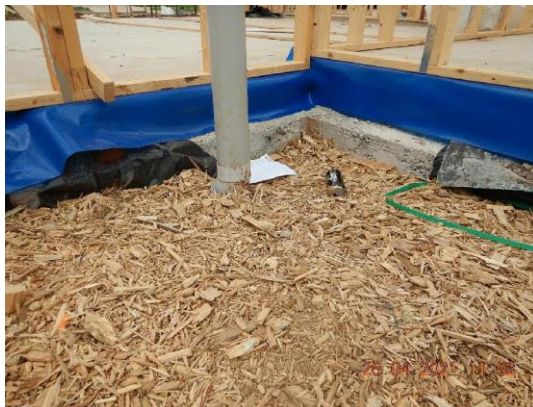
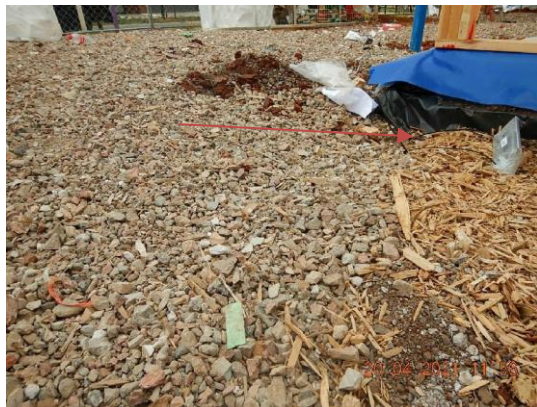
2.

The dwellings slab footings have the opportunity to pool with water due to the way the block has been cut and the lack of back filling.

The NCC is very clear in its requirements to have the soil graded from the start away from the dwelling as a minimum of 50 mm over 1 m. This has not been done. We refer all to the NCC, part 3.1.3.3.

We also refer the builder to the soil report and engineering drawings that clearly call for the site drainage to be managed via sloping water away from the slab and more so, managing same.

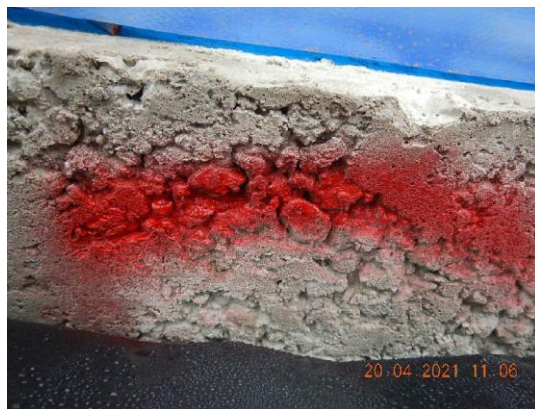
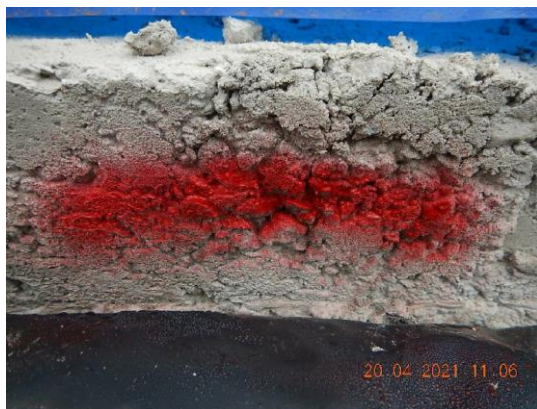
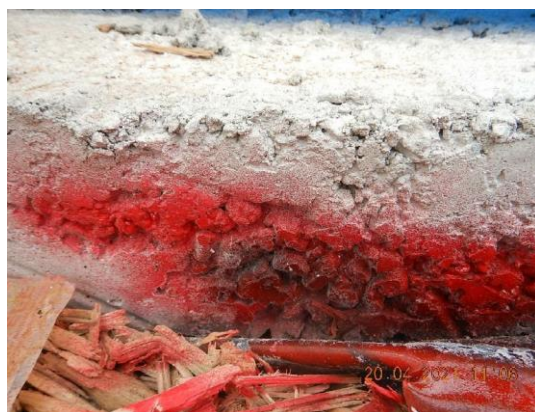
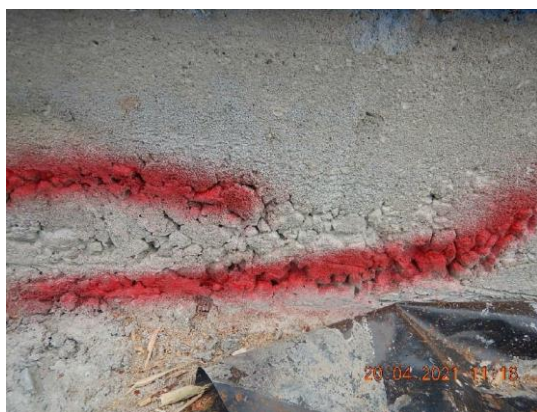
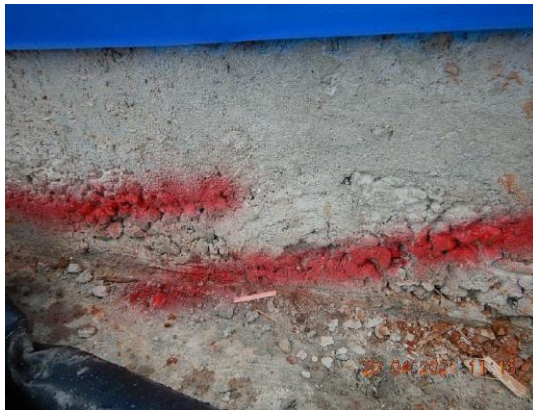
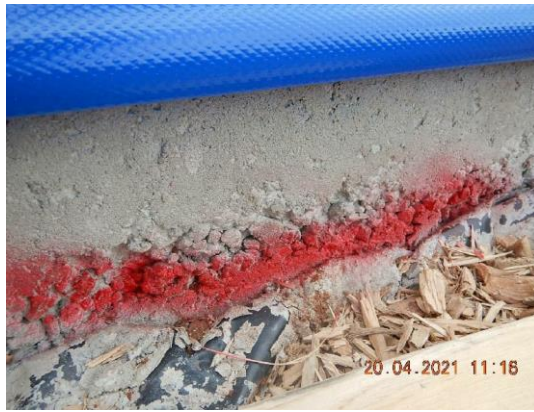
3.

We noted an amount of what is known as bony finish to the edge beam of the home. That is the edge is presenting with air pockets that should have been vibrated out of the installation.

We also noted what is commonly referred to as cold joints in the concrete installation. That is where the installation of concrete has had laps in time between filling sections. You can clearly see the layers of concrete to the side of the slab.

The engineering also calls for the same in the site engineering plans. The builder must ensure that these defects are not present to a slab as it can in certain circumstances weaken the slab.

It is our recommendation that the builder seeks a professional opinion from the site engineers in relation to this defect and seeks documentation to either dismiss my findings or make recommendations on some level of rectification.

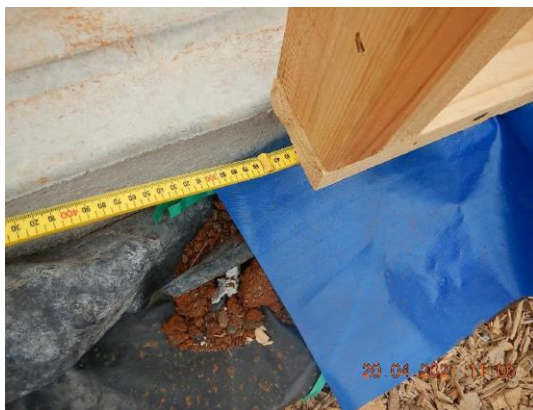
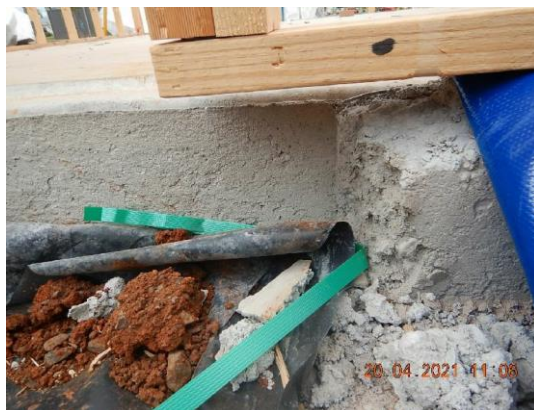
4.

Victorian Building Authority: - The frame overhang as documented needs to be supported in a manner that complies with AS 1684.2, clause 6.3.3, and the BCA. The VBA are quite clear that a set process of rectification and certification must take place.

Rear garage.

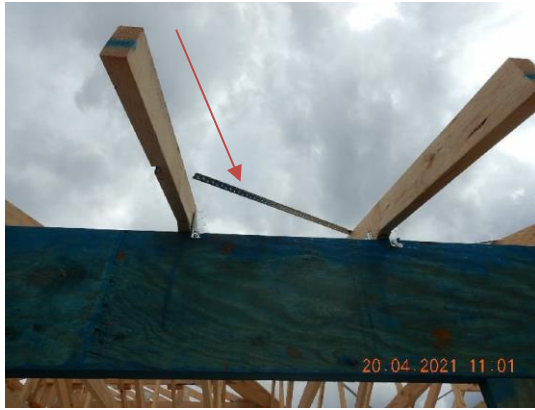
5.

The roof frame speed brace has not met this requirement.

Not fixed.

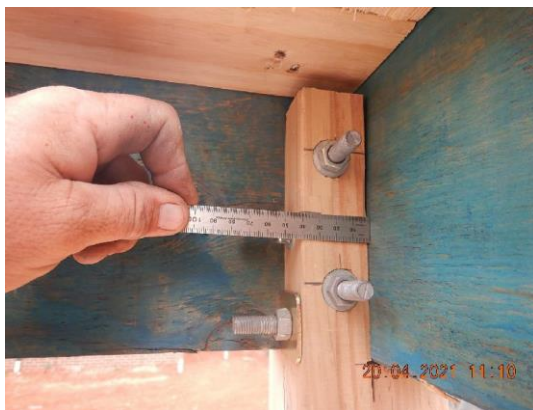
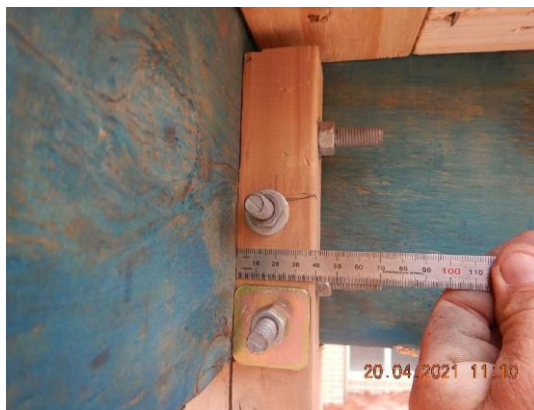
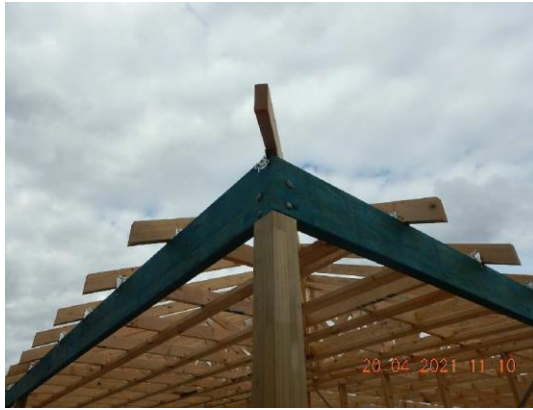
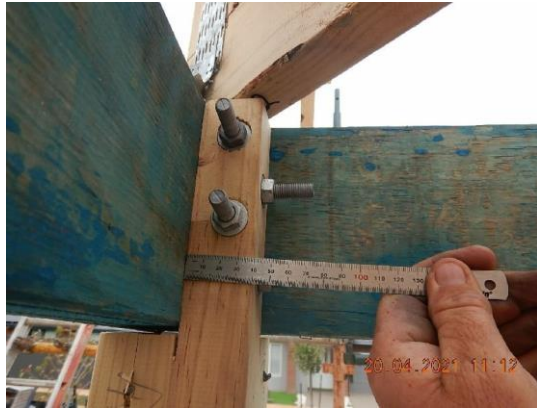
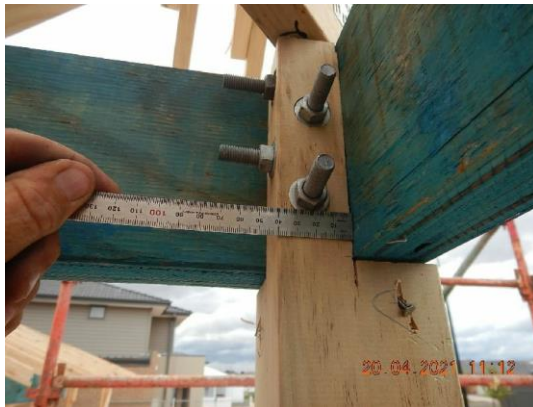
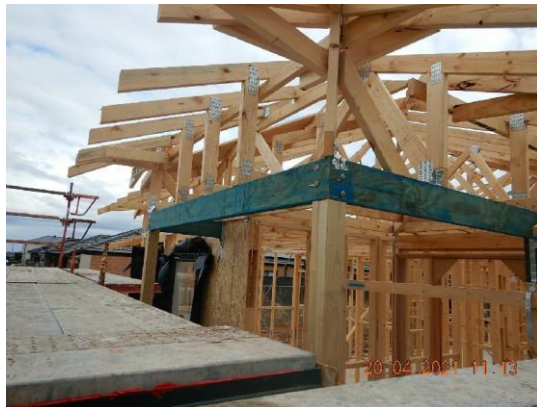
6.

AS 1684.2; 9.2.9, Figure 9.3(a): - Posts supporting members at joints shall have a minimum amount of 50mm retained at the post to adequately resist uplift.

Timber posts have not met this requirement.

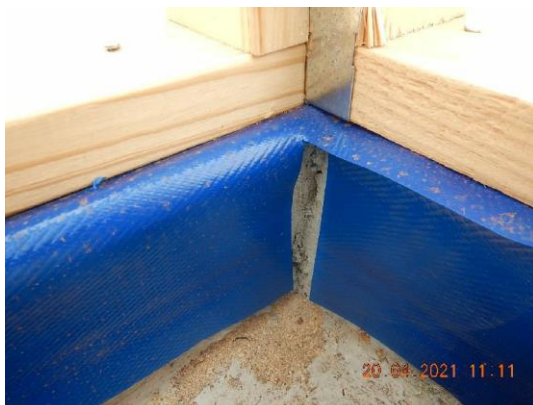
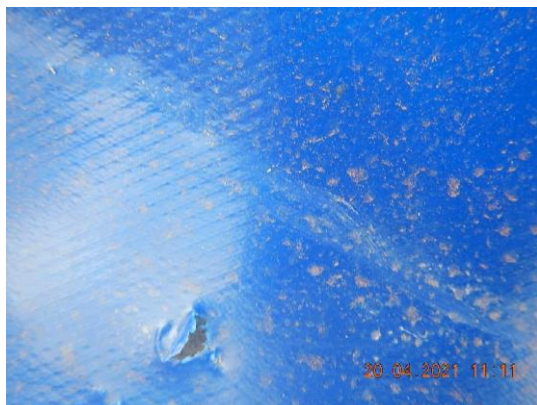
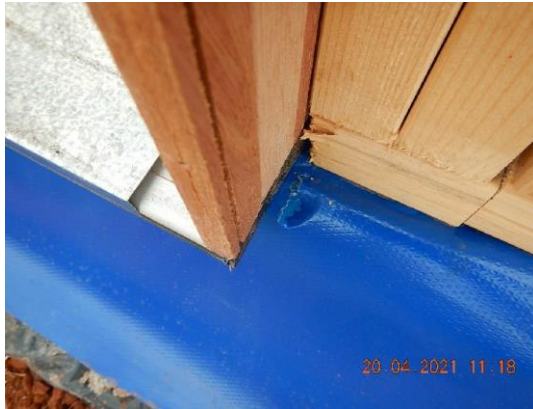
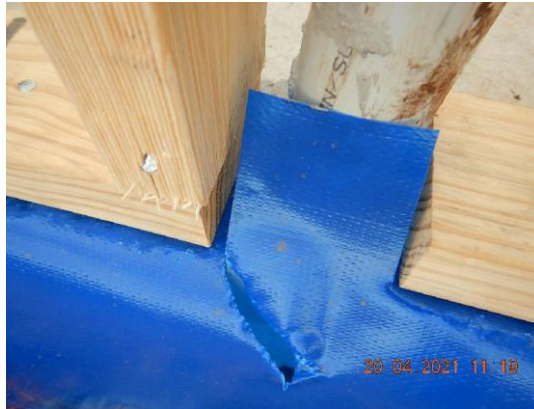
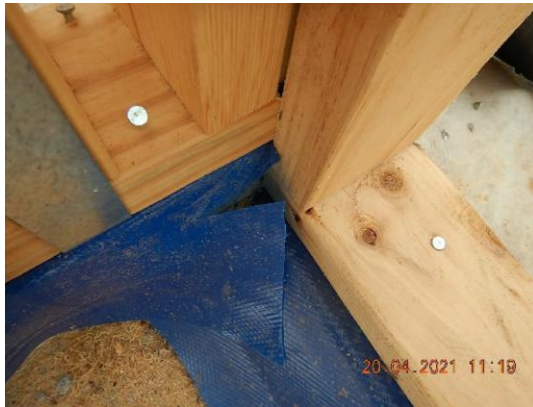
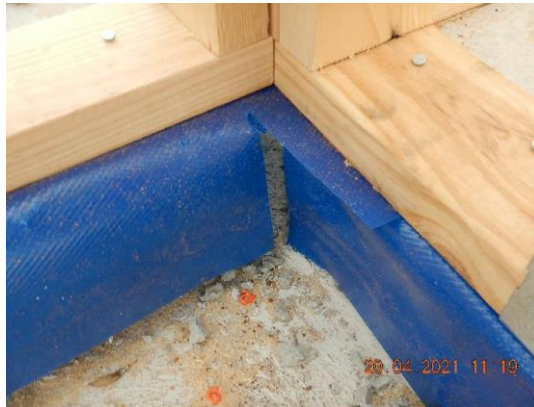
7.

The termite barrier system is presenting with damage, creating open gateways. All areas of the termite system must be complete in accordance with

All areas of damage must be reworked as intended, thus closing off all gateways.

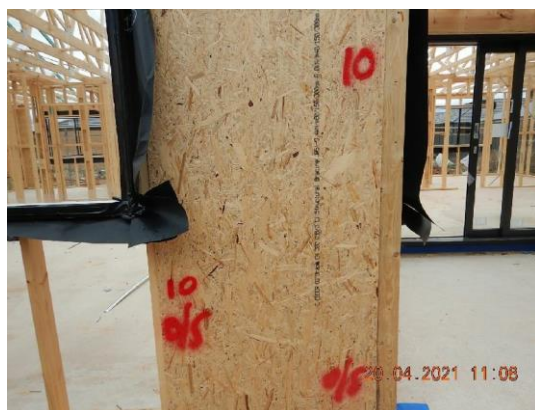
9.

Bracing panels with over shot nails have not met these requirements.

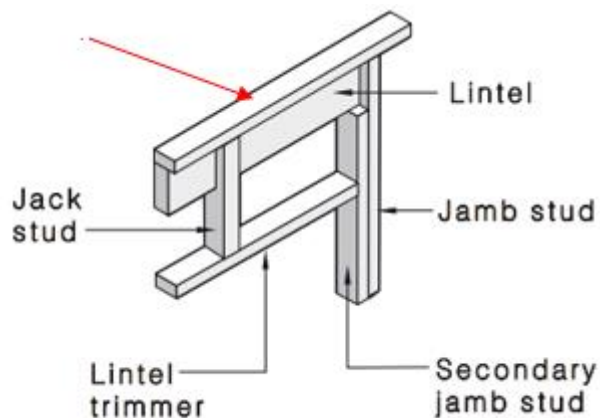
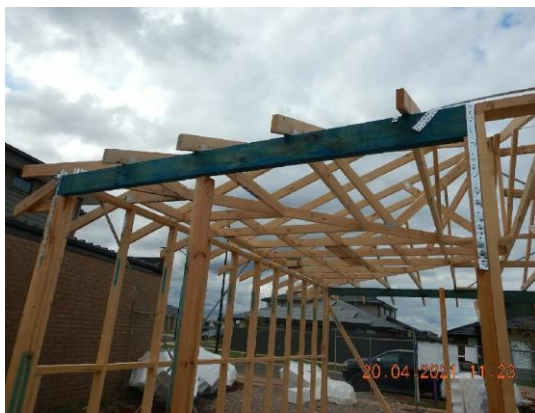
10.

AS 1684.2; 6.3.6.1: - In timber wall framing, top plates shall be provided above lintels.

This requirement has not been met.

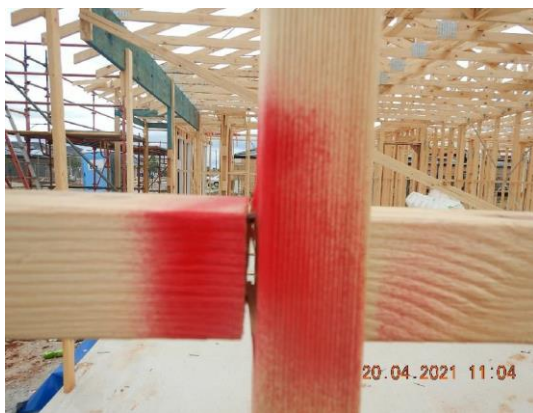
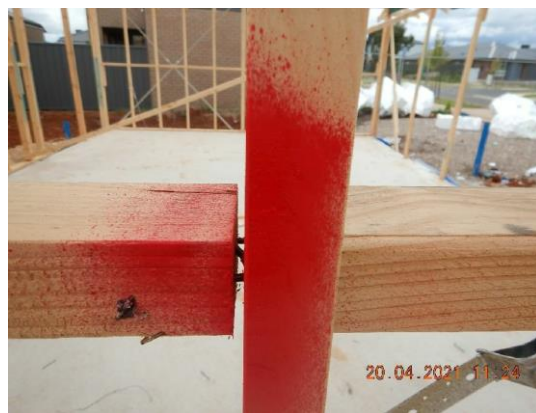
11.

AS 1684.2; 6.2.1.5: - Wall studs shall have continuous rows of noggings at 1350 mm maximum centres.

Breaks in the continuity of the nogging row through either short or missed nogging means that this requirement has not been met.

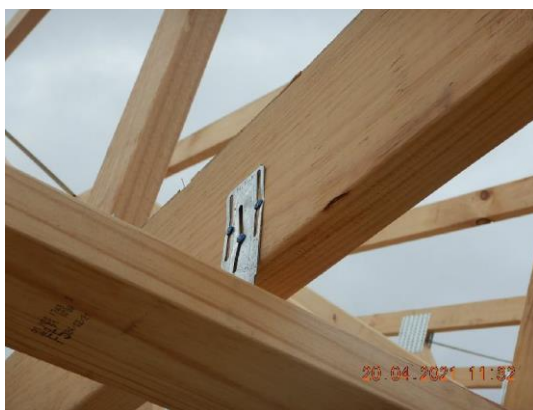
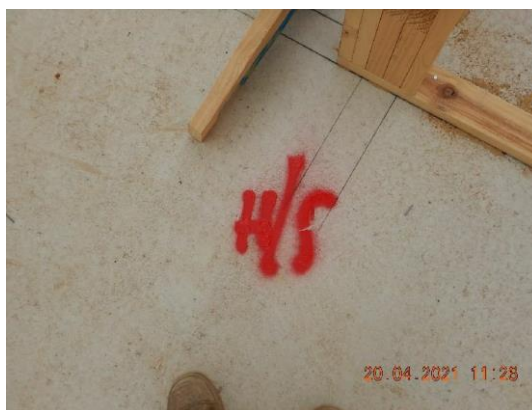
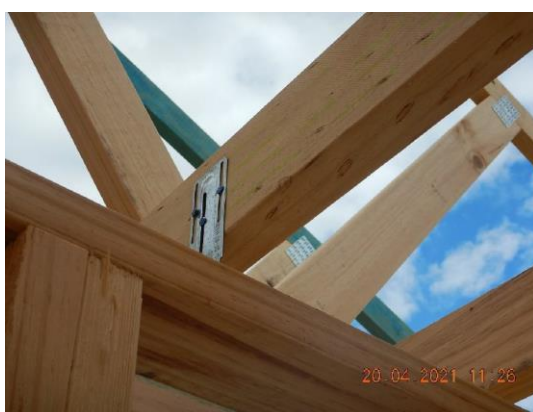
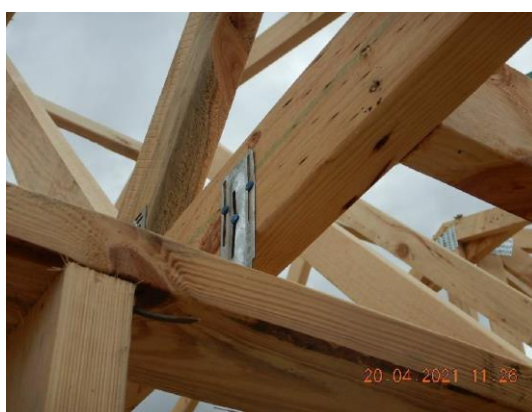
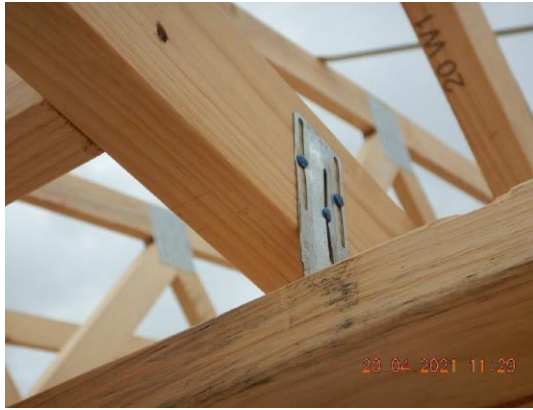
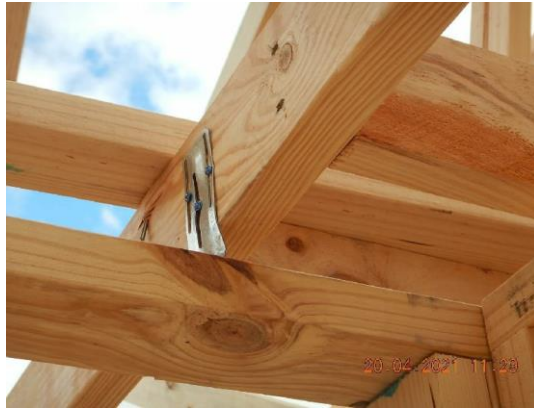
12.

AS 4440; 2.2.3(c), Figure 2.3: - “Do not drive (‘L’ bracket) nails fully home to allow for vertical movement of truss on loading.”

Nails have been driven home hard to the bracket slots. Hence this requirement has not been met.

Check all.

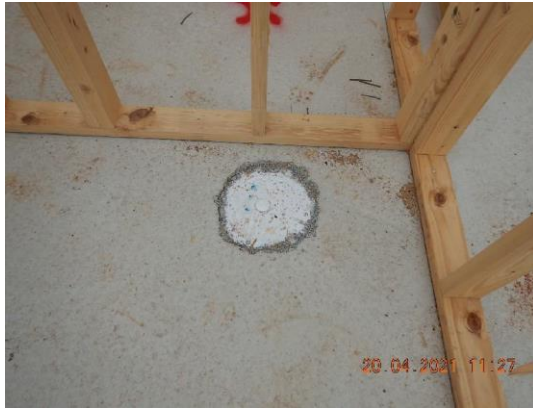
13.

I noted a smart pan waste installed for the closet pan/s. The builder must clarify that the closet pan to this area does not require screws fixed to the concrete floor as per the manufactures installation details.

- The manufacturers clearly state the toilets are to be screw fixed through the provided holes. Under section 26 of the Domestic Building Contracts Act, I request a copy of our clients manufactures installation details.
Note - If the supplied toilet has mounting points within 290mm forward of the timber frame, then this item is not a defect.
- Selleys and others clarified that silicone is not classed as an adhesive and cannot be used for fixing purpose. Its primary function is a flexible caulking sealant.

This item needs to be addressed in a manner that is compliant. Not a quick installation fix as so often occurs.

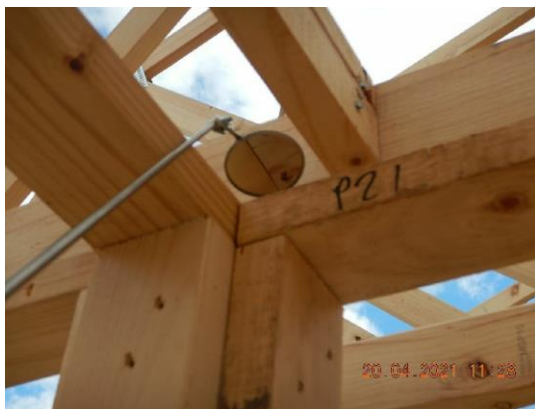
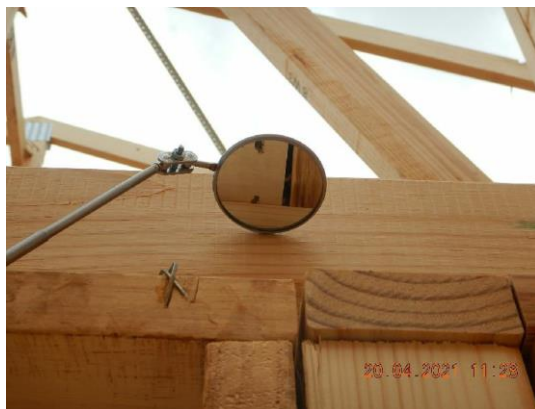
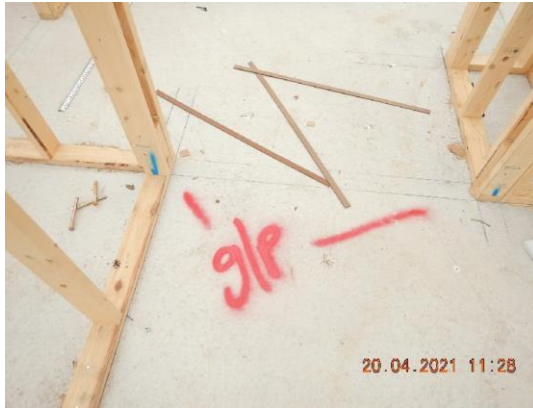
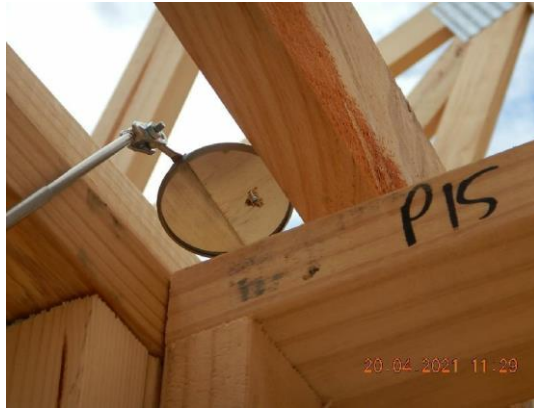
14.

AS 1684.2; 9.2.8: - calls for the installation of a plate connector (gang nail plate or equiv.) at the top of all intersecting walls. Where plates interlock, they are not required.

There are gang nails missing to several of the top plates to the wall's connections. These plates play a vital role in securing one wall to another. It also assists with the racking force resistance on a home.

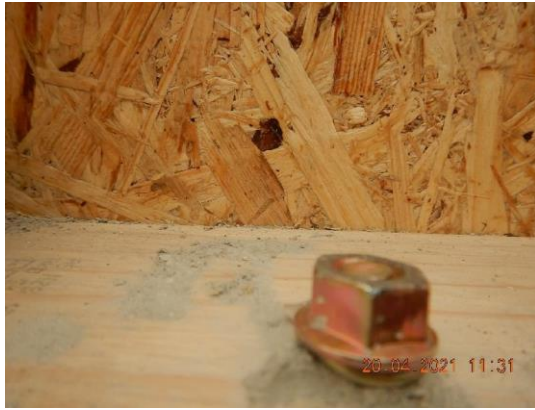
15.

AS 4100, part 14.3.6.1: - At least one clear thread plus the runout thread shall be clear of the nut after tightening.

LHS.

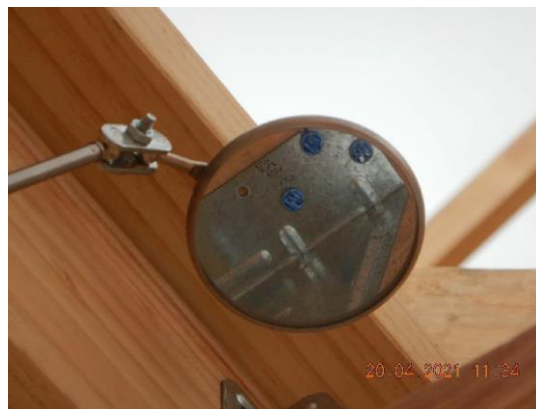
17.

Mitek brace wall bracket installation guide: - Nails are to be installed into the trimmer or truss bottom chord at the top of the slots and to the top of the wall plate. Nails have not been installed at the top of the wall plate as required.

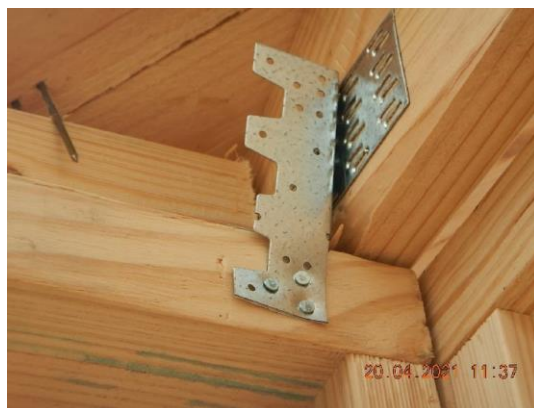
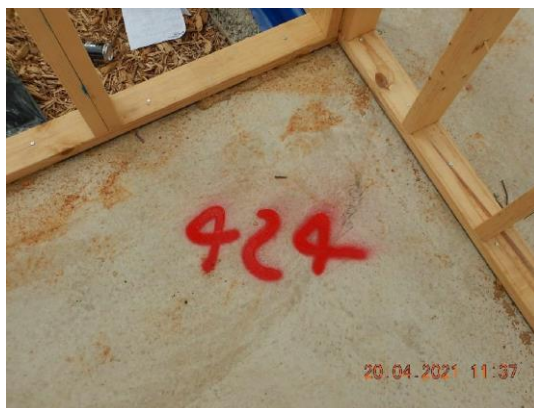
18.

Pryda and Mitek; Triple Grip & Multigrip installation: - Both manufacturers of triple grips and multigrips require 10 hot dipped galvanised reinforced head nails installed in the following configuration when attaching to rafters and trusses. The current installation has not met the manufacturer's requirements.

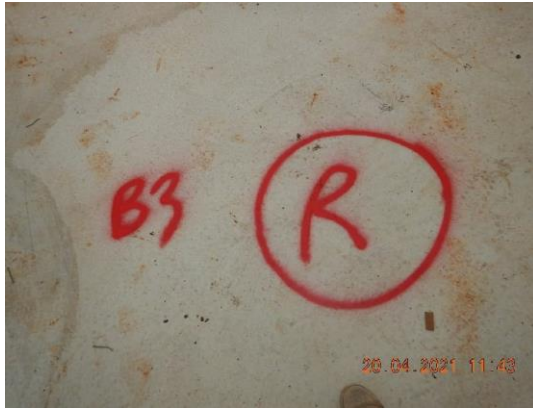
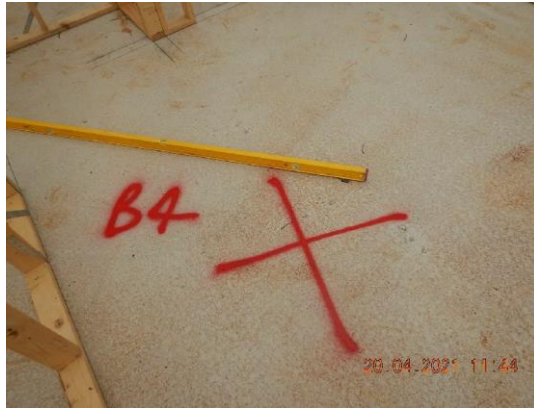
20.

VBA Guide to Standards and Tolerances; 2.08: - New concrete floors must not differ more than 4 mm over any 2 m length or 10 mm in any room or area.

We measured random areas of the concrete slab with a 2 m straight edge and found the slab levels to have not met this requirement.

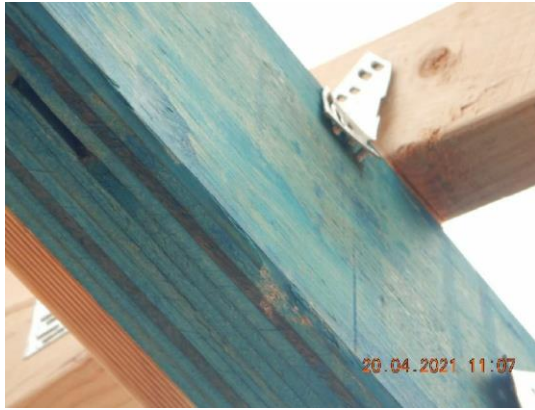
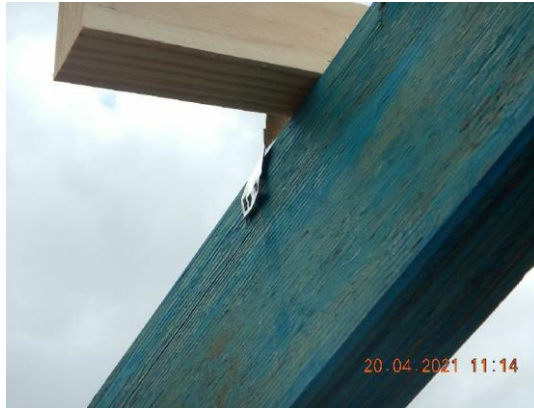
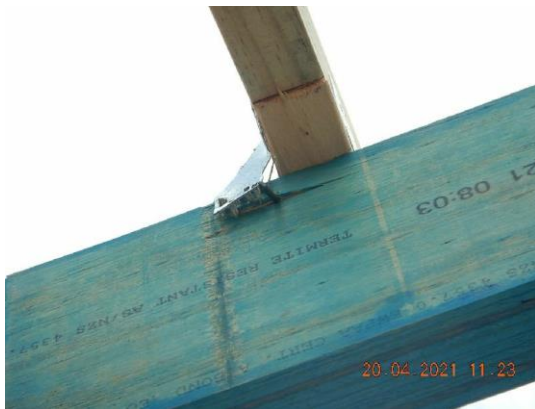
21.

We refer the builder to the implied warranties where the builder agreed to build the dwelling in a **proper and workmanlike manner and with care and skill**.

Hammer home.
