Dwelling type:	House and Garage.
Dwelling configuration:	Single Storey.
Nature of works:	New Building.
Stage of inspection:	Final.
Construction Type:	Brick Veneer.
Garage:	Attached.
Foundations:	Slab.
Builder:

Schedule of Defects:

Defects, observations and other related comments from the Final Inspection on the 26/04/2021:

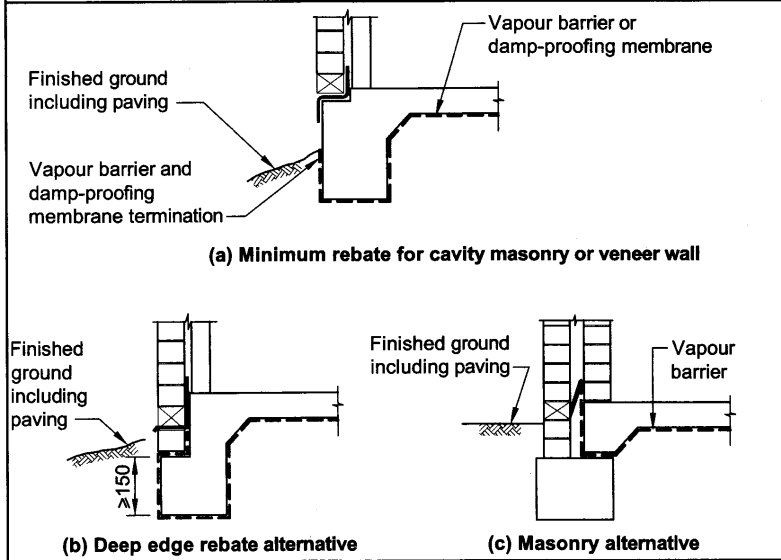
ACCEPTABLE VAPOUR BARRIER AND DAMP-PROOFING MEMBRANE LOCATION

1. This defect was previously noted and had not been fully rectified at the time of the final inspection on the 26/04/21.

The polyethylene vapour barrier from beneath the concrete floor slab has not been turned up the external side faces of its edge beams. It must be prior to them being back filled up against, which will allow moisture ingress via slab edge dampness into the internal timber wall skins and/or the floor coverings if not done.

- 6) This is a defect because the vapour barrier does not extend under the edge beam to finish at ground level as required in the BCA.

All the existing loose fill that has been placed up against the slabs edge beams will need to be removed and the polyethylene vapour barrier properly extended up the external side faces of the edge beams to at least the height of future finished ground level or paving i.e., 75mm below the damp-proof course and bottoms of the weepholes, after which any termite barriers that are in place, if required, will also need to be properly installed.

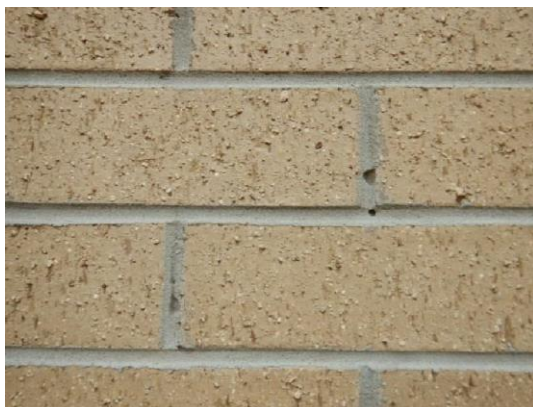
2. **This defect was previously noted and had not been fully rectified at the time of the final inspection on the 26/04/21.**

The VBA Guide to Standards and Tolerances: - Voids, holes, mortar smears, and stains in masonry walls are defective if visible from a normal viewing position.

Masonry faces are defective if they are not cleaned and free of excess mortar. Homeowners are entitled to expect that the works are clean and tidy on completion. This would include paint and plaster excesses, etc. to be removed from the brickwork.

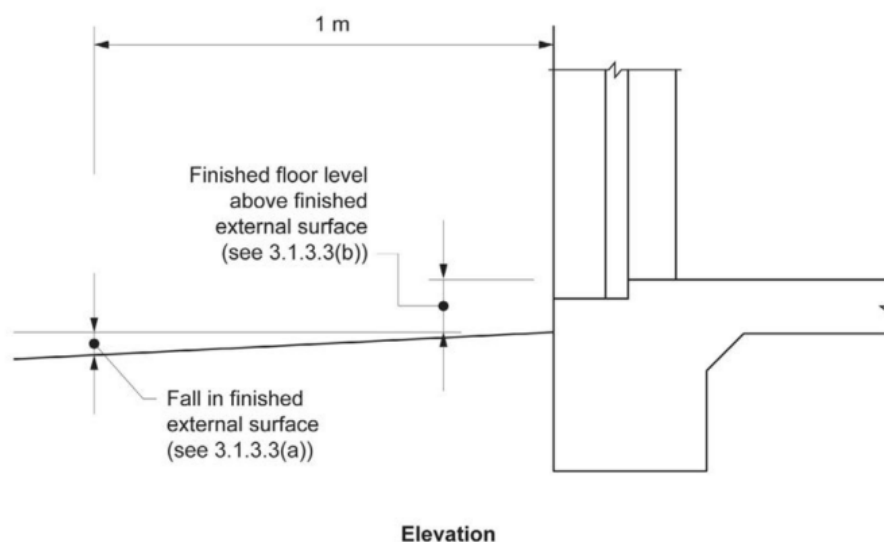
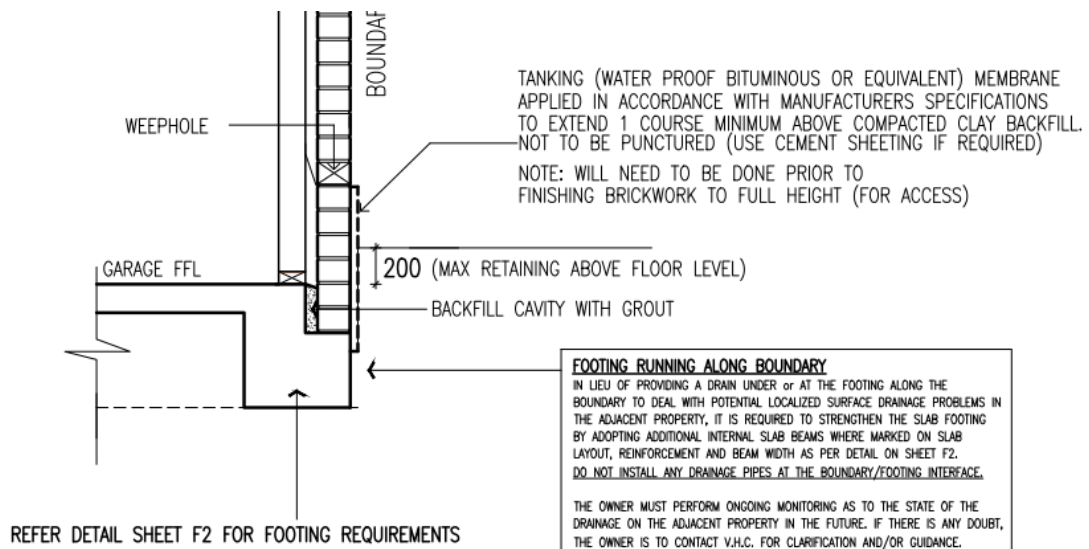
3. This defect was previously noted and had not been fully rectified at the time of the final inspection on the 26/04/21. This is a critical item as will likely result in pooling of water immediately adjacent to footings.

The land to the garage falls back towards the foundations of the slab. Given that this is a zero boundary, the builder must work in provisions for draining the soil to this area.

I noted that the Engineering states that a 50 mm fall away from the footings must be installed. The builder needs to assist us with an understanding of how, with a zero boundary the builder expects to achieve this requirement.

The NCC mandates that water is controlled and must fall away from the dwelling. See part 3.1.2.3 and figure 3.1.2.2.

The builder should have allowed a 150 mm set back to the Garage wall to boundary and installed a water management system to divert water away from the foundations and slab edge as an alternate solution to the mandated requirements.

TANKING TO GARAGE WALL ADJACENT TO BOUNDARY

IF REQUIRED – DETERMINE ON SITE

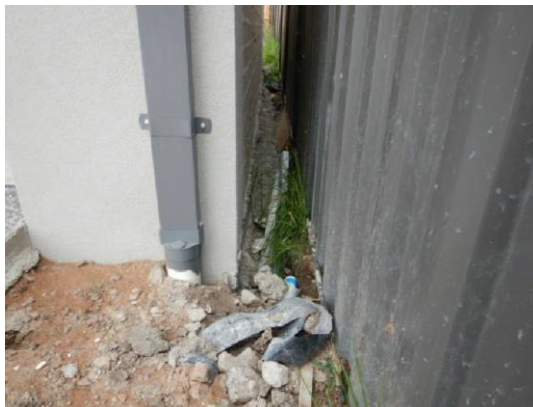
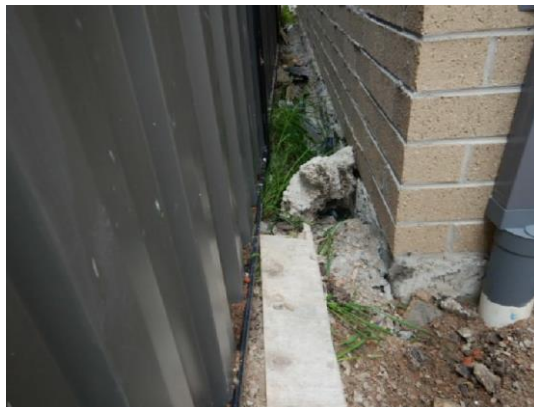
4. This defect was previously noted, engineers comments not recieved at the time of the final inspection on the 26/04/21.

We noted that the slab has been cut and opened. We further noted that the repair is poorly constructed.

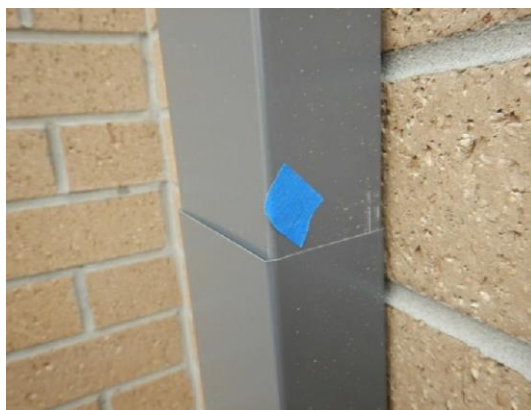
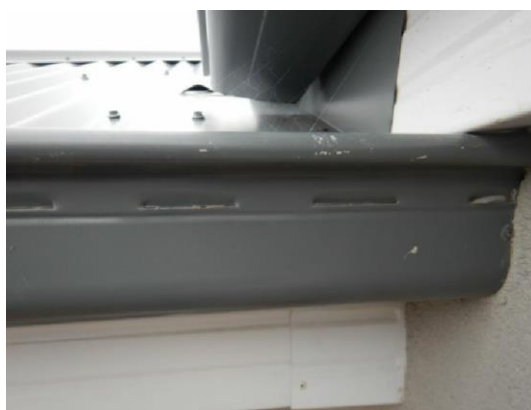
6. This defect was previously noted and had not been rectified at the time of the final inspection on the 26/04/21.

AS 3500.3: - The minimum allowable gradient is 1:500 to achieve an effective gradient with no permanent ponding.

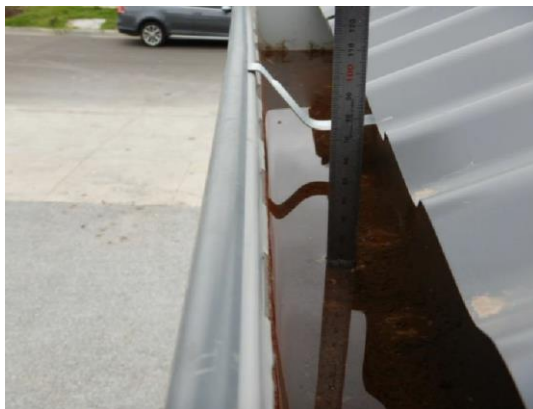
7. This defect was previously noted and had not been rectified at the time of the final inspection on the 26/04/21.

Normal installation practices such as drilling and cutting usually leave offcuts and metallic swarf on or around the roof area. These materials and all other debris, including blind rivet shanks, nails and screws are to be cleaned from the roof area and gutter regularly during the installation process as unsightly staining of the surface due to oxidation of the metal particles will result, leading to corrosion and possible failure of the roofing material or guttering. Where practicable, the entire installation should be cleaned down with a blower vac, swept or, alternatively, if a water supply is available, hosed down at the completion of the work.

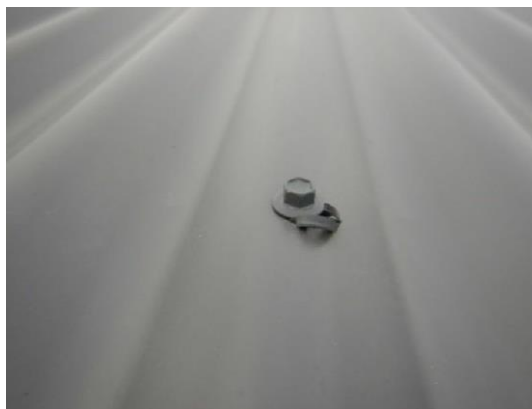
8. This defect was previously noted and had not been rectified at the time of the final inspection on the 26/04/21.

A number of roof screws have been over tightened deforming the washers. This must be avoided as it can lead to a loss of the water seal and lead to future water leaks.

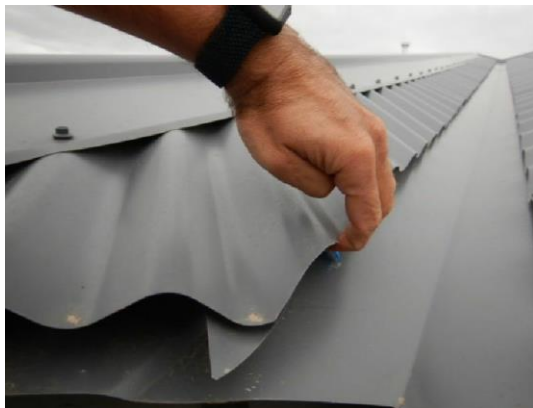
9. **This defect was previously noted and had not been fully rectified at the time of the final inspection on the 26/04/21. Critical item potentially allowing water ingress to roof frame.**

NCC 2019; 3.5.1.5: - Roof sheets must be fixed off as per Table 3.5.1.4.

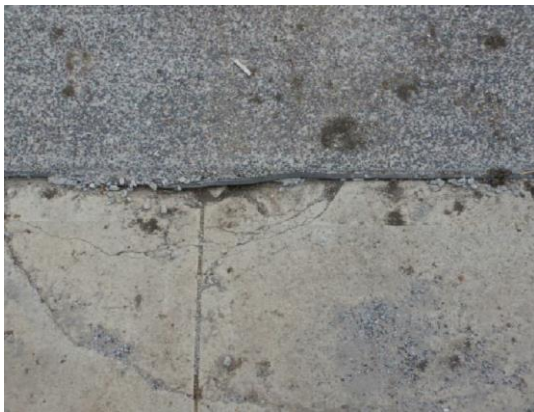
Foot path/Drive cross over

10. This defect was previously noted and had not been fully rectified at the time of the final inspection on the 26/04/21.

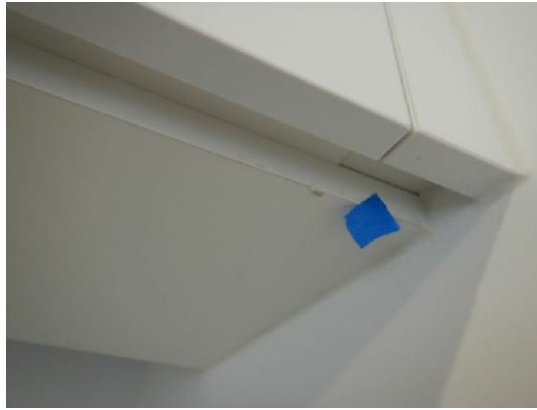
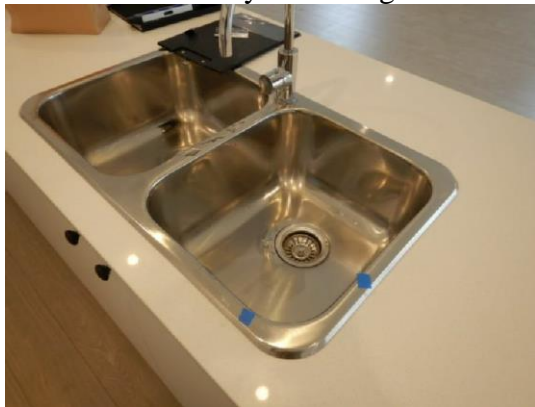
Kitchen sink scratched

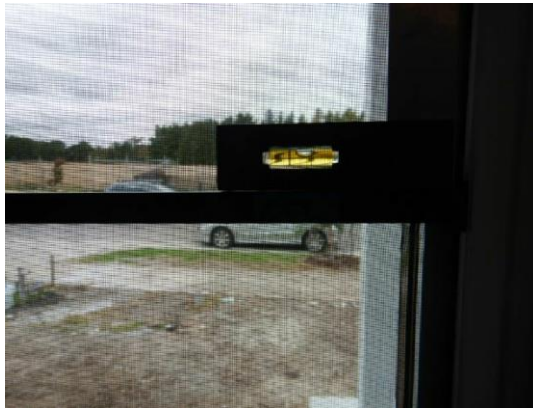
Mullion OOL

12. This defect was previously noted and had not been fully rectified at the time of the final inspection on the 26/04/21.

Frames are defective if they deviate from plane (horizontal or vertical bow) by more than 4 mm in any 2 m length of wall. Refer to Diagram E.

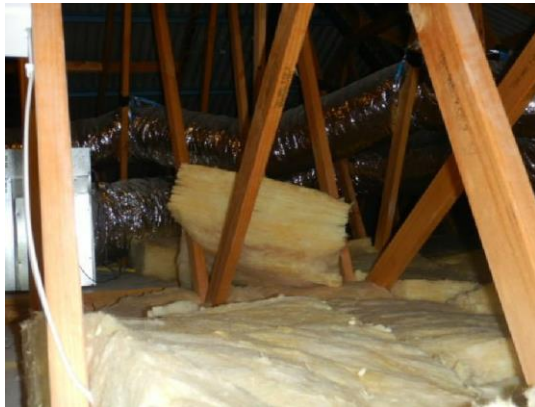
13. This defect was previously noted and had not been fully rectified at the time of the final inspection on the 26/04/21.

The insulation in the ceiling has the following defects.

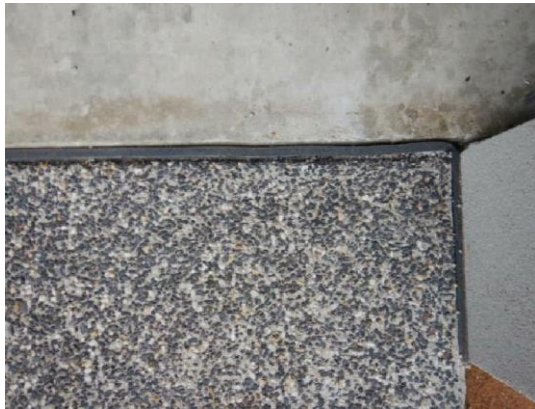
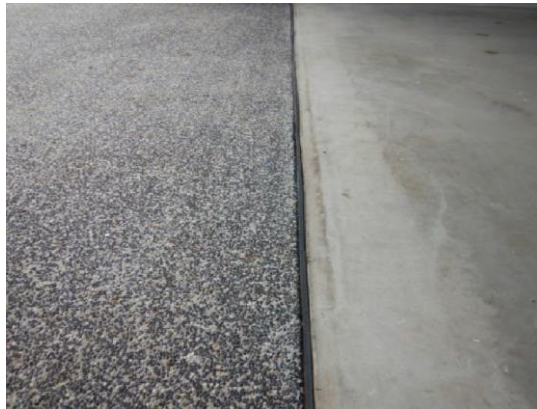
It was noted the concrete paving has not been caulked to the dwelling at the isolation joints. This caulking will need to be completed in accordance with AS 3727.1, figure, 5.4.3.

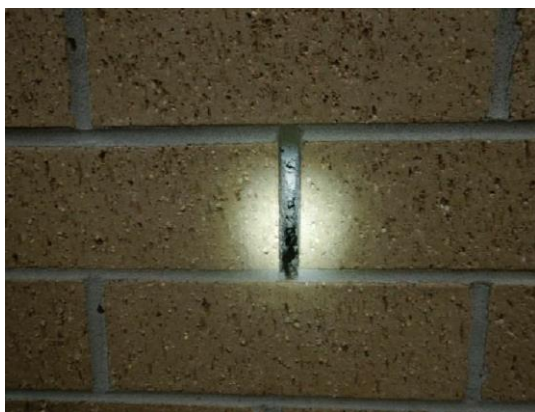
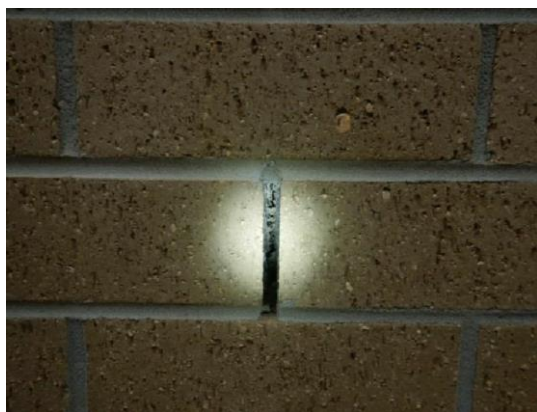
16.

AS 4773.2, part 9.6.2.1: - Veneer walls shall be drained to weep holes spaced at 1200 mm maximum centres. The raking of the perpendicular joints shall extend the full width of the masonry including the bed joint.

Special care must be taken to ensure the DPC flashing is not damaged / breached.

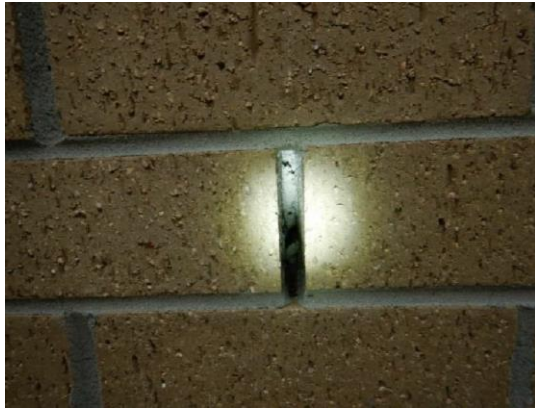
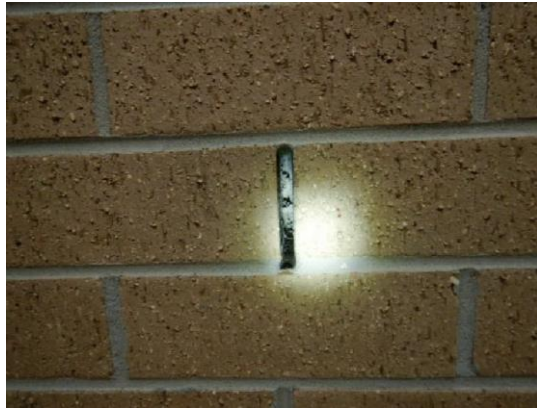
17.

- Veneer walls shall be drained by weepholes at 1200 mm maximum centres. The raking of perpendicular joints to form weepholes shall extend the full width of masonry (through the wall) including bed joint at the level of the flashing.
- Where cavity flashings are penetrated, the flashing shall be punched through or cut from the inside of the wall, and be fitted around the penetration and sealed.

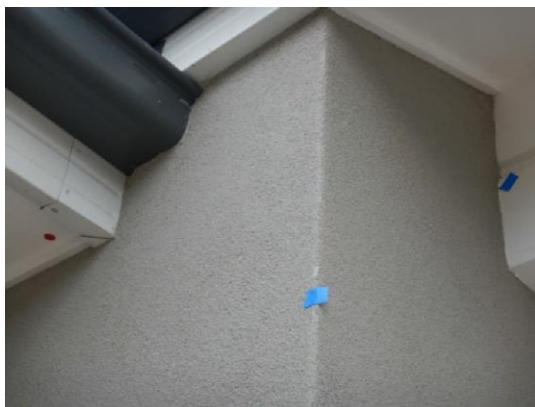
20.

VBA Guide to Standards and Tolerances: - Rendered surfaces that show spot rust marks and other blemishes are defective if visible from a normal viewing position.

Obvious spot rust marks, due to the composition of the material and other blemishes are defective if they are visible from a normal viewing position.

All areas to comply

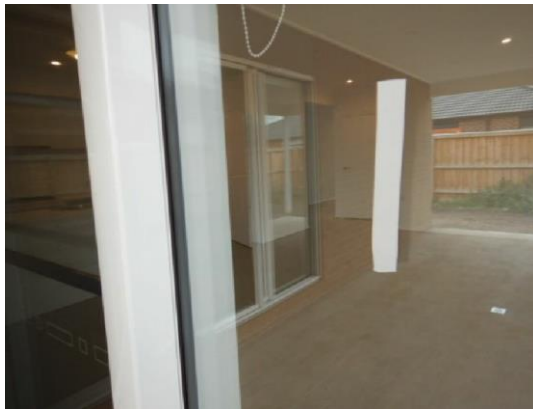
21.

The Victorian Building Authority: - Calls for all glass to be protected during the build. Allowance is made for minor damage. This dwelling glass in parts exceeds the allowance stated in the VBA advice below.

Given this item can be difficult to see, it can be assumed not all areas have been marked. The owner and builder will need to check for additional scratches in different lighting conditions.

All areas to comply

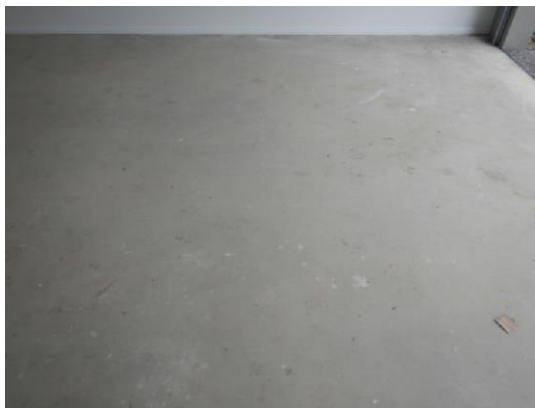
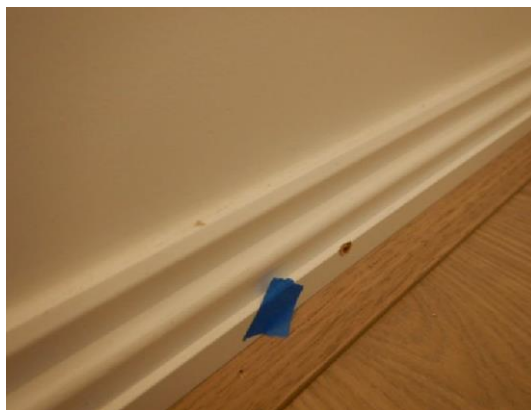
Paintwork is defective if the application has blemishes such as paint runs, paint sags, wrinkling, dust, bare or starved painted areas, colour variations, surface cracks, irregular and coarse brush marks, sanding marks, blistering, non-uniformity of gloss level and other irregularities in the surface that are visible from a normal viewing position.

Defect noted through out dwelling, refer to tape on site.

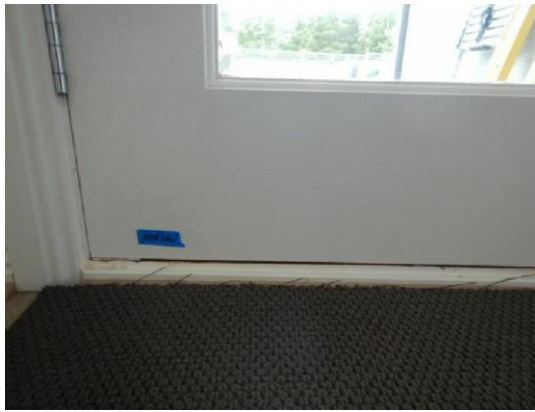
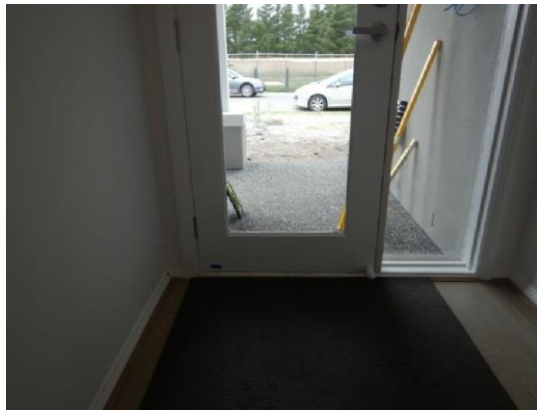
24.

A number of door margins will need to be reworked to comply with the inserted.

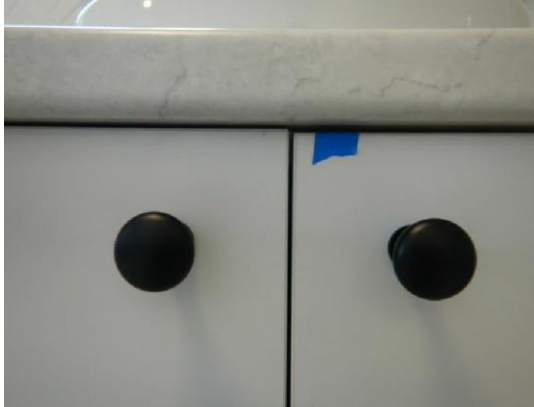
VBA Guide to Standards and Tolerances: - Cabinet door and drawer fronts are defective if they do not align, or do not have consistent gaps, and can be seen from a normal viewing position.

Small number of locations

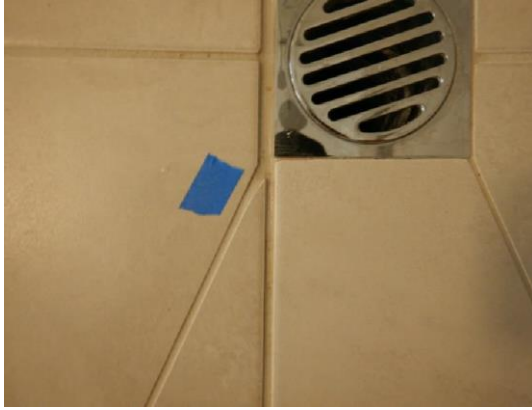
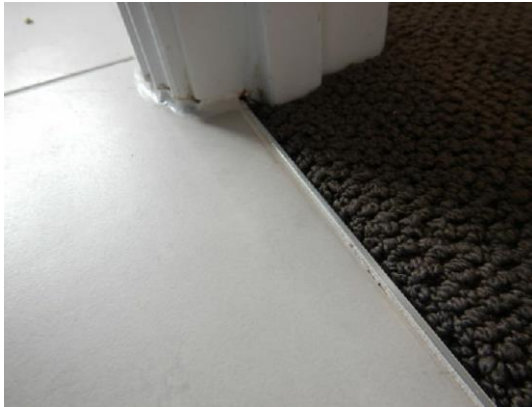
27.

All installed grout needs to be installed as per AS 3958.1, part 5.7.1. Any area presenting with these defects will need to be reworked prior to settlement.

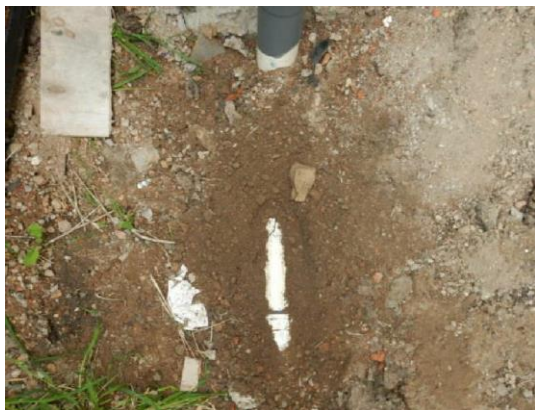
100mm cover to pipe
