Dwelling type:	House and Garage.
Dwelling configuration:	Double Storey
Nature of works:	New Building.
Stage of inspection:	Fixing & Waterproofing.
Construction Type:	Hebel.
Garage:	Attached.
Foundations:	Slab.
Builder:

An inspection was conducted at the above address on 27/04/2021 for the purpose of a general home inspection, requested by the 'client'.

Defects, observations and other related comments from the Fixing & Water Proofing Inspection on the 27/04/2021:

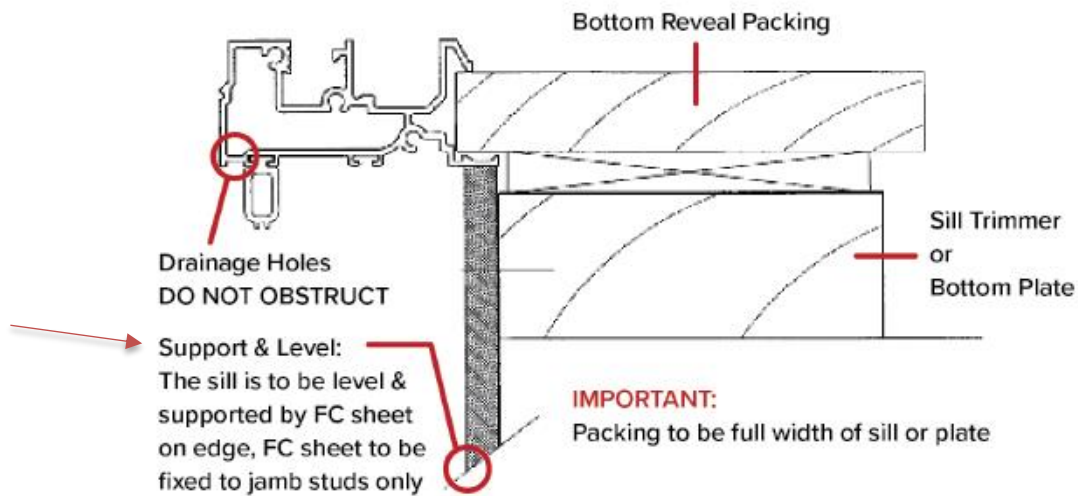
7. Item previously noted, not rectified at the time of Inspection on 27/04/21.

Installed windows assemblies shall prevent water penetration and excessive air infiltration.

All areas to comply

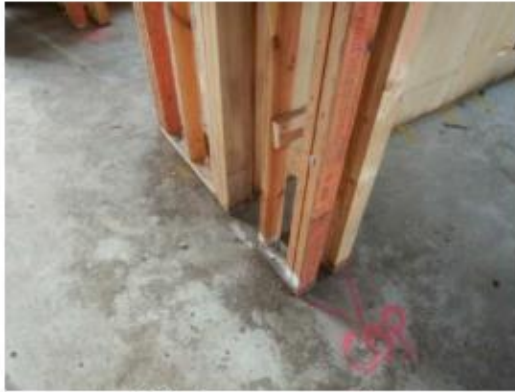
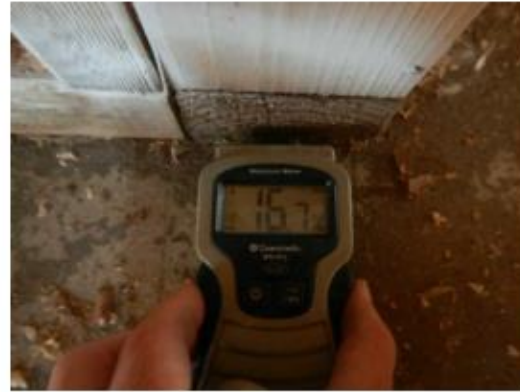
- 8. Item previously noted, concealed at the time of Inspection on 27/04/21.
Builder to confirm rectification carried out prior to concealing this item.**

AS 2589; 2.6.2 & AS 1684.2; Appendix E: - The maximum moisture content for seasoned timber at the time of installing gypsum linings shall be less than 15%.

All Areas to comply.

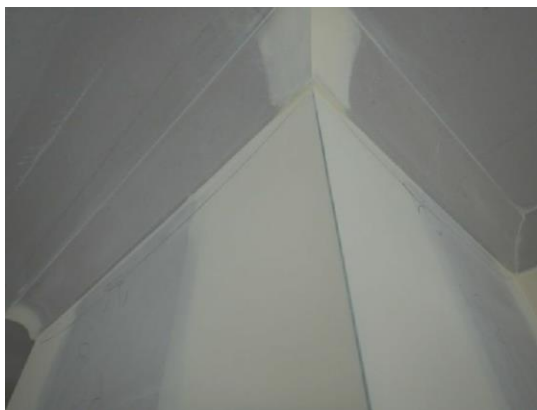
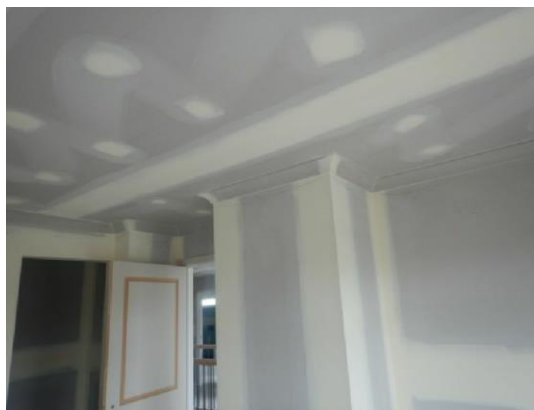
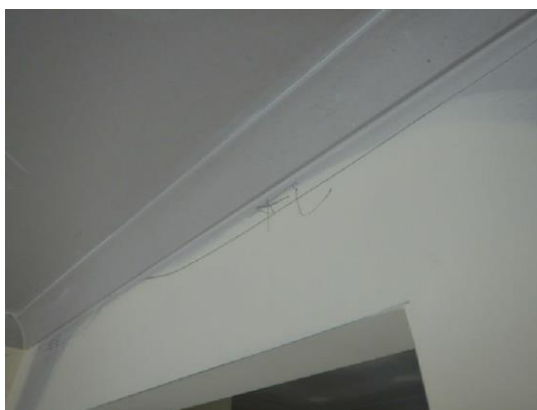
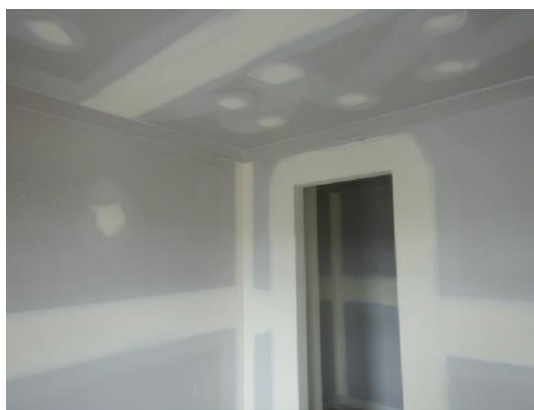
14.

There are a few areas in the home that exceed the allowance of 4 mm tolerance over 2 m.
