<b>Dwelling type:</b>	House and Garage.
<b>Dwelling configuration:</b>	Double Storey
<b>Nature of works:</b>	New Building.
<b>Stage of inspection:</b>	Fixing & Waterproofing.
<b>Construction Type:</b>	Hebel.
<b>Garage:</b>	Attached.
<b>Foundations:</b>	Slab.
<b>Builder:</b>

### **Defects, observations and other related comments from the Fixing & Water Proofing Inspection on the 10/02/2021:**

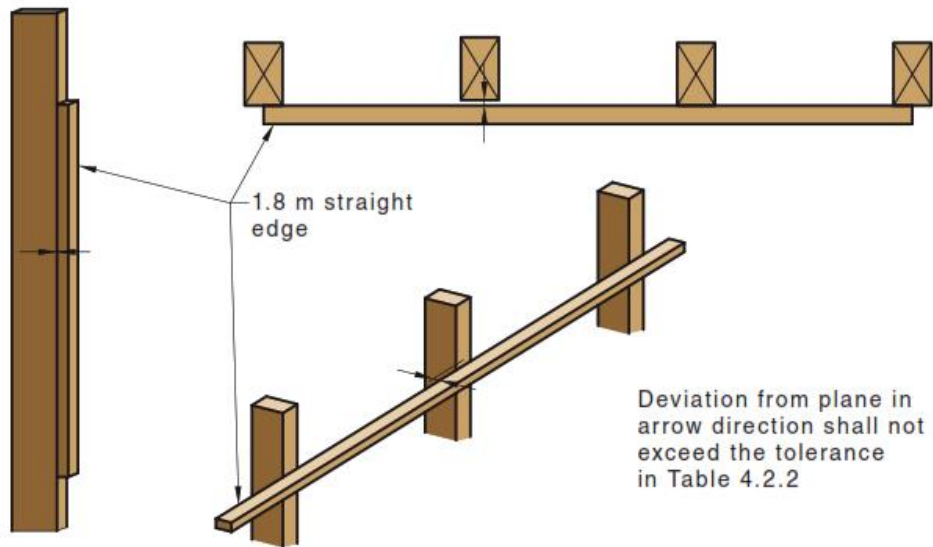
FIGURE 4.2.2(A) ASSESSING FRAMING TOLERANCE

The deviation in the position of the bearing surface of the finished framing immediately prior to installation of lining from a 1.8 m straight edge shall not exceed the values given in Table 4.2.2 when measured over a 1.8 m span at any point [see Figure 4.2.2(A)].

Where the dimensional tolerances of the fixing surface plane fall outside these tolerances, a suitable levelling system shall be used [see Figure 4.2.2(B)].

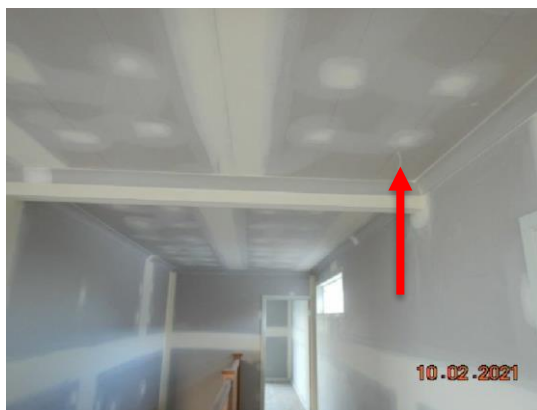
Out of alignment

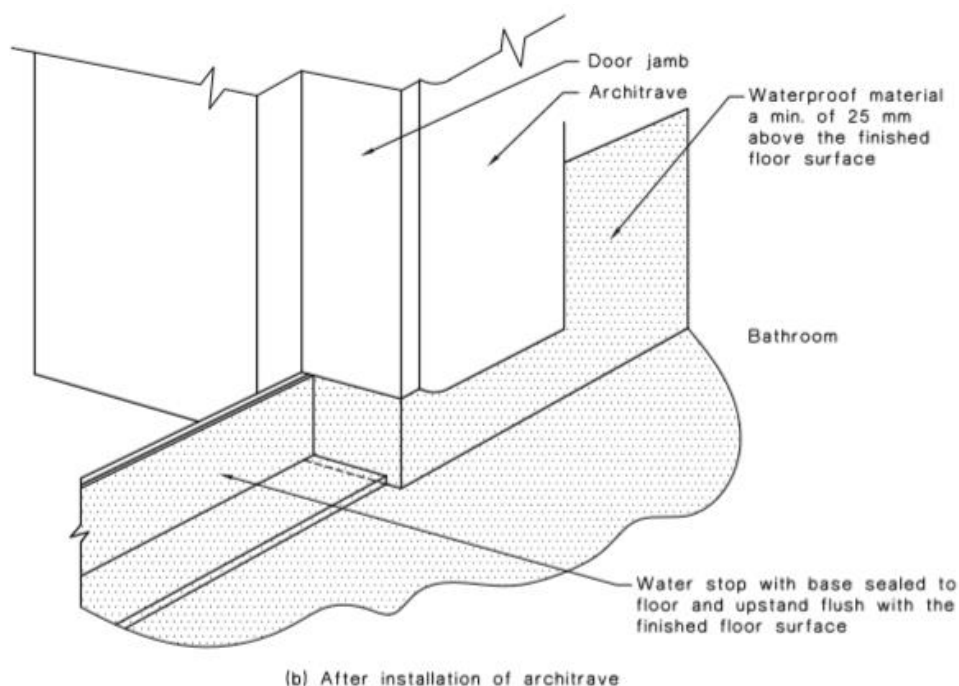
**FIGURE 3.3 TYPICAL BATHROOM DOOR DETAIL FOR WHOLE BATHROOM WATERPROOFING**

- 1 For typical door detail, see Figure 3.3.
- 2 Where possible, the doorjambs and architraves should be installed above the floor tiling.

**Note: Trimming of the architraves whilst in place must be done with extreme care so as not to damage the waterproofing membrane.**

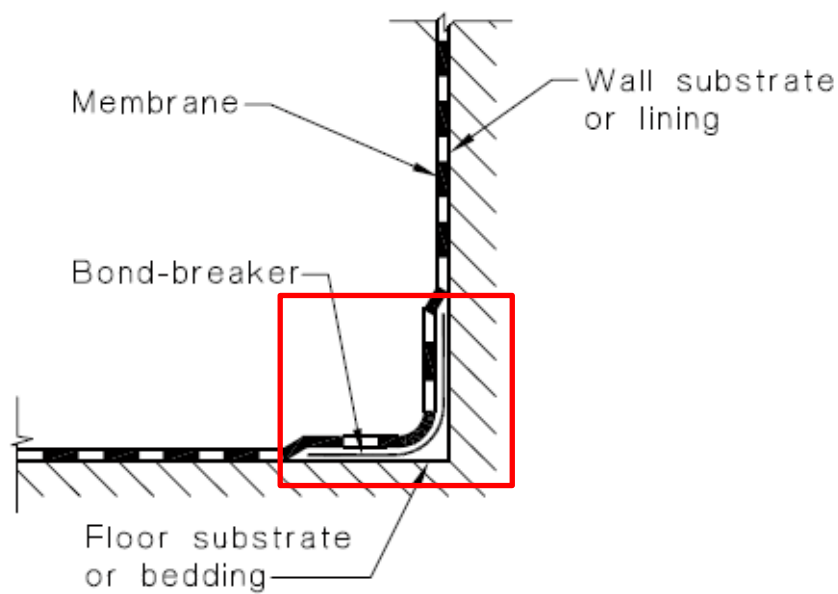
(b) Class II membrane

The floor junctions to all wet areas have not been waterproofed as per AS 3740. The junction is to be installed with bond breaker and as per the extract below.

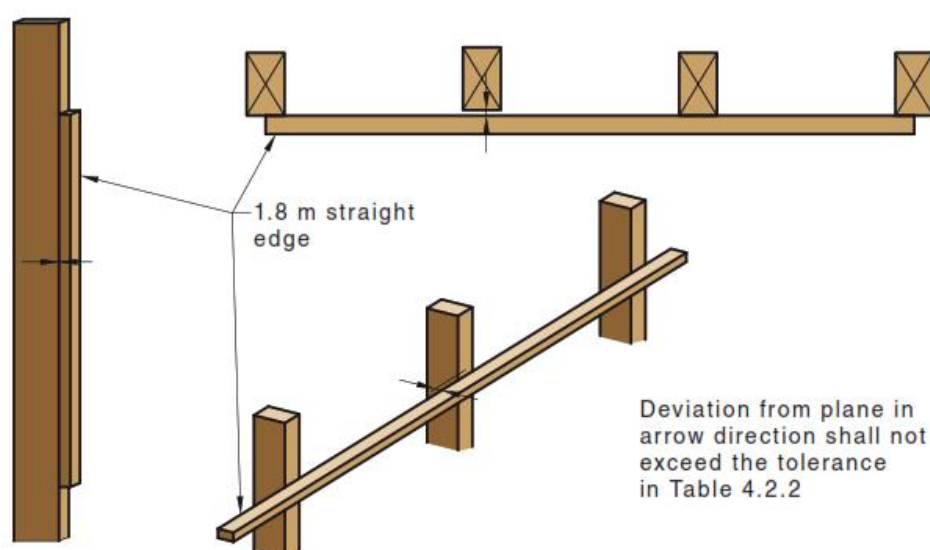
FIGURE 4.2.2(A) ASSESSING FRAMING TOLERANCE

The deviation in the position of the bearing surface of the finished framing immediately prior to installation of lining from a 1.8 m straight edge shall not exceed the values given in Table 4.2.2 when measured over a 1.8 m span at any point [see Figure 4.2.2(A)].

Where the dimensional tolerances of the fixing surface plane fall outside these tolerances, a suitable levelling system shall be used [see Figure 4.2.2(B)].

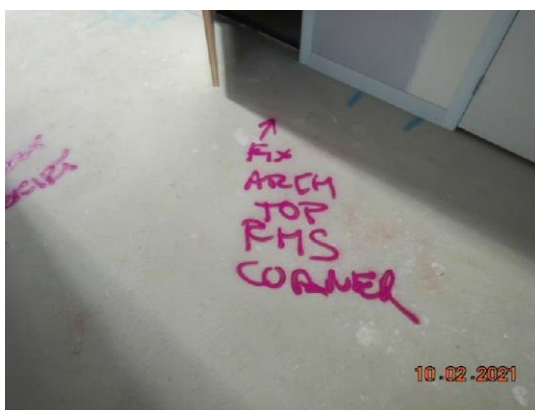
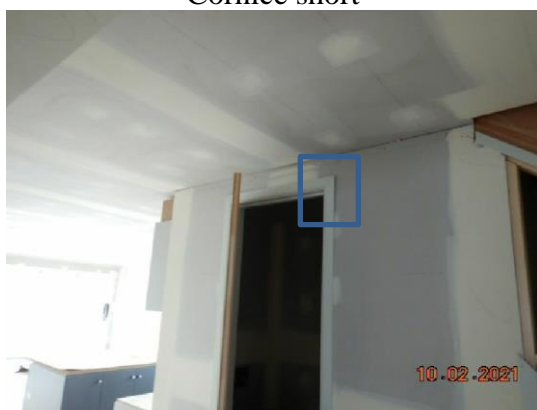
Cornice short

**Rectification Required: YES**
