Dwelling type:	House and Garage.
Dwelling configuration:	Single Storey.
Nature of works:	New Building.
Stage of inspection:	Frame.
Construction Type:	Brick Veneer.
Garage:	Attached.
Foundations:	Slab.
Builder:

Schedule of Defects:

Defects, observations and other related comments from the Frame Inspection on the 20/04/2021:

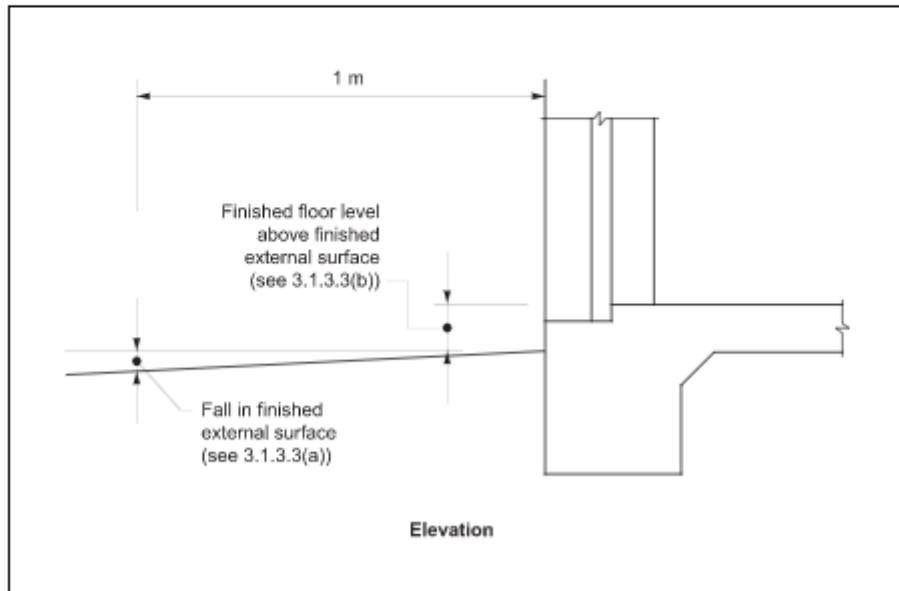
3.

We noted an amount of what is known as bony finish to the edge beam of the home. That is the edge is presenting with air pockets that should have been vibrated out of the installation.

We also noted what is commonly referred to as cold joints in the concrete installation. That is where the installation of concrete has had laps in time between filling sections. You can clearly see the layers of concrete to the side of the slab.

The engineering also calls for the same in the site engineering plans. The builder must ensure that these defects are not present to a slab as it can in certain circumstances weaken the slab.

It is our recommendation that the builder seeks a professional opinion from the site engineers in relation to this defect and seeks documentation to either dismiss my findings or make recommendations on some level of rectification.

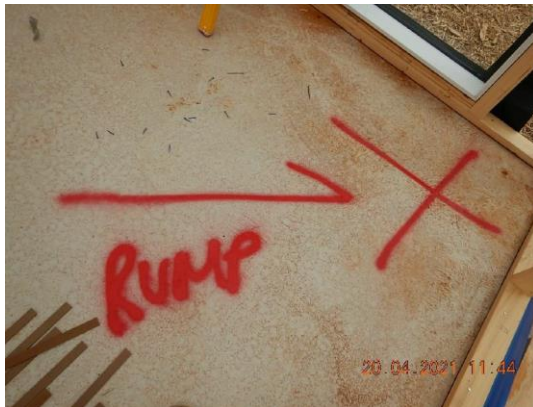
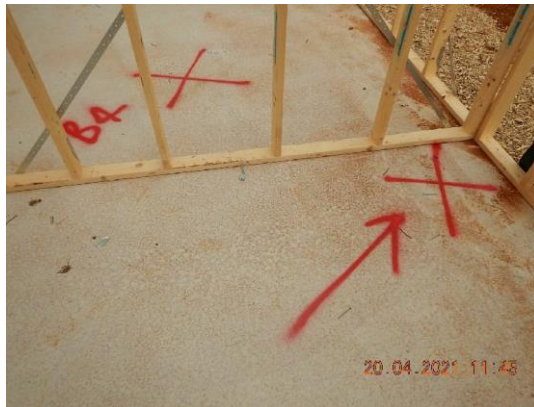
21.

We refer the builder to the implied warranties where the builder agreed to build the dwelling in a **proper and workmanlike manner and with care and skill**.
