Dwelling type:House and Garage.Dwelling configuration:Single Storey.Nature of works:New Building.Stage of inspection:Pre Pour.Construction Type:Brick Veneer.Garage:Attached.Foundations:Slab.

# **Inspection and Report**

<u>Defects</u>, observations and other related comments from the Pre Pour Inspection on the 27/04/2021:

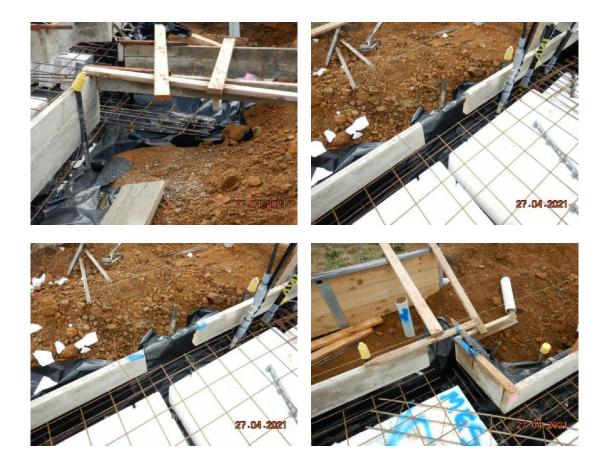
1.

**NCC 3.2.2.1:** - Gaps between the formwork and the ground may result in concrete overpour. The concreter needs to either add additional boards or vigilantly trim the concrete excesses whilst wet to create vertical sides that will not add to the bearing area of the edge beam and will not interfere with future landscaping and paths.

Non vertical sides of slab edge beams do not comply with the NCC.

# 3.2.2.1 Excavation for footings

(a) Excavation for footings, including thickenings for slabs and pads must be clean cut with vertical sides, wherever possible.

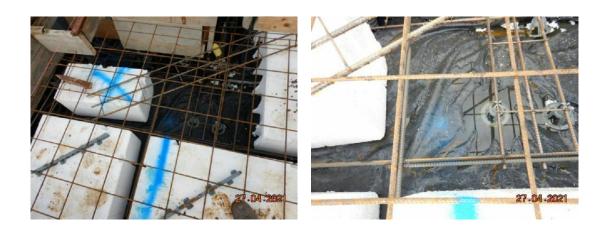
4.

**AS 2870; 3.4.3:** - Pods have been deleted resulting in widening of the designed beam width. The missing pods need to be installed or additional reinforcing bars are required to be installed in accordance with the following.

The current installation does not meet this requirement.

Additional reinforcement shall be provided for all beams where the stem width exceeds 150 mm. The size and specification of top bars shall be the same as bottom bars except as specified in Figure 3.4. The total number of reinforcement bars in beams shall be as follows:

# FIGURE 3.4 (in part) WAFFLE RAFT

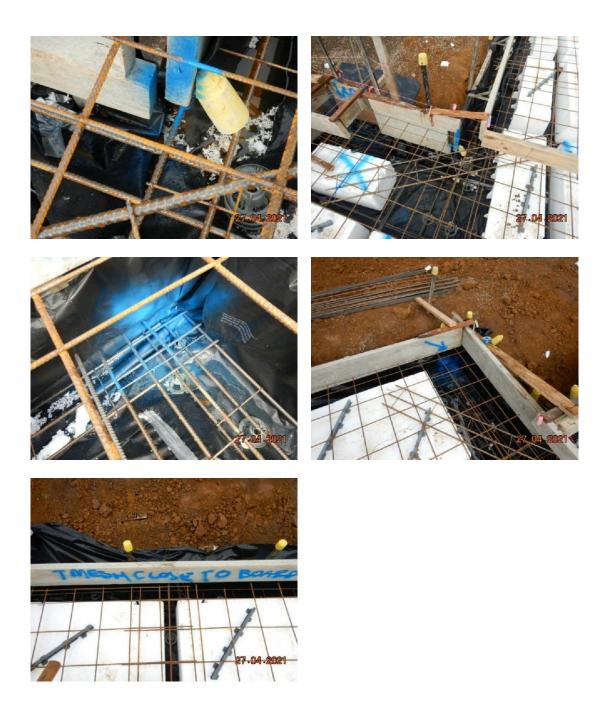
5. NCC 2019, 3.2.3.2 (d): - The minimum distance from the outer edge of reinforcement bars to the formwork is 30mm.

Areas of reinforcement steel to this dwelling do not comply with this minimum requirement.

- (d) Footings and slabs-on-ground must have concrete cover between the outermost edge of the reinforcement (including ligatures, tie wire etc.) and the surface of the concrete of not less than the following:
  - (i) 40 mm to unprotected ground.
  - (li) 30 mm to a membrane in contact with the ground.
  - (iii) 20 mm to an internal surface.
  - (iv) 40 mm to external exposure.

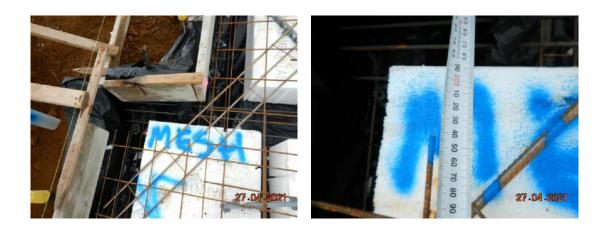
**AS 2870, Residential Slabs and Footings:** - The slab fabric finishes short of the edge rebate formwork and does not transition over the footing or edge beam. It therefore falls short of the proposed external loadbearing frame. Ideally, all slab fabric should

terminate approximately 40mm from the edge rebate but at no times closer than 30mm. This is depicted in all slab diagrams in AS 2870.

The slab fabric is short in areas and therefore has not met this requirement.

FIGURE 3.4 (in part) WAFFLE RAFT
