ABN 12 115 961 487  
PO Box 88  
Bacchus Marsh Vic 3340  
Phone: (03) 5366 6900  
Email:  
Report By:

<b>Dwelling type:</b>	House and Garage.
<b>Dwelling configuration:</b>	Single Storey.
<b>Nature of works:</b>	New Building.
<b>Stage of inspection:</b>	Final 2nd Re-inspection.
<b>Construction Type:</b>	Brick Veneer.
<b>Garage:</b>	Attached.
<b>Foundations:</b>	Slab.
<b>Builder:</b>

### **Defects, observations and other related comments from the Final Inspection on the 2021:**

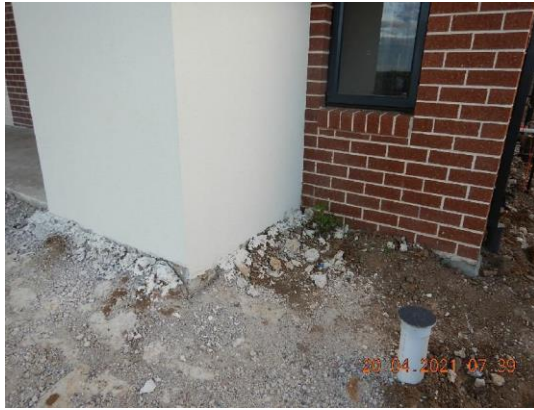
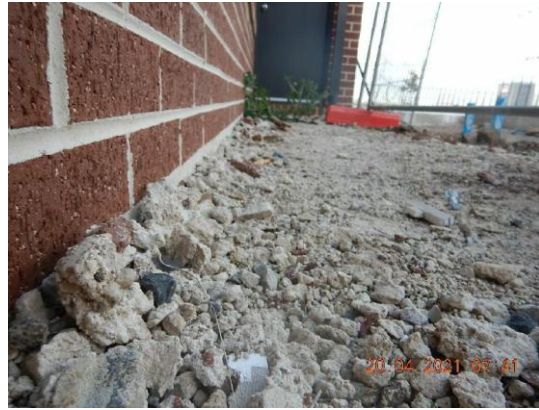
It was noted in parts around the dwelling the Vapour Barrier has been allowed to fall below FGL. Other areas are well installed.

It is a requirement of Part 3.2.2.6 Vapour Barriers of the NCC that *'The vapour barrier must be placed beneath the slab so that the bottom surface of the slab is entirely under laid and extends under edge beams to finish at ground level in accordance with Figure 3.2.2.3.'*

Otherwise, the builder must ensure that the barrier is fully installed as per the NCC and AS 2870.

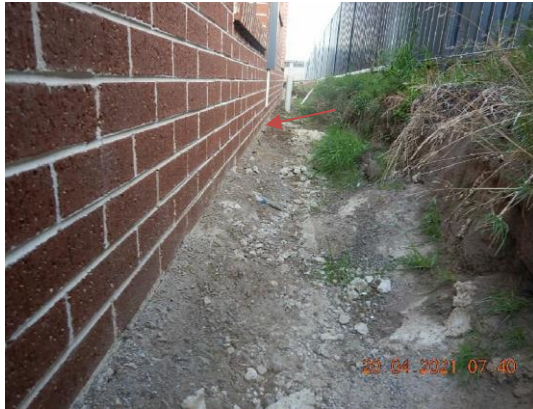
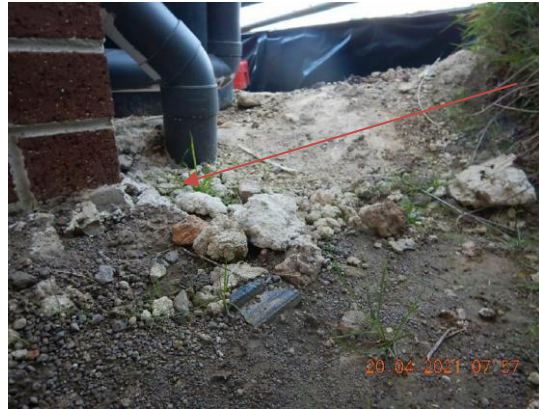
## 2.

The dwellings slab footings can pool with water due to the way the block has been cut and the lack of back filling.

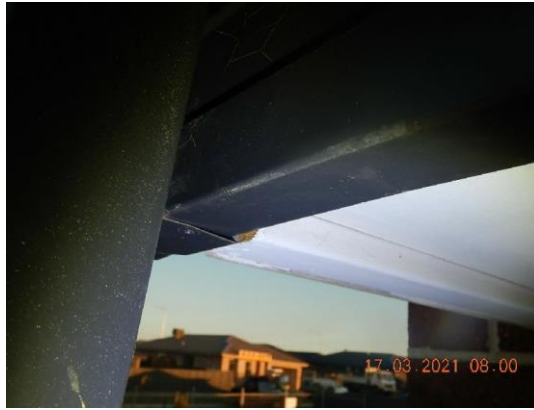
Front porch.

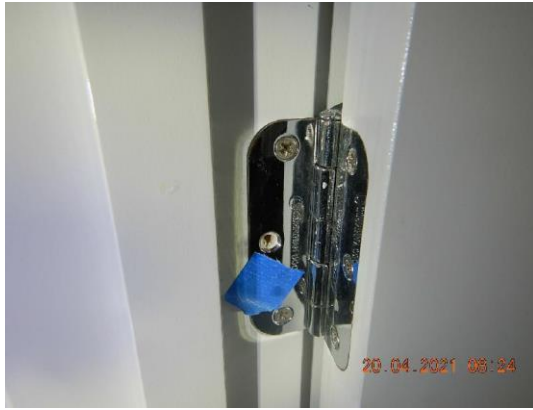
Screws & over paint.

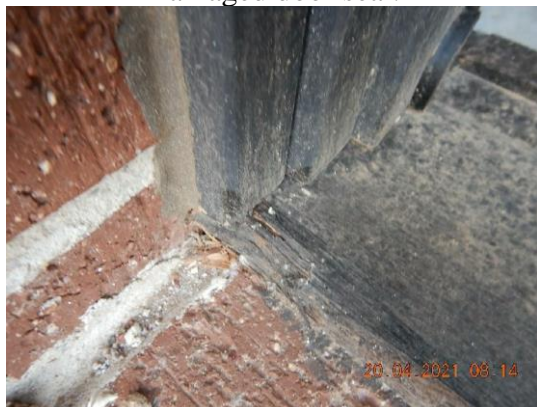
Hammer damage garage rear door.

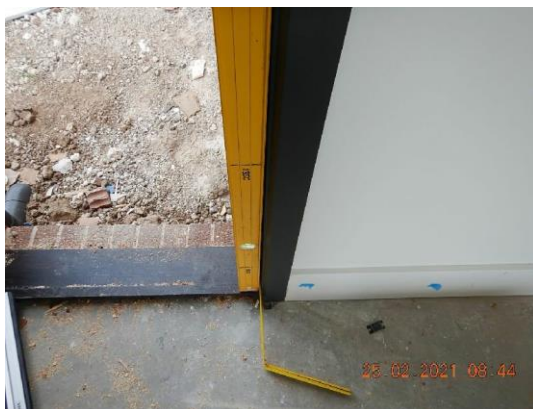
A small number of window and door frames are presenting out of plumb more than the 4 mm over 2 m tolerance.

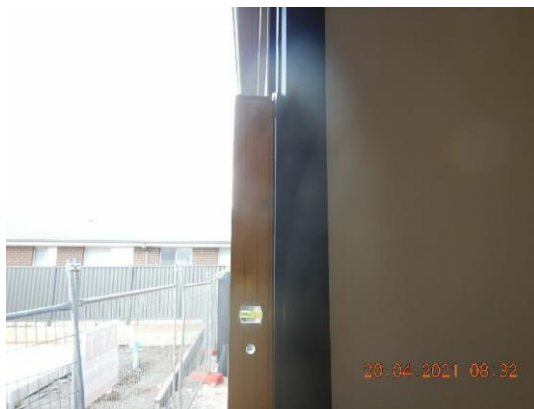
Garage.

Frame is still bowed, door difficult to latch.

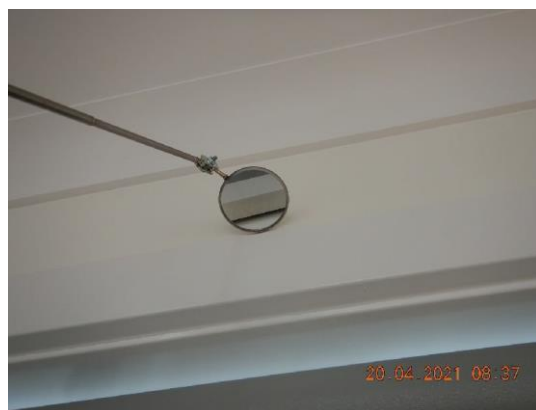
The required weather seal as documented is non-functional. The NCC and the energy report on the dwelling calls for all doors and windows to be sealed, all areas must comply.

All areas to comply.

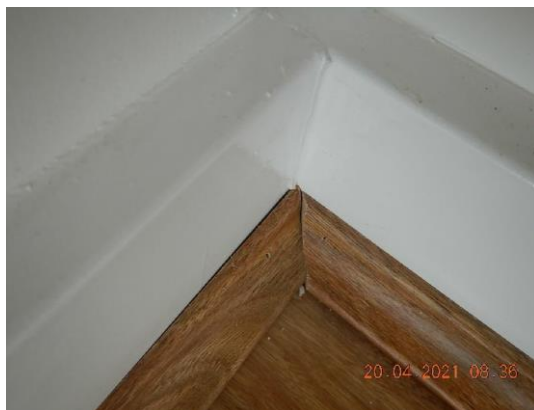
Misaligned.

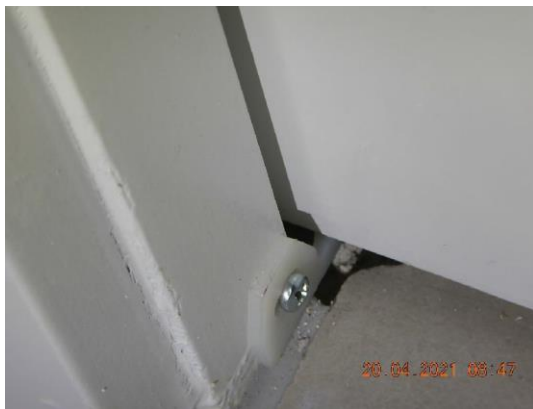
Chipped.

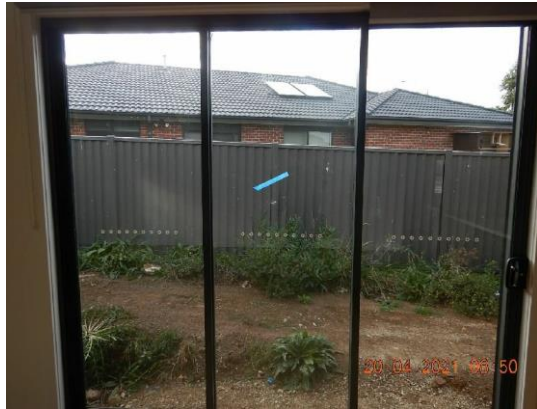
Scratched.

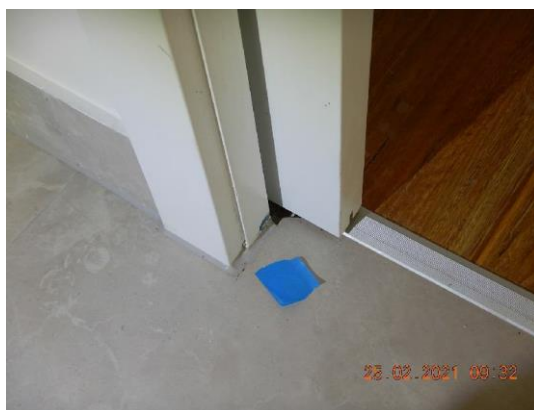
### 28.

Under the cavity sliding doors there are not water stops. A rigid water stop must pass in front (or below) any plastic guide that may be installed, creating the waterproof seal to the perimeter.

The Australian Standard 3740 states that a complete barrier at the door opening is required to contain moisture within the wet area to prevent damage occurring to building elements. The water stop angle is to be waterproofed to the perimeter flashing.

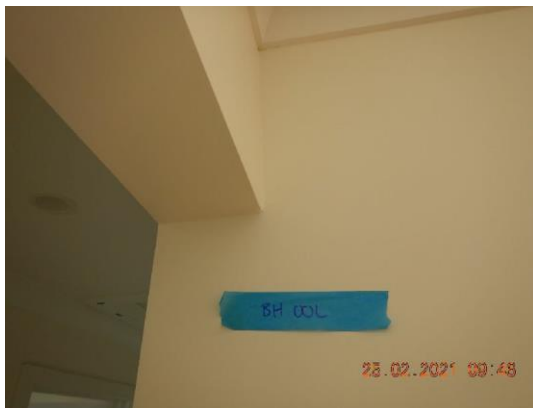
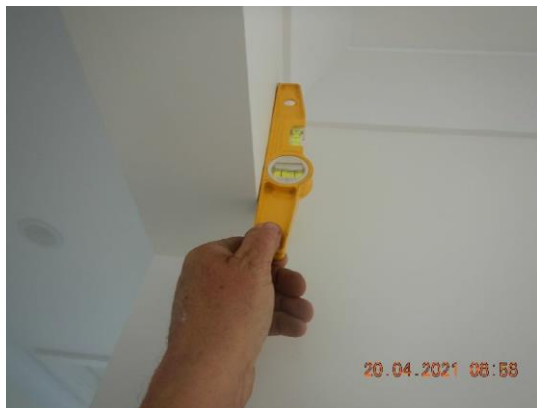
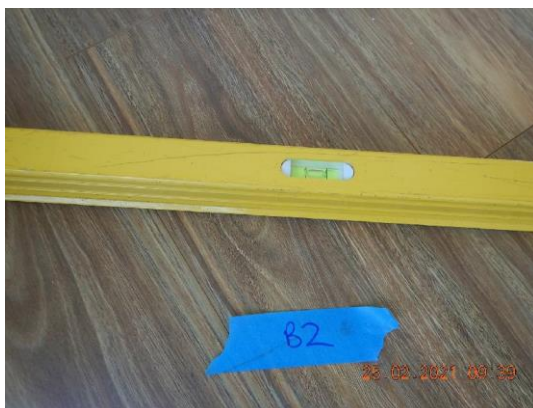
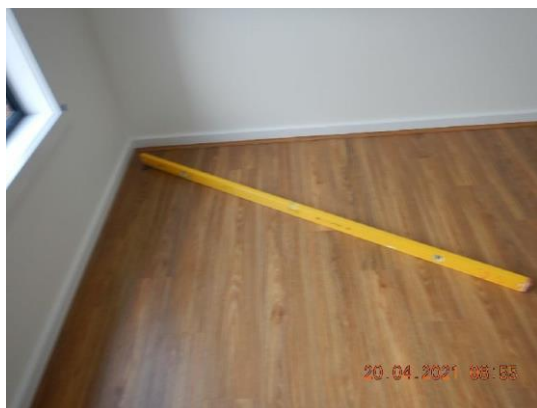
### 29.

There are a few areas in the home that exceed the allowance of 4 mm tolerance over 2 m.

Frames are defective if they deviate from plane (horizontal or vertical bow) by more than 4 mm in any 2 m length of wall. Refer to Diagram E.

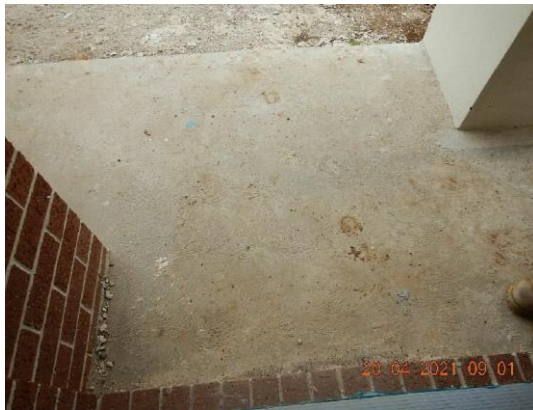
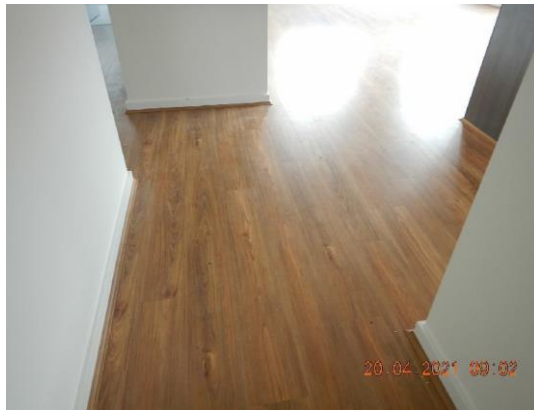
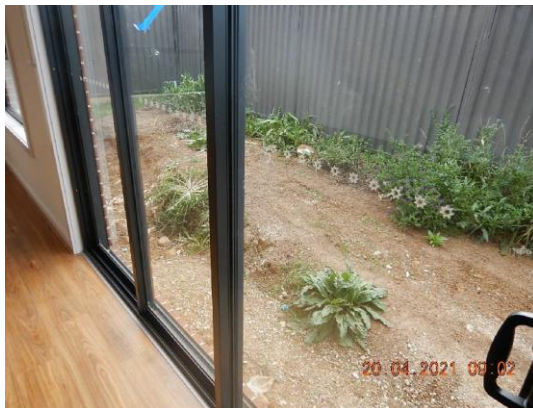
30.

**VBA guide to standards and tolerances 2015:** - All areas shall be cleaned prior to handover, in accordance with part 18.08.

Building sites are defective if they are not clear of building debris.

Building works are defective where windows are not clean, floors are not swept, mopped or vacuumed as appropriate, tiles, sinks, basins, troughs, baths, etc. are not cleaned, and shelving, drawers and cupboards ready for use.

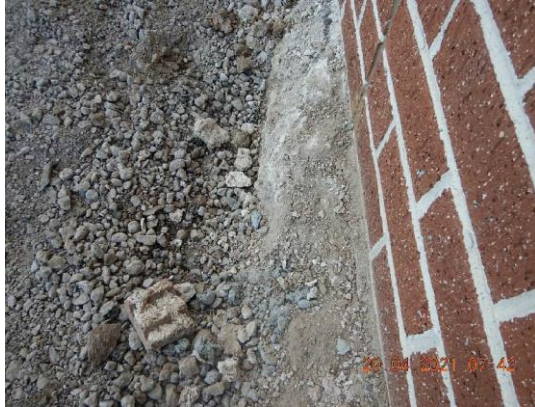
Garage.

Concrete over pour increases the effectiveness of the footing width and depth and decreases the bearing capacity required to support the external walls. This can result in lifted or more highly loaded areas. Concrete over pours below finished ground level allows water to accumulate on top of the footings and prevents normal evaporation drying of subsoil moisture. Concrete over pours can interfere with future site works or landscaping.

All footings in the NCC and AS 2870 are shown with edges of their footings vertical and without overspill, easily achieved with adequate boxing.

All excess concrete over pour from the dwelling needs to be removed to allow the footing to work efficiently as designed.

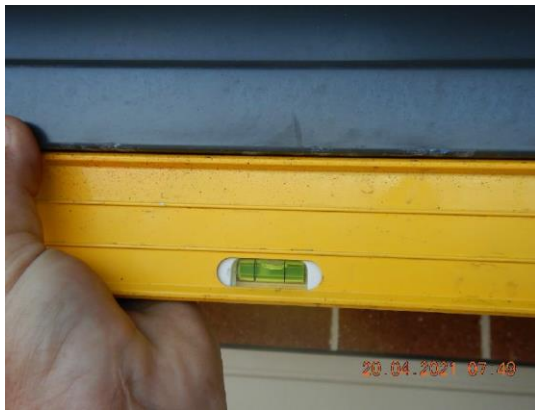
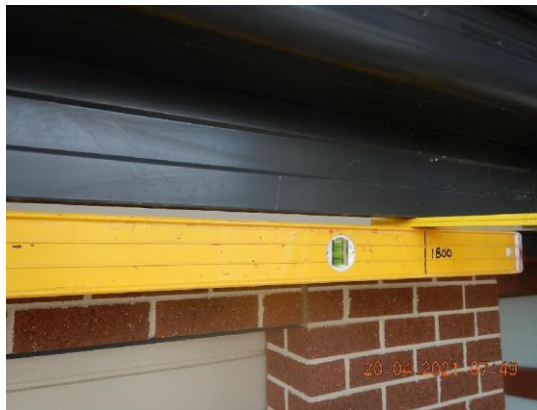
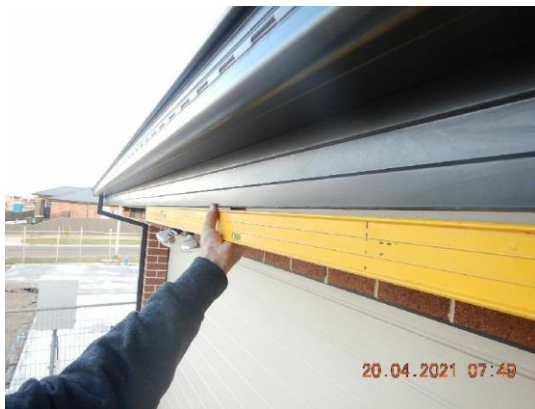
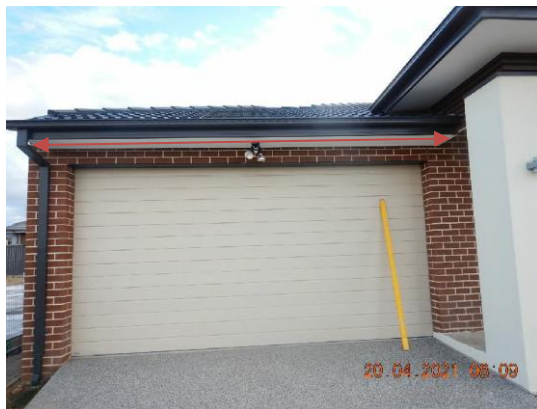
36.

Front facade - the eave trimming is uneven to the brickwork line. It is also showing the fascia out of level, front elevation.

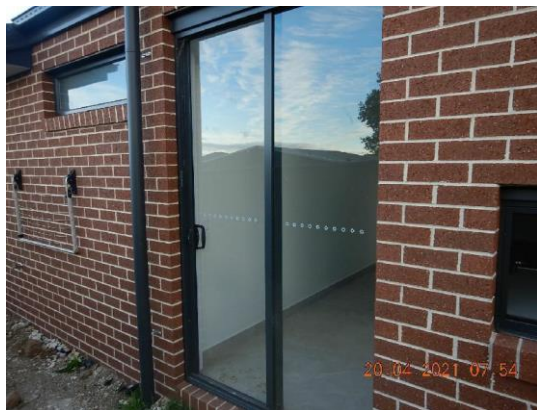
Loose.

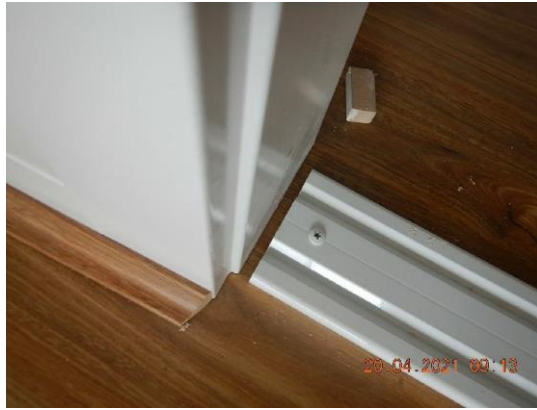
Short track.

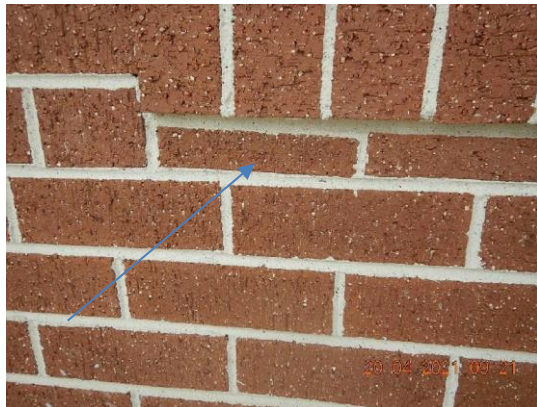
Brick OOL front elevation.

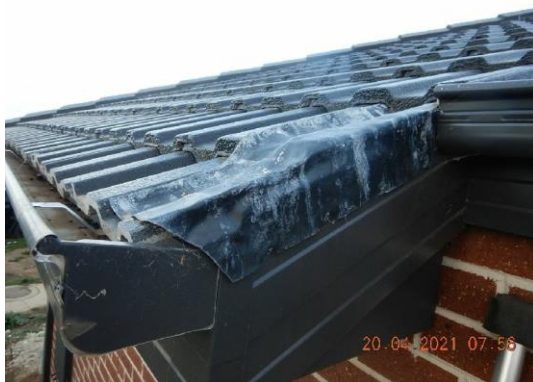
Unsightly flashing, poor workmanship.

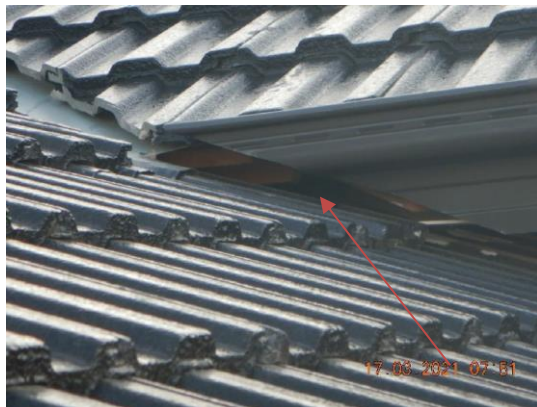
Excessive gap, rework.

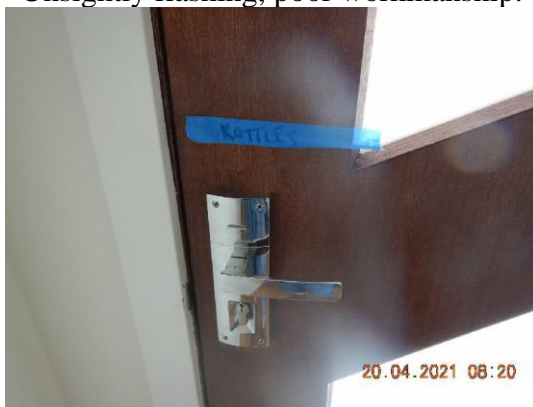
Rattles.

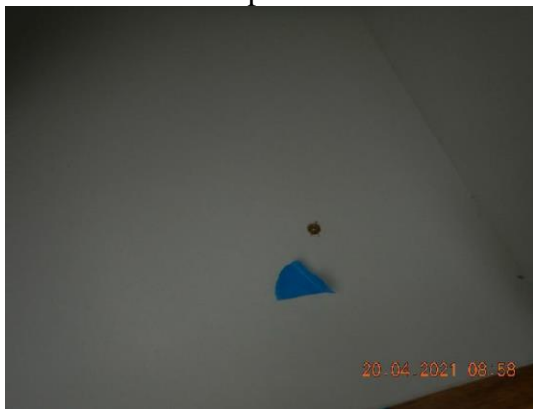
Screws in cupboards not capped.

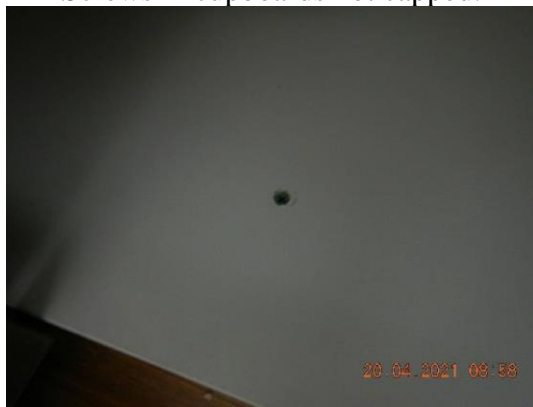
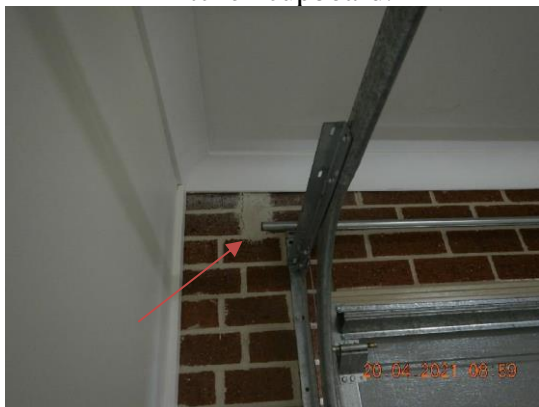
Poor workmanship, rework.

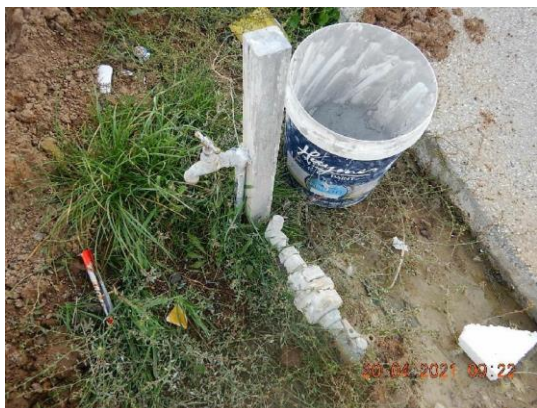
### 38.

The front water meter has been damaged and needs to be made new prior to hand over. The meter and tap have been covered in builder's waste. The meter was new when the project started and is not the property of the builder to damage. It must be made "as new" prior to handover.

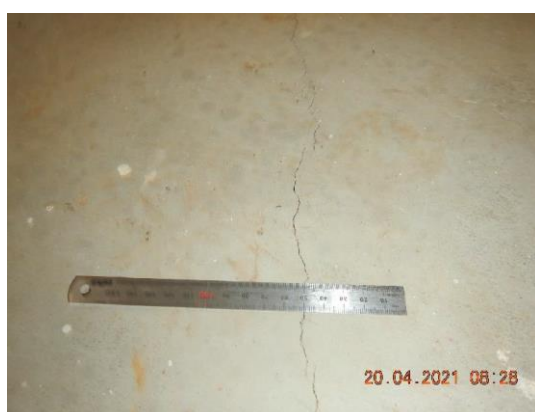
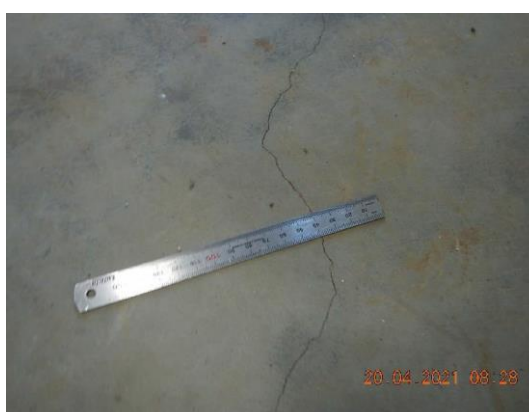
The concrete slab surface is showing category 1 cracking, these cracks are measuring between 1 - 2mm.

Category 1 and 2 cracks to slabs are to be monitored for a period of 12 months. At the end of the monitoring period, cracks are defective if they are greater than category 2 and attributed to the actions of the builder.

The builder and or homeowners may choose to photograph and document the cracking, then monitor its stability and changes (if any) over an agreed period.

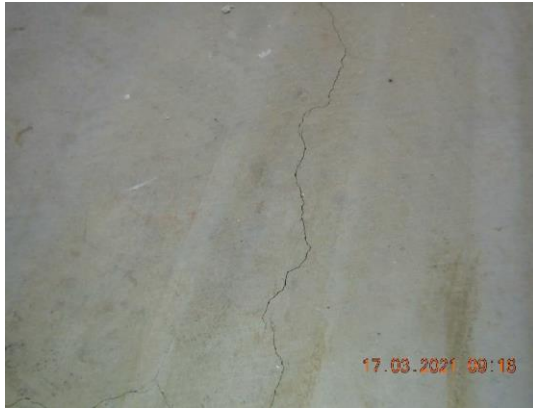
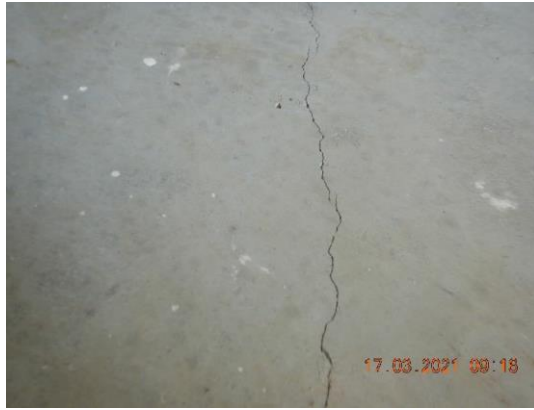
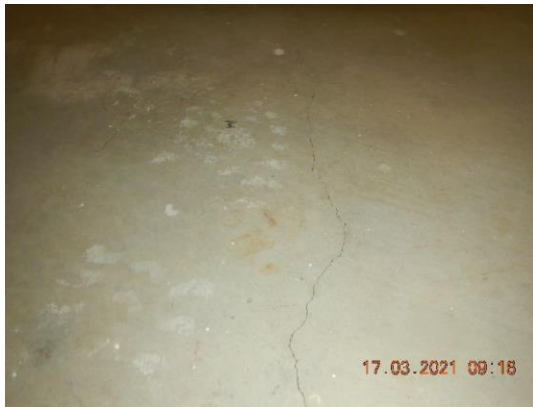
Cracks to slabs are defective where they are Category 3 and 4.
